Creek Erosion Control and Constructed Drainage Channel Case Studies

Version 2, 2022

Prepared by: Grant Witheridge, Catchments and Creeks Pty Ltd

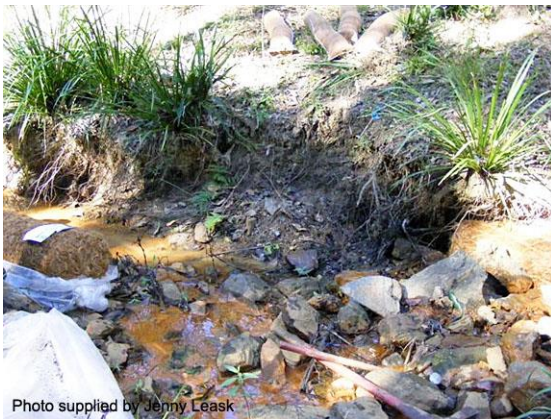
- On the southern bank of the tributary (opposite the eroded, dispersive soil bank) the soils are more stable, but high velocity flows discharging from the upstream culvert had caused significant toe erosion.
- The toe of the bank was stabilised with jute logs and planted with *Lomandra*.
- Both the jute log stabilisation of the *Lomandra* plants proved successful in stabilising the toe of the bank.

Bank erosion (2012)

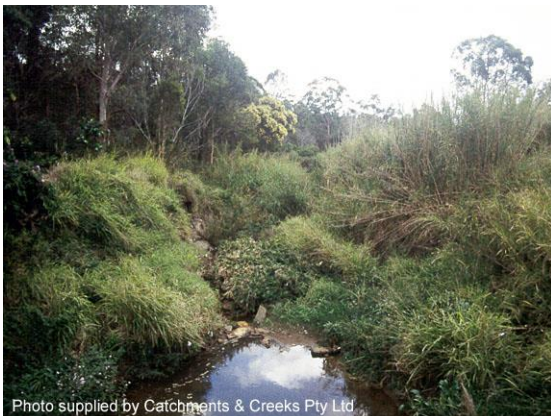
Looking downstream from Rode Rd (1997)

- With the weeds removed, and with the failed establishment of an effective native plant cover, the western bank (shown here to the left of the channel) experienced significant erosion (just visible in this 1997 image).
- Significant weed establishment along the bed of the creek also increased the erosion stress on the creek bank.

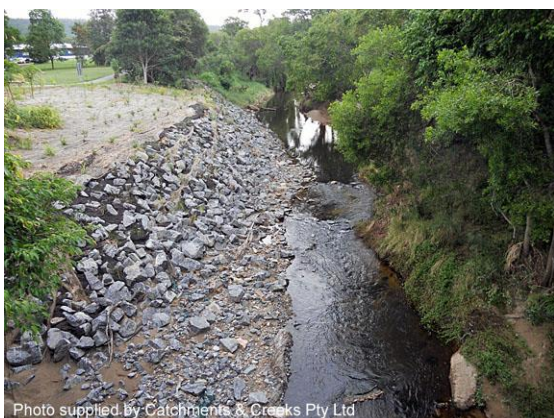
Damage by high bank stream flow, 8/2/13

Flood damage, 2013

- Moderate creek flooding in early 2013 caused the total loss of the jute mesh from the creek bank.
- However, the jute mesh remained in the over-bank area where the mesh was able to be adequately pinned into the soil.

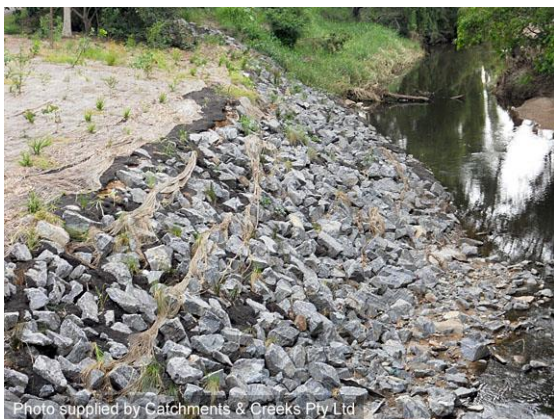
Removal of jute mesh, 8/2/13

Flood damage, 2013

- Some soil was lost from the rock voids; however, significant quantities of soil remain.
- The adverse outcomes produced by the loss of soil from the bank during floods are considered to be out-weighted by the potential benefits gained by actively promoting early plant establishment over the creek bank.

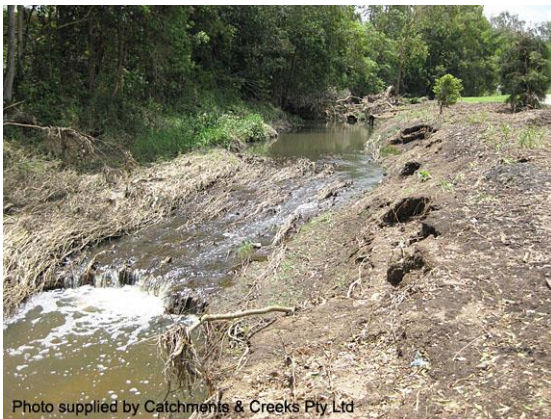
Looking upstream (2008)

- In 2008 a storm event caused significant bank erosion along the area previously cleared of weeds.
- Adding to the erosion problem was the fact that the eroded bank had a southern aspect resulting in the bank being heavily shaded once a near-vertical bank was formed through the creek erosion.
- The eroding creek bank progressively moved north towards the now established over-bank trees.

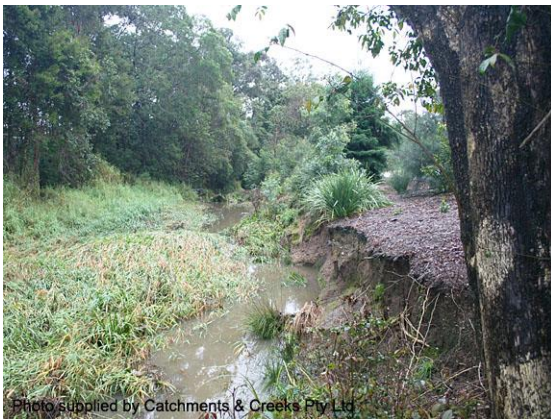
- Bank erosion commenced during the 2008 micro-storm that severely damaged the nearby suburb of The Gap.
- The top-of-bank is just 1 metre from the base of the tree (visible in top-right of image).

Looking upstream, November 2010

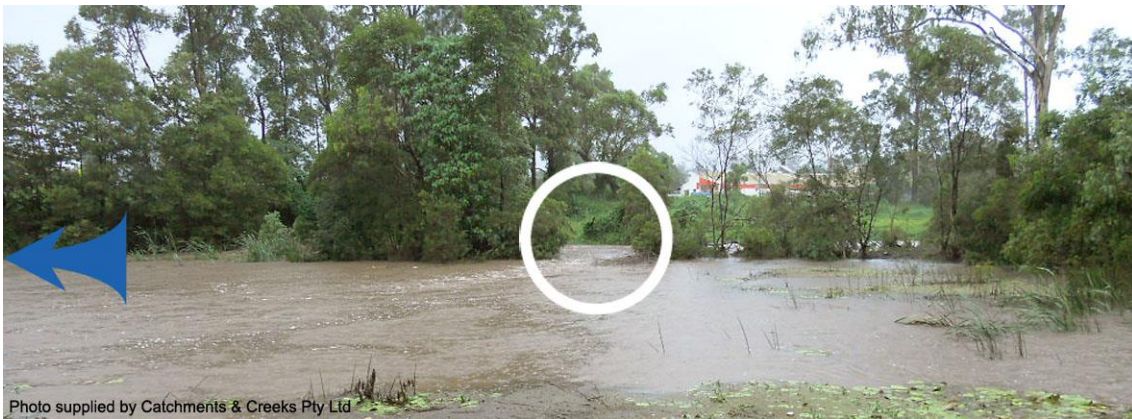
- On the 11 October 2010, flood waters passing down Kedron Brook reached and held a height of 'bankful flow' for an extended period of time.
- Floodwaters spilt from the main Kedron Brook channel into the stormwater treatment wetland causing significant damage to the connecting embankment.
- Floods during 2009, 2010, and 2011 had also caused significant erosion along the northern bank of Kedron Brook just upstream (to right) of the wetland.

Over-bank spill-through on 11 October 2010 (Ferny Way culvert to left)

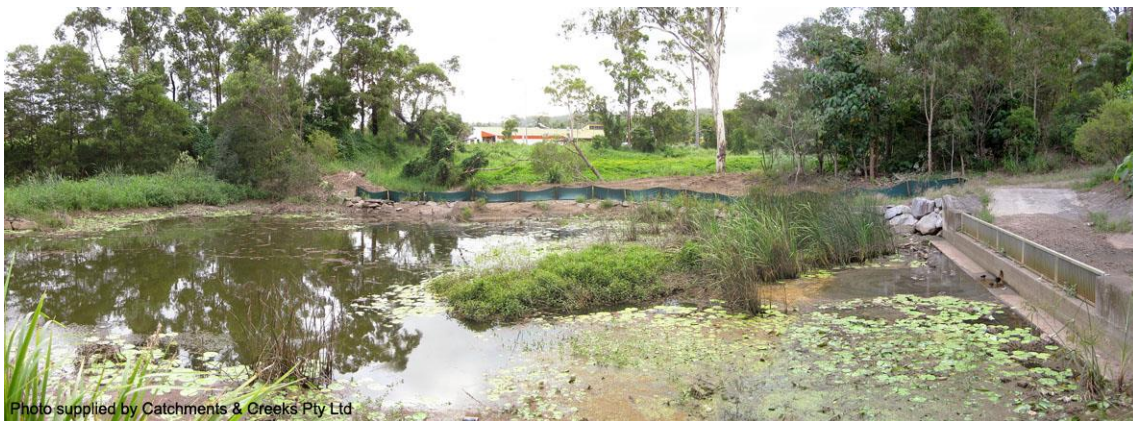
Re-construction of creek bank, January 2011 (Kedron Brook in background)

- As a result of the extensive bank damage caused during 2010 and 2011, the northern creek bank (the outside bank of a sweeping channel bend) was stabilised with rock as part of the emergency, post-2011 flood works.
- The bank was lined with rock, all voids filled with soil, covered with jute mesh, and pocket planted with natives.
- The chosen native plants have low woody branches, which will add bank roughness.

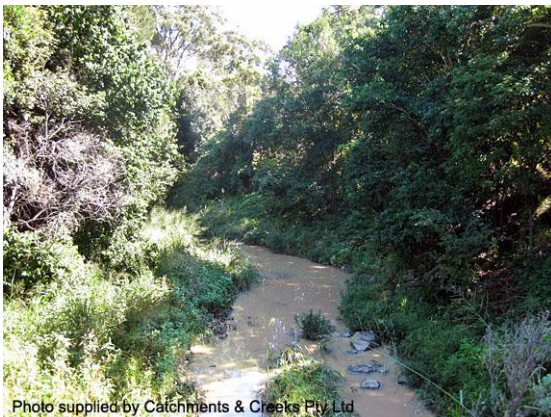
- Riparian vegetation has thinned due to the past drought.
- Channel bed thick with weeds, mainly grasses.
- This image shows the channel just after a storm that caused the bed vegetation to fold in the direction of the flow.

Looking upstream from Wardell St (2011)

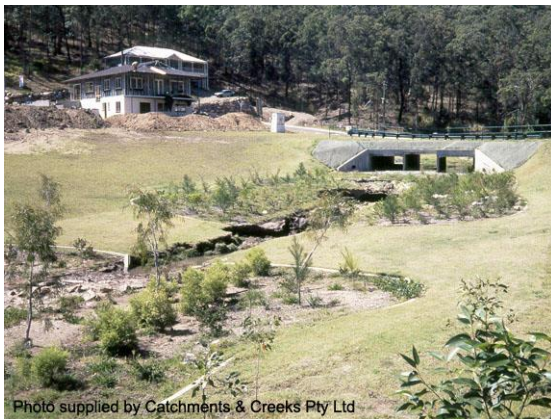
Damage to landscaping by storm (1996)
