# **Creek Erosion Control and Constructed Drainage Channel Case Studies**

## **Creek Erosion Control and Constructed Drainage Channel Case Studies**

Version 2, September 2022

Prepared by: Grant Witheridge, Catchments and Creeks Pty Ltd

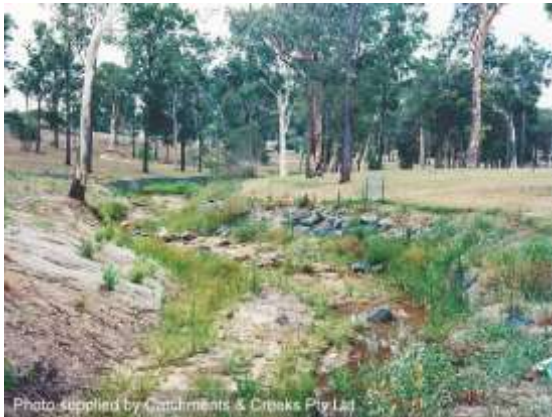
- This creek passes through a region of highly erodible dispersive subsoils.
- The creek had largely been cleared of riparian vegetation resulting in a weedy, open canopy waterway.
- In the past, parts of the creek had been stabilised with grouted rock, which is now failing largely due to the highly erodible underlying soils.

Repaired creek bank on right (1995)

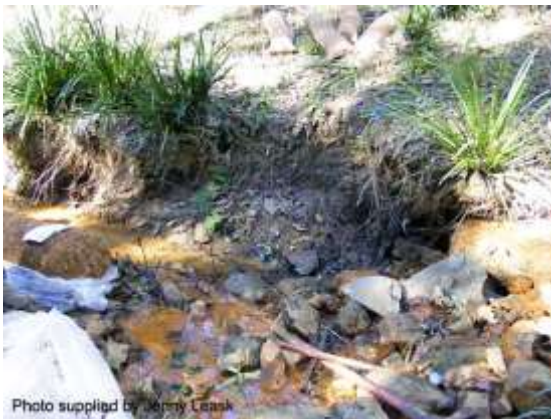
- On the southern bank of the tributary (opposite the eroded, dispersive soil bank) the soils are more stable, but high velocity flows discharging from the upstream culvert had caused significant toe erosion.
- The toe of the bank was stabilised with jute logs and planted with *Lomandra*.
- Both the jute log stabilisation of the *Lomandra* plants proved successful in stabilising the toe of the bank.

Bank erosion (2012)

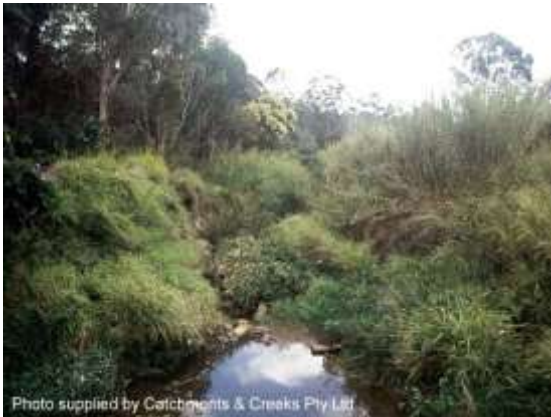
**Looking downstream from Rode Rd (1997)**

- With the weeds removed, and with the failed establishment of an effective native plant cover, the western bank (shown here to the left of the channel) experienced significant erosion (just visible in this 1997 image).
- Significant weed establishment along the bed of the creek also increased the erosion stress on the creek bank.

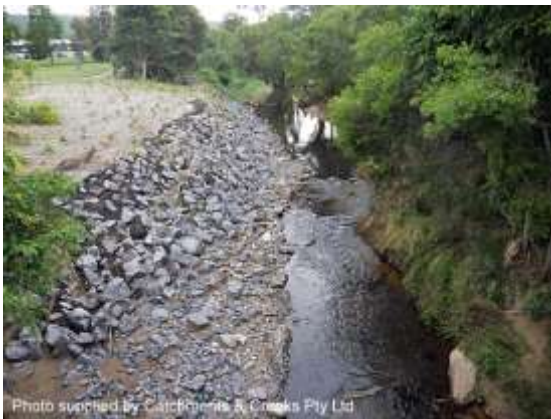
Damage by high bank stream flow, 8/2/13

- Moderate creek flooding in early 2013 caused the total loss of the jute mesh from the creek bank.
- However, the jute mesh remained in the over-bank area where the mesh was able to be adequately pinned into the soil.

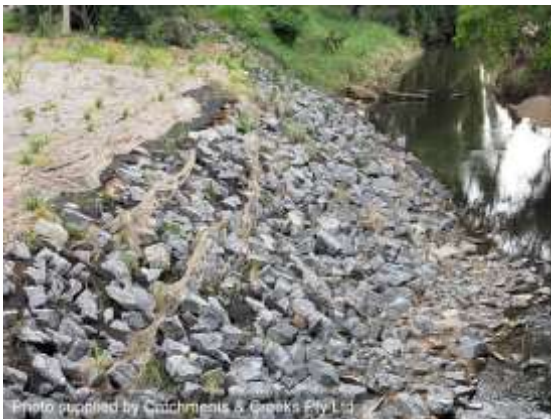
Removal of jute mesh, 8/2/13

- Some soil was lost from the rock voids; however, significant quantities of soil remain.
- The adverse outcomes produced by the loss of soil from the bank during floods are considered to be out-weighed by the potential benefits gained by actively promoting early plant establishment over the creek bank.

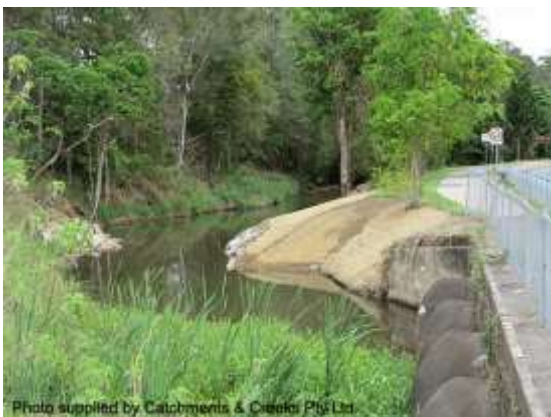
Looking upstream (2014)

- In 2008 a storm event caused significant bank erosion along the area previously cleared of weeds.
- Adding to the erosion problem was the fact that the eroded bank had a southern aspect resulting in the bank being heavily shaded once a near-vertical bank was formed through the creek erosion.
- The eroding creek bank progressively moved north towards the now established over-bank trees.

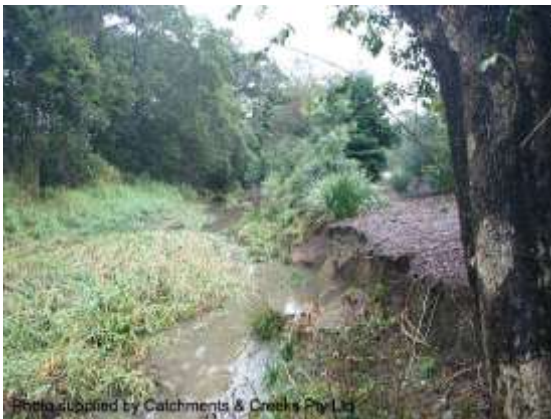
Looking upstream, November 2010

- Bank erosion commenced during the 2008 micro-storm that severely damaged the nearby suburb of The Gap.
- The top-of-bank is just 1 metre from the base of the tree (visible in top-right of image).

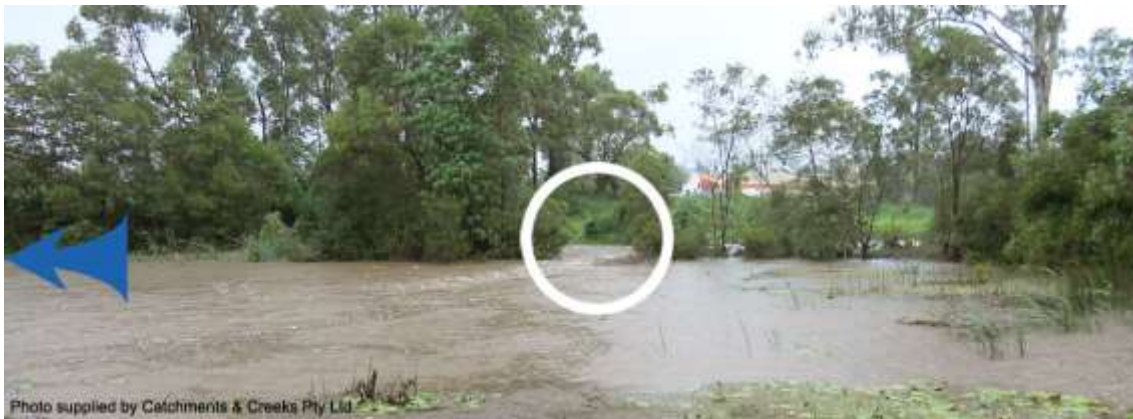
- On the 11 October 2010, flood waters passing down Kedron Brook reached and held a height of 'bankful flow' for an extended period of time.
- Floodwaters spilt from the main Kedron Brook channel into the stormwater treatment wetland causing significant damage to the connecting embankment.
- Floods during 2009, 2010, and 2011 had also caused significant erosion along the northern bank of Kedron Brook just upstream (to right) of the wetland.

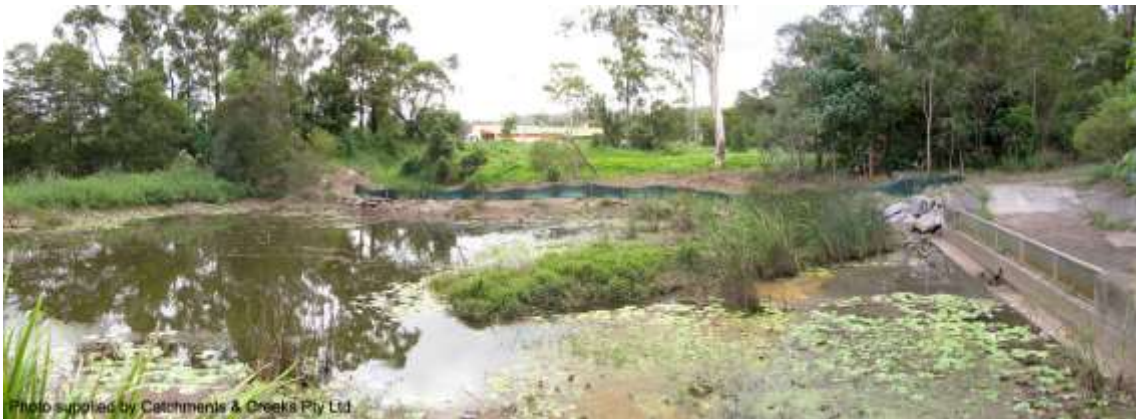
- As a result of the extensive bank damage caused during 2010 and 2011, the northern creek bank (the outside bank of a sweeping channel bend) was stabilised with rock as part of the emergency, post-2011 flood works.
- The bank was lined with rock, all voids filled with soil, covered with jute mesh, and pocket planted with natives.
- The chosen native plants have low woody branches, which will add bank roughness.

Re-construction of creek bank, January 2011 (Kedron Brook in background)

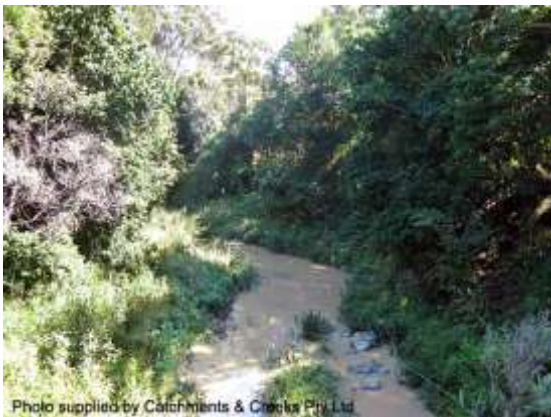
Looking upstream from Wardell St (2011)

- Riparian vegetation has thinned due to the past drought.
- Channel bed thick with weeds, mainly grasses.
- This image shows the channel just after a storm that caused the bed vegetation to fold in the direction of the flow.

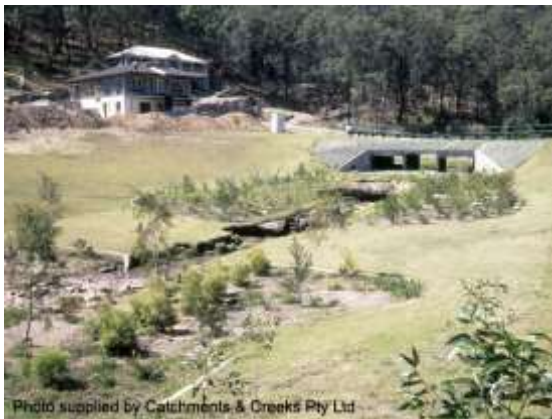
Damage to landscaping by storm (1996)
