Creek Rehabilitation Case Studies

Version 1, December 2014

Prepared by: Grant Witheridge, Catchments and Creeks Pty Ltd

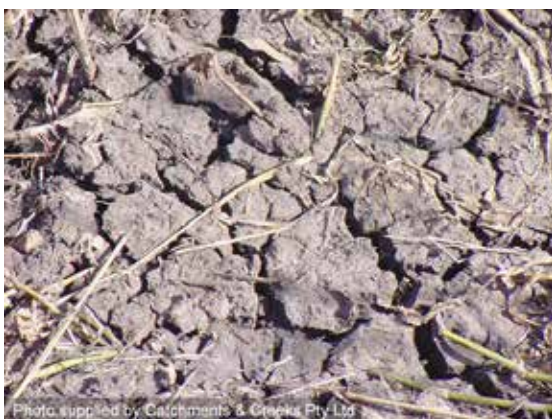
Erodible, cracking black soils

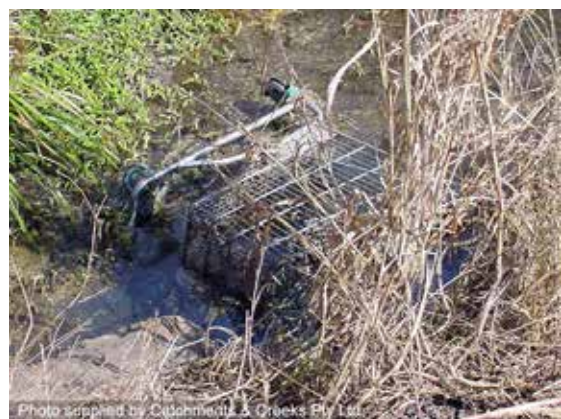
Deposition of rubbish in storm drain

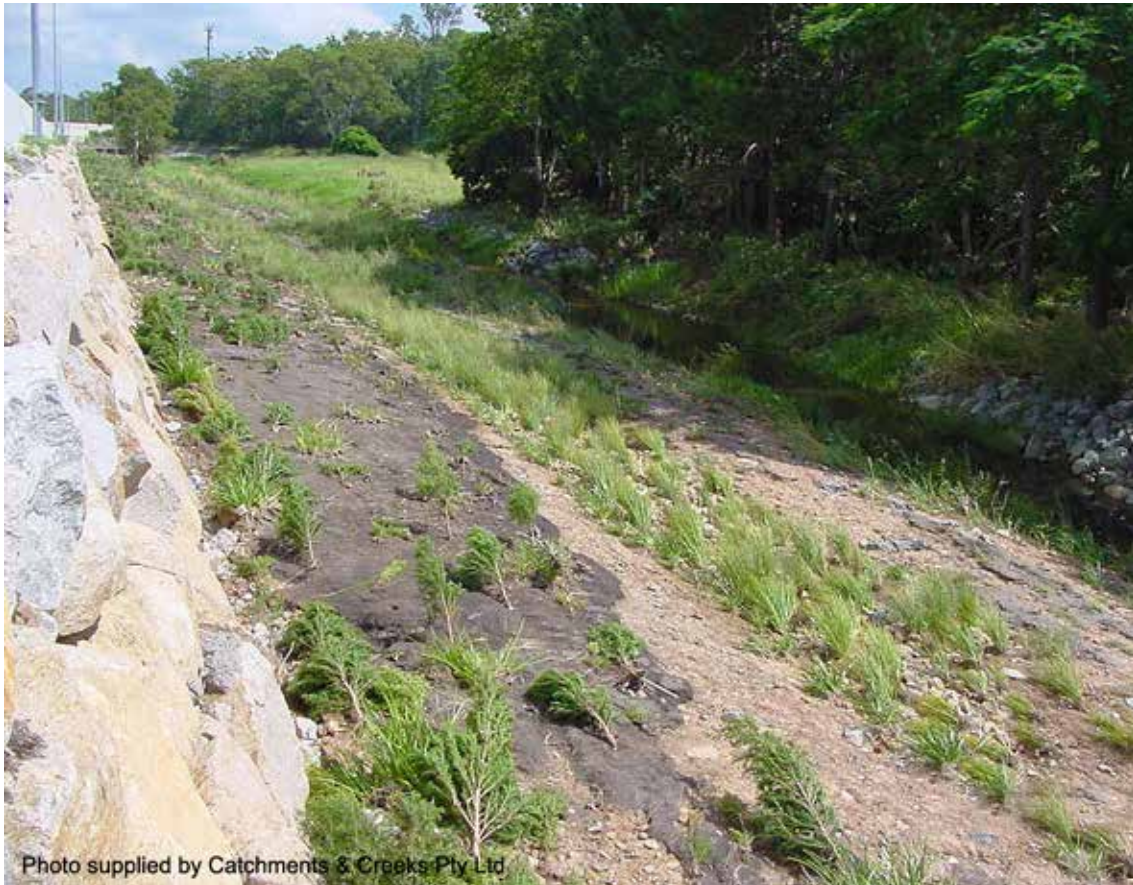
Looking downstream towards the culvert (after flood damage, 2001)

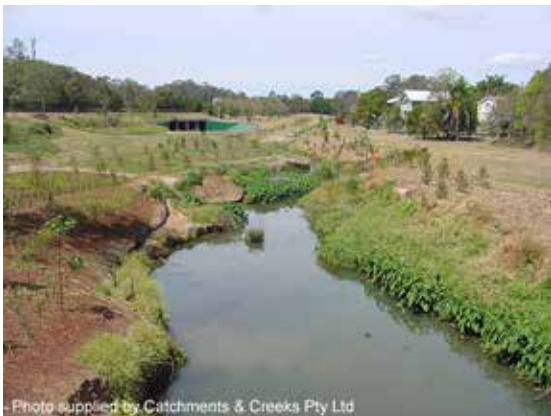
Following first stage of works (2001)

- Post works condition.
- Pools and riffles established with some planting within over-bank areas.
- Creek is nutrient-rich with heavy algae growth.

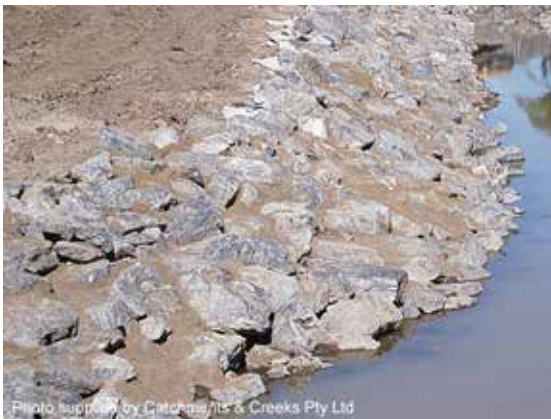
- Significant quantities of rubbish (burnt tree stumps) and highly erodible slaking soils were found in the stream banks adjacent the low-flow channel, which resulted in the need for this material to be removed.
- The channel was then lined with stable soil and a rock-lined pool-riffle system was constructed.

Soil-filled voids ready for planting (1999)

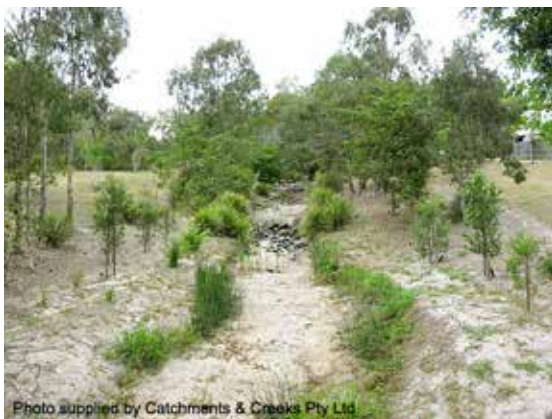
Year 2014

- During the early years, plant establishment was dominated by reeds and weeds within the moist low-flow channel.
- At this stage there is the risk of floods causing bank erosion on either side of the reed-infested low-flow channel.

Upstream of Laurel Oak Dr (Nov, 2014)

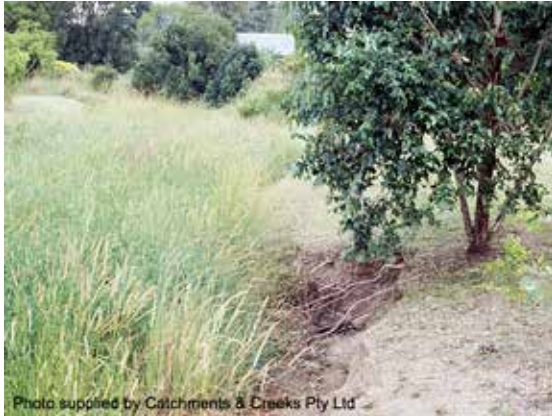
April 1996

Looking upstream (April, 1996)

- Bank erosion is evident along the northern bank of the creek.
- The bank erosion is worse adjacent the growing shrub due to the increased shading of the bank caused by the presence of the shrub.
- The root system of the shrub cannot control this form of scour erosion.

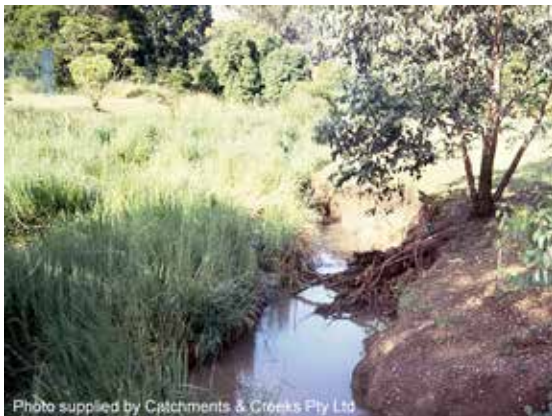
November 1996

Looking upstream (November, 1996)

- A new low-flow channel is forming along the base of the northern bank as a result of the following factors:
 - weaker bank vegetation along the northern (shaded) bank
 - weed infestation along the creek bed
 - sediment deposition within the channel.
- This image (left) represents the creek condition after the severe May 1996 storms.

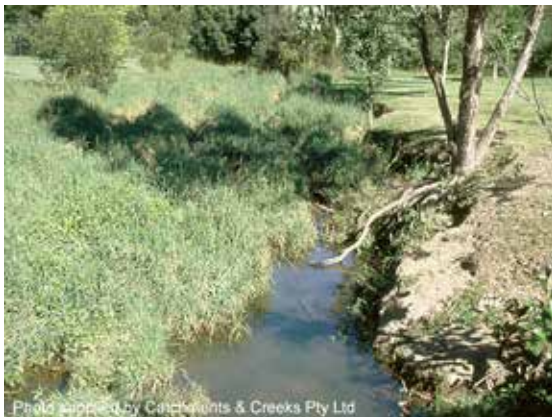
Year 1999

Looking upstream (1999)

- The bank-side shrub is in poor health due to the severe soil loss around its root system and the resulting root damage.
- The fluvial condition being demonstrated here is the accelerated migration of a creek channel to the north caused by the removal of a canopy cover from the creek.

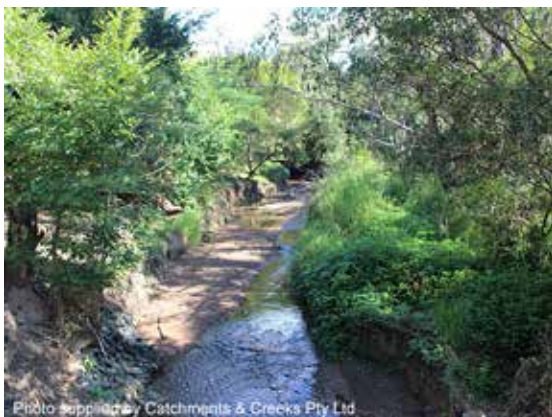
Year 2011

Looking upstream (2011)

- Riparian cover returned to both banks of the creek, which has reduced the density and strength of the in-channel weeds.
- Significant channel flows over the period 2009 to 2011 have caused the previously settled sediment to be displaced resulting in the formation of near-vertical creek banks.
- Subsequent bank erosion can in some cases undermine the newly established bank vegetation.

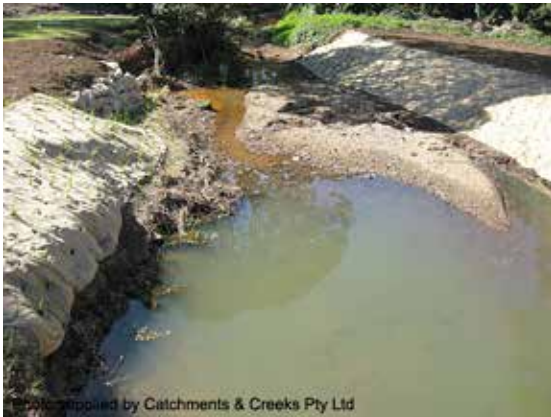
- The reduced channel roughness caused by the upstream weed removal has increased flow velocities within the creek.

Looking d/s from footbridge (Aug, 2009)

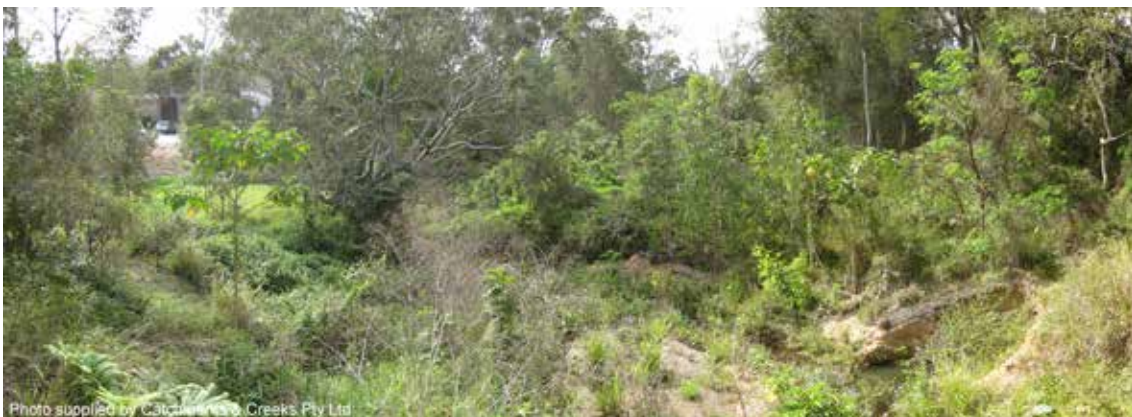
- As of 2014 the bank erosion had not been repaired; instead the area was left to revegetated naturally.

Looking downstream from the Beverley Reserve footbridge (2014)

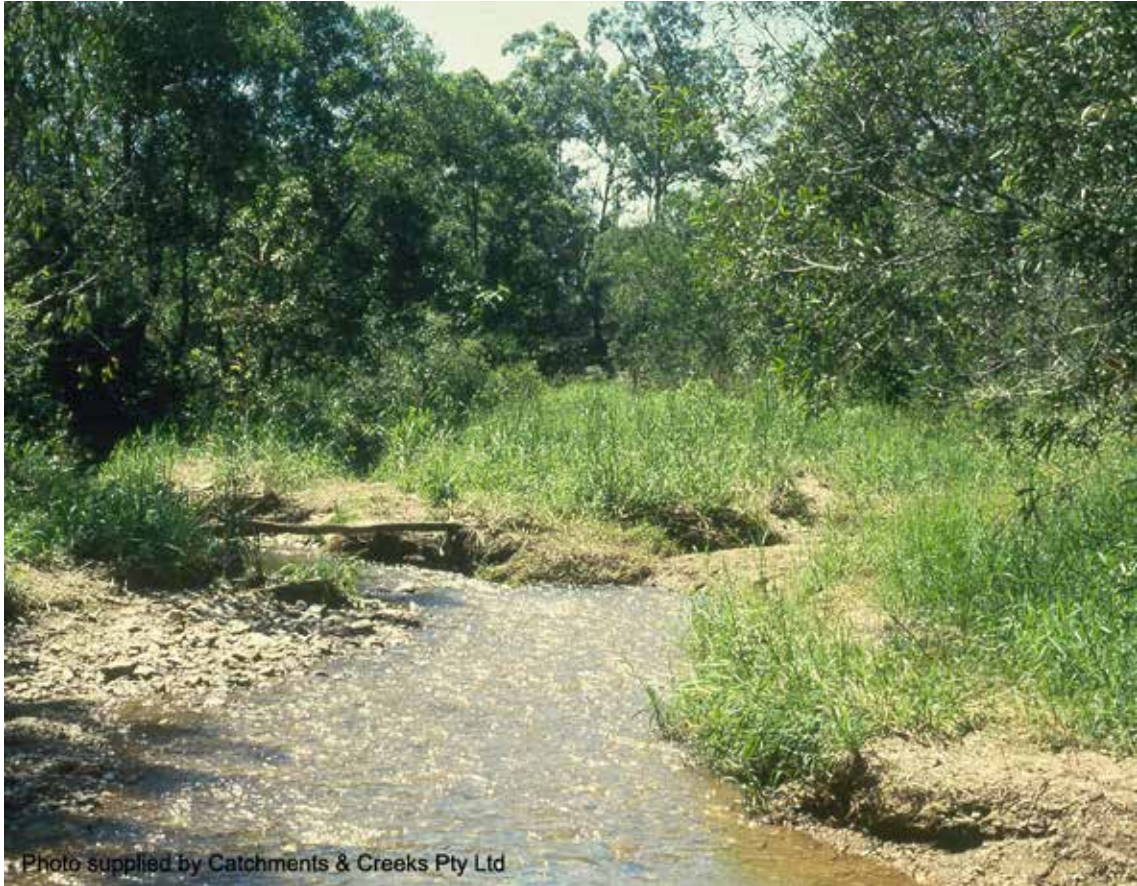
Looking downstream to sediment deposit adjacent Falconglen Close, Ferny Grove (1994)

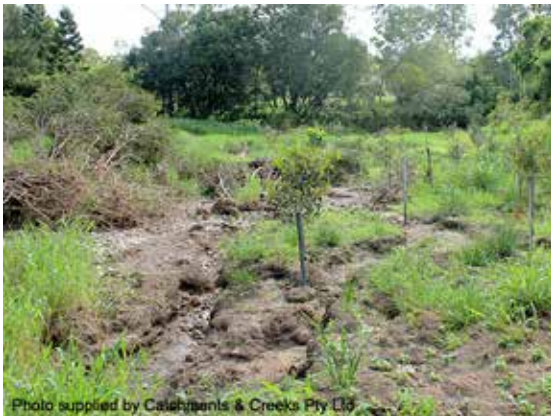
Flood damage (2013)

- Significant as the flood damage was, it was not as devastating as had occurred within other creeks during wet years of 2010 to 2013.
- This site proved the benefit of retaining significant weed cover during the establishment phase of the replacement native plants.
- If complete weed removal had occurred on this site, then the flood damage would have likely been more extensive.

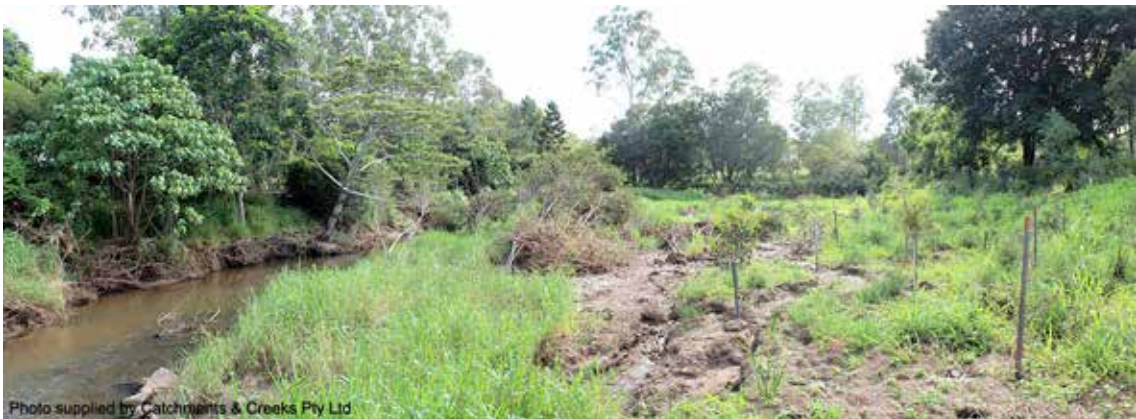
Looking downstream through the area of greatest flood damage (2013)
