Creek Erosion Control and Constructed Drainage Channel Case Studies

Version 2, 2022

Prepared by: Grant Witheridge, Catchments and Creeks Pty Ltd

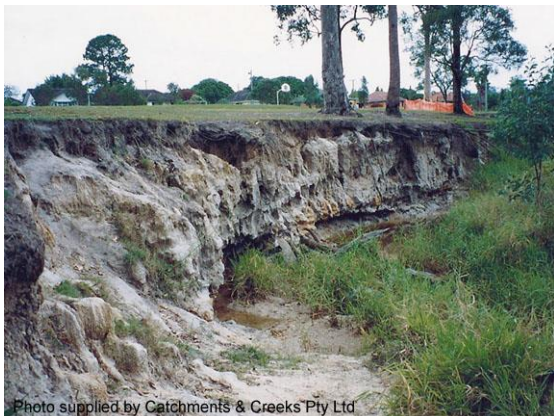
Severe bank erosion, Inala, Qld

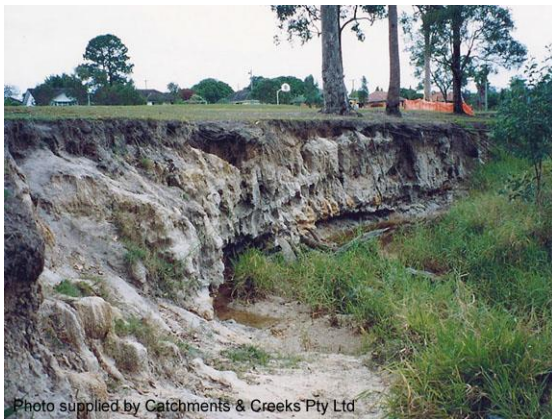
Bank erosion looking upstream (1993)

- This creek passes through a region of highly erodible dispersive subsoils.
- The creek had largely been cleared of riparian vegetation resulting in a weedy, open canopy waterway.
- In the past, parts of the creek had been stabilised with grouted rock, which is now failing largely due to the highly erodible underlying soils.

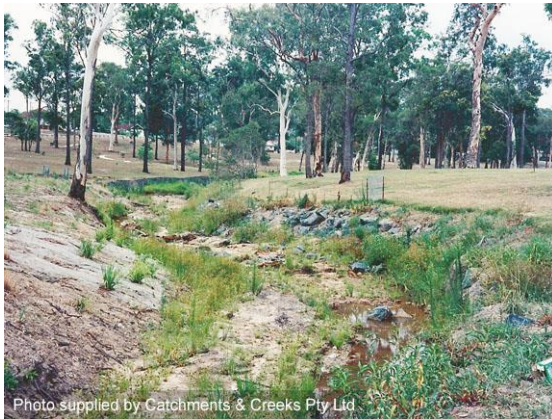
Repaired creek bank on right (1995)

- The key feature of this project was the matching of the rehabilitated bank with the existing aesthetics of the creek.
- Covering the rocks with vegetation has helped to remove the 'constructed' appearance of the creek bank.
- In time the bank will be planted with natives in association with riparian restoration along the opposite bank.

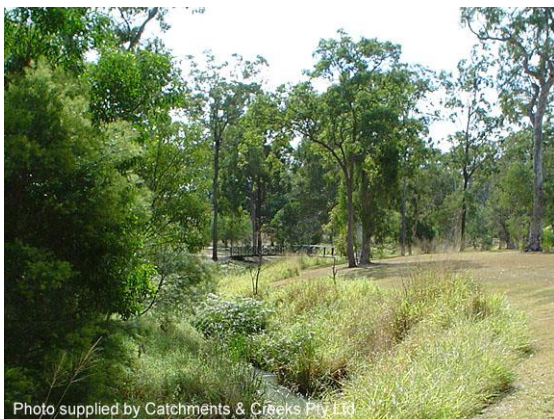
Year 2004

Looking d/s with works on right (2004)

- Significant loss of middle and upper-storey natives is obvious.
- Grasses dominate along the bank.

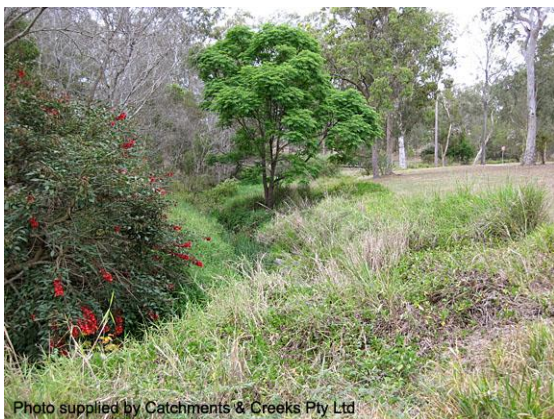
Year 2014

Looking d/s with works on right (2014)

- Grasses still dominate the bank vegetation, but the bank remains erosion-free and very stable.

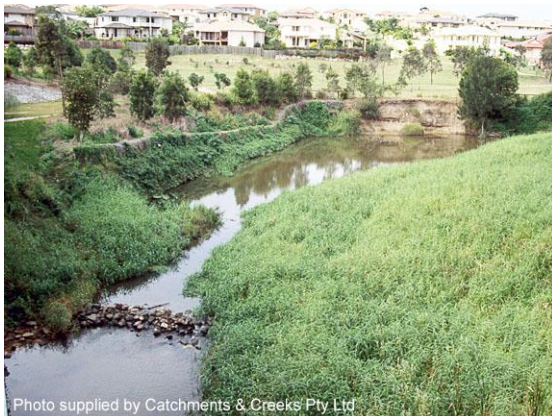
Looking upstream from bridge (2000)

- One of the main problems associated with gabion structures in Brisbane waterways is their propensity to attract non-native vines.
- Once established within the gabions, these vines can then move into the adjacent riparian zone.
- By the year 2000, vines had already established along the gabion wall.

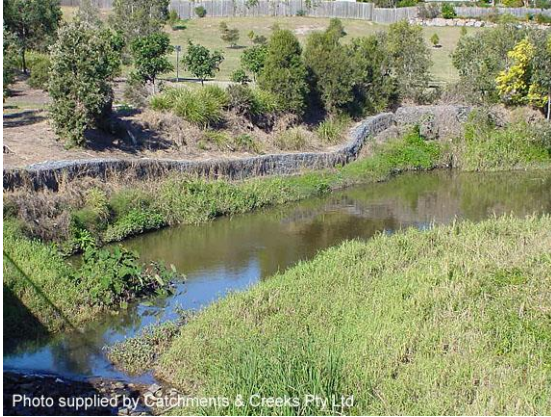
Year 2001

- The problem caused by the placement of the gabion wall on the outside of a significant channel bend was that it induced high flow velocities to exist along the face of the gabion wall.
- As a result of this, high flow velocities also existed adjacent the creek bed causing a scour hole to form at the base of the gabion wall.
- Consequently, the gabion wall started to slide (slump) into the creek bed.

Looking upstream from bridge (2001)

- Maintenance work had cleared the gabions of the vines.
- The gabion wall continues to slump into the creek bed.

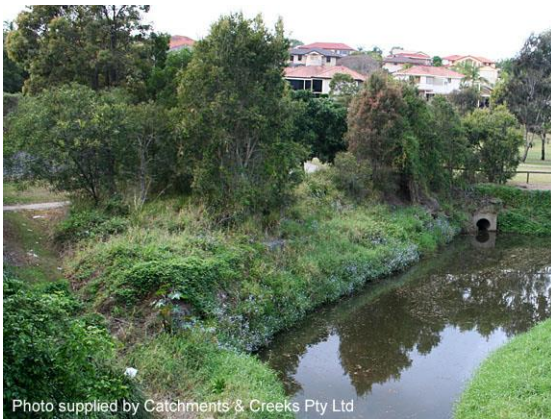
Year 2008

Looking upstream from bridge (2008)

- The gabion wall is now heavily vegetated, mainly with weed species.

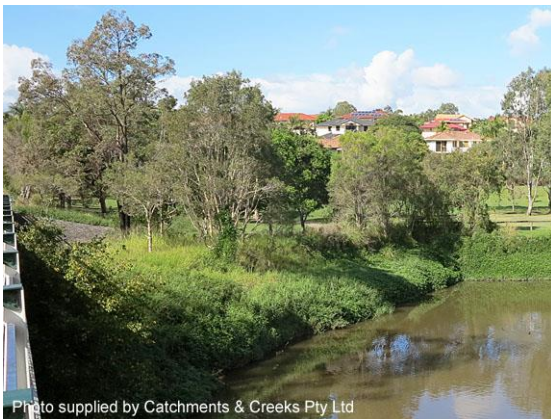
Year (early) 2014

Looking upstream from bridge (2014)

- The ongoing slumping of the creek bank has allowed a lower bench to form at the base of the bank.
- The formation of this bench, and the ongoing establishment of woody species should see the creek bank achieve a more 'natural' profile and stability.

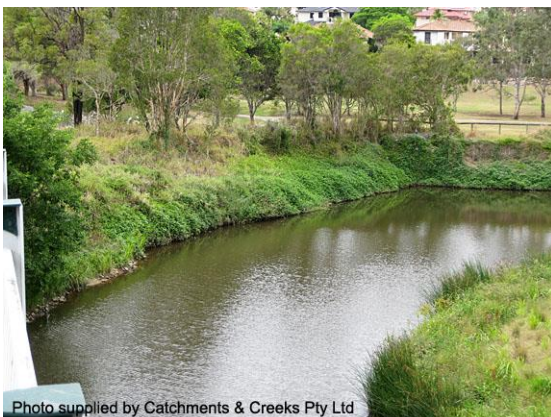
Year (late) 2014

Looking upstream from bridge (2014)

- No visible indications left of the gabion wall.
- Weeds still dominate the bank vegetation.

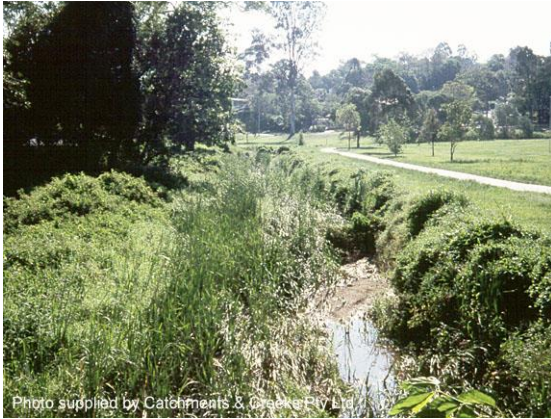
Year 1995

Upstream of footbridge (1995)

- In the absence of other controlling factors, there is a greater tendency for bank erosion to occur predominantly on the more-shaded northern banks of streams.
- This problem becomes less significant north of the Tropic of Capricorn.
- This 1995 photo shows the steep northern bank (right) and the heavily vegetated, more gradual southern bank (left) prior to the initiation of the bank erosion.

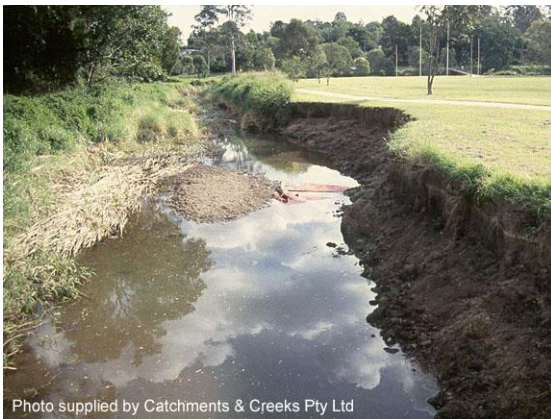
Year 1996

Upstream of footbridge (1996)

- Significant rainfall and flooding occurred in Brisbane during May 1996.
- This image shows the eroded northern bank of the creek after the May 1996 storm.
- Note that the eroded bank is in shade.
- Note also, the limited amount of erosion experienced on the more substantially vegetated southern bank.

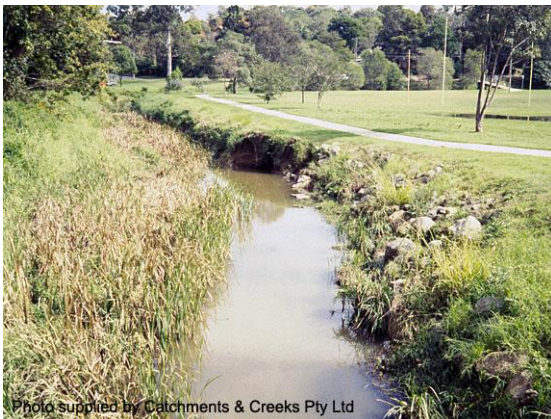
Year 1997

Upstream of footbridge (1997)

- Rock stabilisation was placed against the bank in 1996 and sediment and grasses were allowed to establish within the rock voids.

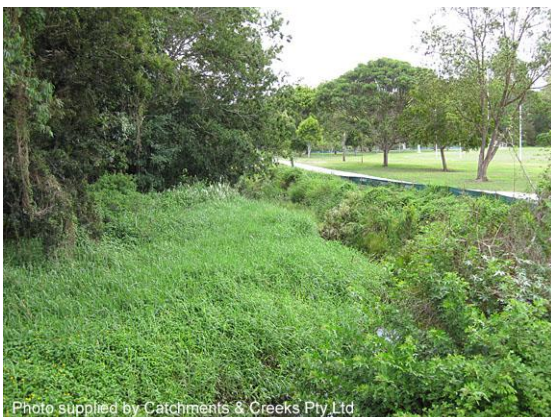
Year 2014

Upstream of footbridge (2014)

- The rock stabilisation is now completely covered with grasses.
- This section of Cubberla Creek is yet to be rehabilitated with respect to the establishment of native riparian vegetation.
- Similar to other creeks in Brisbane, major creek restoration initially occurs within the upper reaches, then slowly moves down towards the lower reaches.

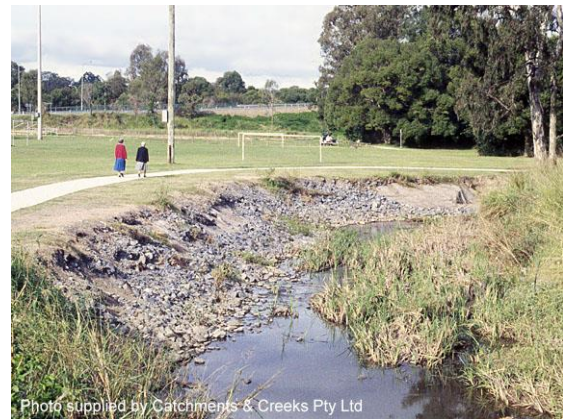
Year 1996

- In the absence of vegetation, rock-lined banks can induce high flow velocities to occur adjacent the rock-lined surface.
- These same high velocities can also exist adjacent the unprotected creek bed causing bed scour.
- Toe erosion at the base of the rock-lined bank, and the existence of a smooth filter cloth underlay, caused the rocks to slide down the face of the bank into the creek.

- Bed scour adjacent the rock-stabilised bank has undermined the creek bank.
- Having been placed on a ‘smooth’ geotextile mat, the rock simply slipped down the bank onto the creek bed.

Downstream of footbridge (1996)

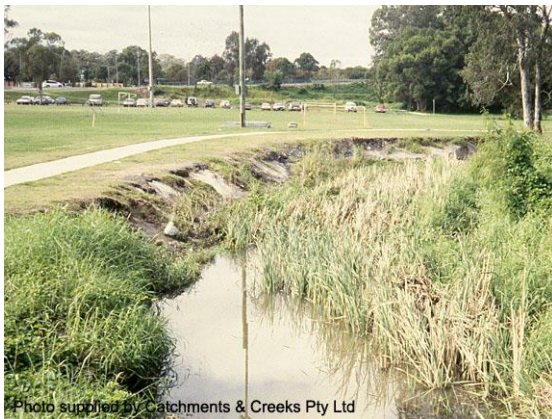
Year 1997

Downstream of footbridge (1997)

- Plants have now established within the deteriorating filter cloth.

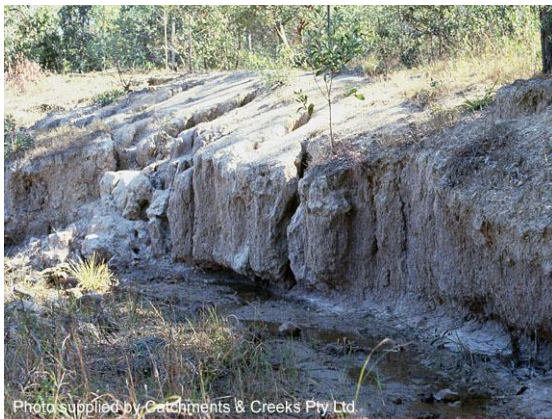
Eroded, dispersive soil bank (1991)

- Downfall Creek contains some of the most erodible soils in Brisbane.
- The subsoils found at the community centre are largely dispersive, meaning the soils contain a significant (>6%) quantity of sodium, which causes the soil to be unstable and disperse in water.
- A small tributary to the creek flows through the Bushland Centre and this tributary was experiencing significant bank erosion as a result of the exposure of these dispersive subsoils.

- Rehabilitation of the eroded creek bank became a demonstration project for the use of a new (in 1991) erosion control product, 'jute matting'.
- The eroded bank was re-profiled, stabilised with rock along the toe of the bank, seeded with grass, then covered with 'thin' jute matting.
- The bank was initially stabilised with grass before native plants were introduced to the stable bank over the following years.

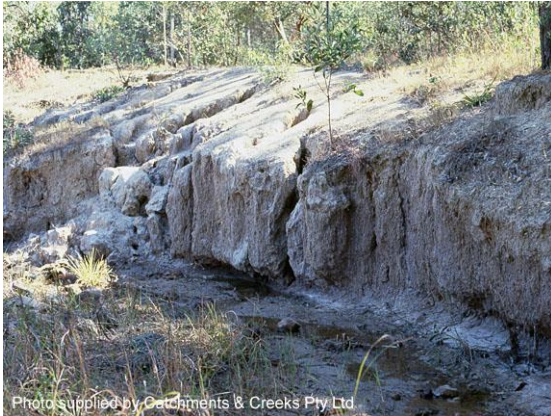
Tributary, looking upstream (1991)

- The exposed sodic subsoil on the northern bank experienced significant vertical rilling known as ‘fluting’.
- Tunnels had formed in the soil (tunnel erosion) passing from the base of the eroded bank up through the soil into the adjacent bushland.
- In a ‘misguided’ attempt to stop this tunnel erosion (the author’s error!), plastic sheeting was placed against the subsoil prior to placing the earth fill, rock and the jute matting.

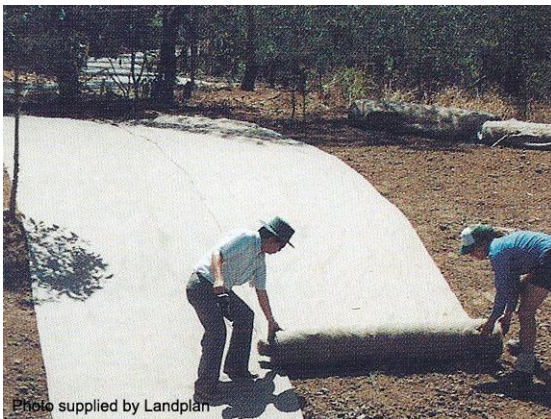
Placement of jute matting (1991)

- The eroded bank was first stabilised in 1991 as part of a demonstration field test of jute matting (a new product in 1991).
- The eroded bank was re-profiled, grass seeded, then covered with ‘*Jutemaster*’ jute matting.
- The demonstration project involved people from Queensland DPI, Brisbane City Council, Landplan and Greening Australia.

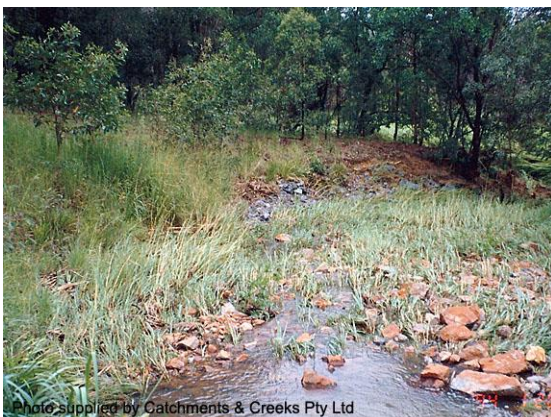
Tributary, looking downstream (1994)

- Some die-back of the grass is beginning to occur.
- Newly established native trees are clearly visible above the grass.
- Grasses have established within the rock-stabilised creek bed.

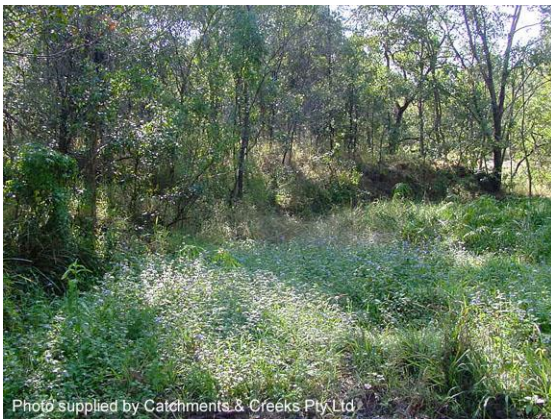
- Some minor bed erosion is visible at the downstream end of the tributary at the point where the tributary spills into the main Downfall Creek channel (see photo below).

Tributary, looking downstream (2001)

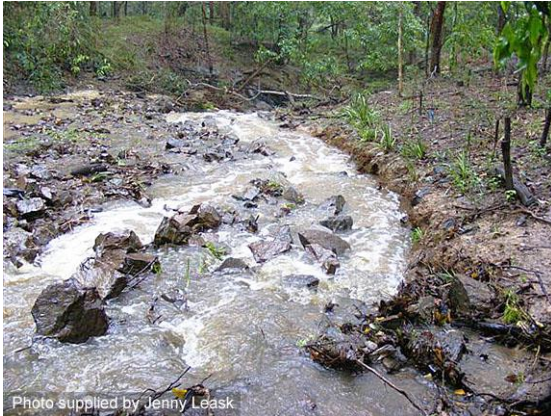
Storm flow 11 October 2010

- On the southern bank of the tributary (opposite the eroded, dispersive soil bank) the soils are more stable, but high velocity flows discharging from the upstream culvert had caused significant toe erosion.
- The toe of the bank was stabilised with jute logs and planted with *Lomandra*.
- Both the jute log stabilisation of the *Lomandra* plants proved successful in stabilising the toe of the bank.

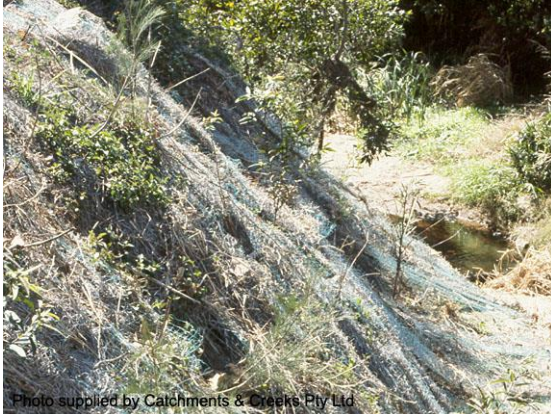
Synthetic matting placed on bank (1991)

- In 1991, the western bank of the main Downfall Creek channel was cleared of weeds and stabilised with synthetic reinforced erosion control matting.
- Use of this synthetic reinforced matting proved most unsatisfactory in a bushland setting because native reptiles were found to become entangled in the plastic mesh.
- Preference is now given to the use of jute and coir mesh in creek and bushland settings.

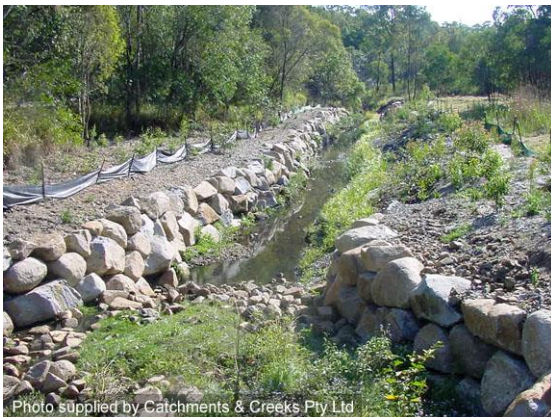
Looking downstream from Rode Rd (2001)

- The western bank was stabilised with rock boulders set against a bench.
- The bank was 'benched' in order to provide access for the heavy machinery required to place the rock—thus avoiding the loss of mature riparian trees.
- At the same time the bed of the creek was de-silted and cleared of weeds.

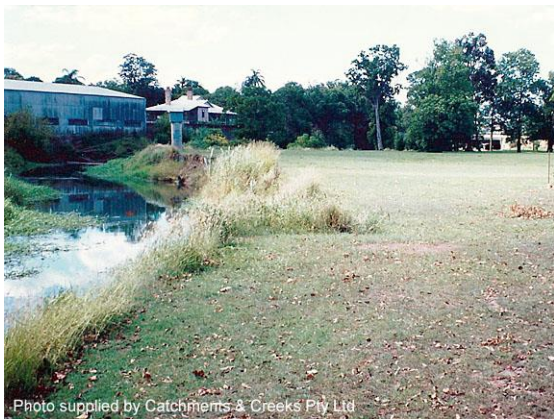
Looking downstream towards weir (1993)

- The Enoggera Creek weir is located at the creek bend just visible in the background of this 1993 image.
- The State Government's stream gauging station tower can be seen at the top of the creek bank adjacent the weir.
- Ongoing bank erosion had caused the formation of an unstable, steep creek bank that was seen as a safety risk to children playing in the adjacent park.

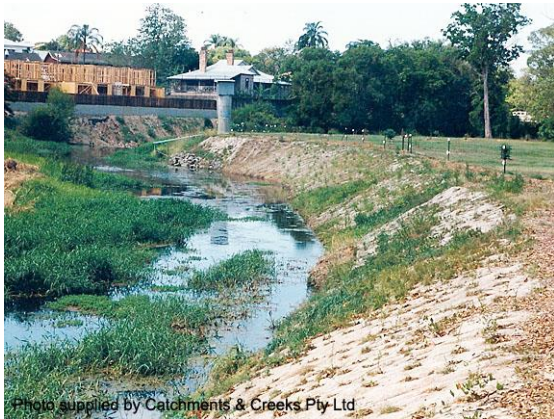
Looking downstream towards weir (1993)

- In 1993 the creek bank was battered at approximately a 1 in 2 gradient.
- The bank was covered with a jute blanket and planted with various native shrubs and trees.
- In general, it is not desirable for highly flexible, non-woody, ground covers to dominate on the outside bank of channel bends; instead, woody species are preferred in order to reduce flow velocities adjacent to the bed and bank.

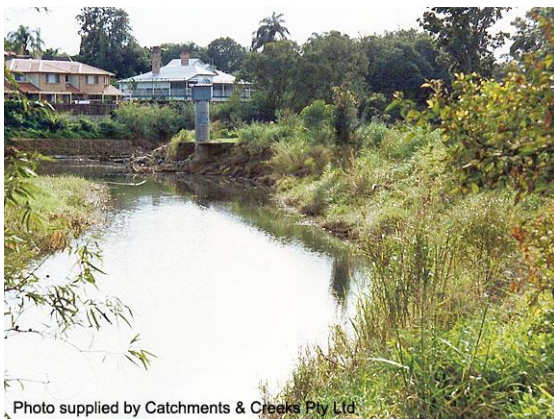
Looking downstream towards weir (1996)

- A good mix of ground covers, middle storey and upper storey plants was established along the creek bank.
- Significant bank erosion has occurred around the base of the abandoned stream gauging station tower (background).

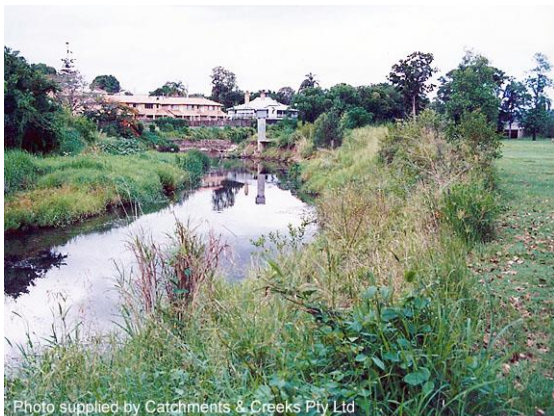
Looking downstream towards weir (1996)

- Significant loss of middle storey and upper storey plants has occurred.
- Non-woody ground cover grasses now dominate along the bank.
- Such a vegetation cover on the bank is likely to reintroduce high flow velocities along the toe of the bank, possibly leading to the return of bank erosion problems.

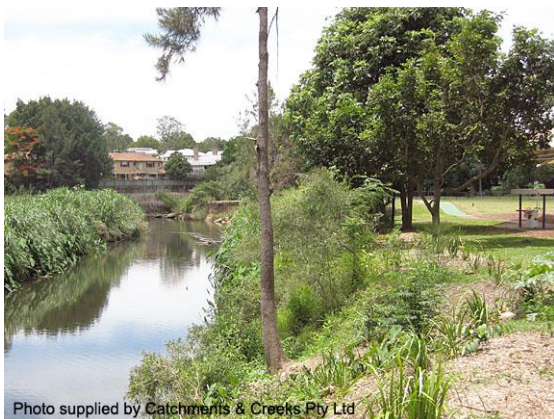
Looking downstream towards weir (2011)

- Native plants have increased in number, but the bank still lacks the required density of low woody branches that such a creek bank requires to prevent ongoing bank erosion.

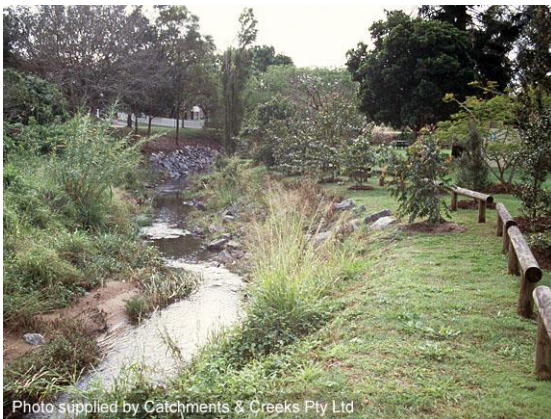
Looking downstream (1999)

- Woolcock Park had undergone significant enhancement by 1999, which had seen increased riparian planting both within the park and downstream of Waterworks Road.

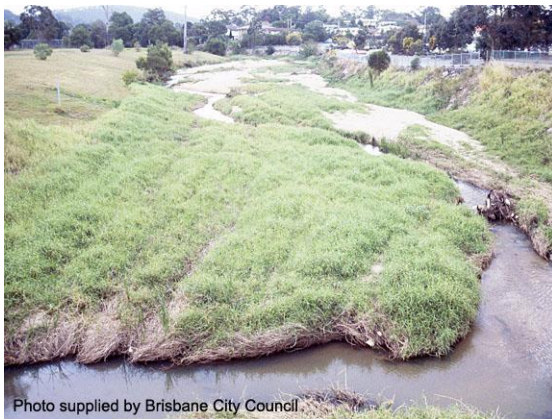
Looking u/s from Dawson Pde (pre 1991)

- After the 1974 flood, many of the creeks in Brisbane had undergone significant widening and channelisation.
- This section of Kedron Brook adjacent Arana Hills shopping centre had been modified into a wide, grass-lined trapezoidal channel.
- By the time of this photo, sedimentation had caused a low-flow channel to return to the bed of the creek.

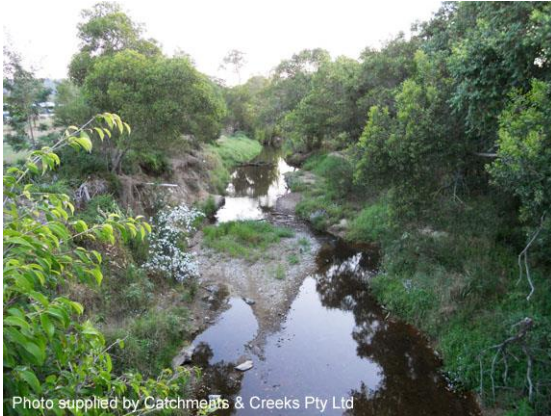
Eroded bank on left, 28/9/12

- In 2012, rock stabilisation was placed against the southern bank (LHS looking upstream).
- The voids between the rocks were filled with soil and pocket planted, which has enhanced the establishment of vegetation on this bank.

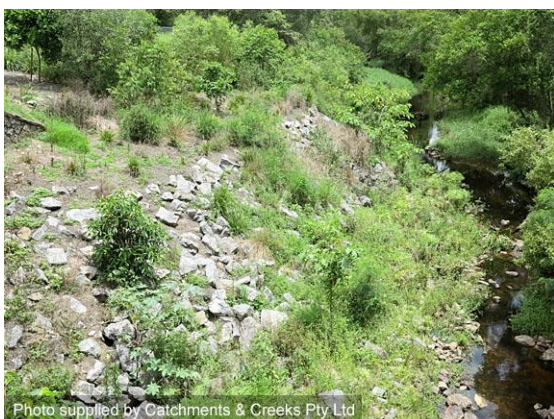
Establishment of vegetation (2014)

- Early stages of plant establishment in 2014.

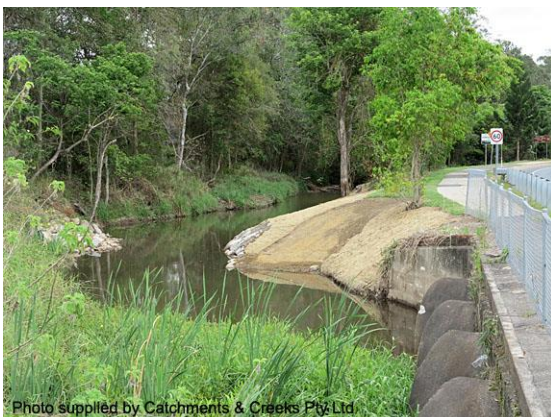
Looking upstream (2014)

- In 2014 the bank was stabilised with rock at the same time the creek was de-silted.
- Final bank shaping consisted of exposed rock stabilisation in the lower third of the bank, with a vegetated upper two-thirds batter.
- The upper bank was initially stabilised with jute mesh prior to the establishment of plants.

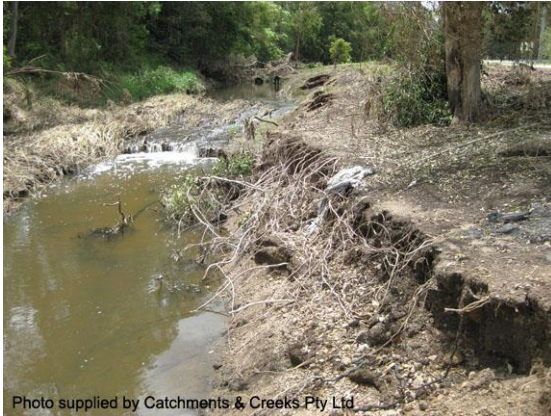
Looking upstream, November 2008

- Bank erosion commenced during the 2008 micro-storm that severely damaged the nearby suburb of The Gap.
- The top-of-bank is just 1 metre from the base of the tree (visible in top-right of image).

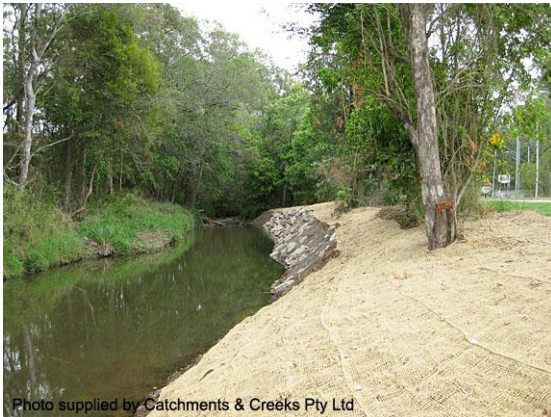
Looking upstream, September 2014

- Rock stabilisation has occurred along the lower third of bank with the voids filled with soil ready for planting.
- The upper two-thirds of the bank will be stabilised with vegetation.
- Initial upper bank stabilisation consists of pegged jute mesh.

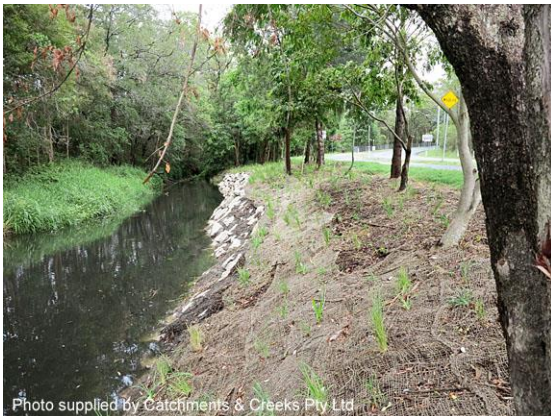
Looking upstream, December 2014

- Plants established within the erosion control mesh.
- This site has already experienced a near bankful event since September with no significant damage.

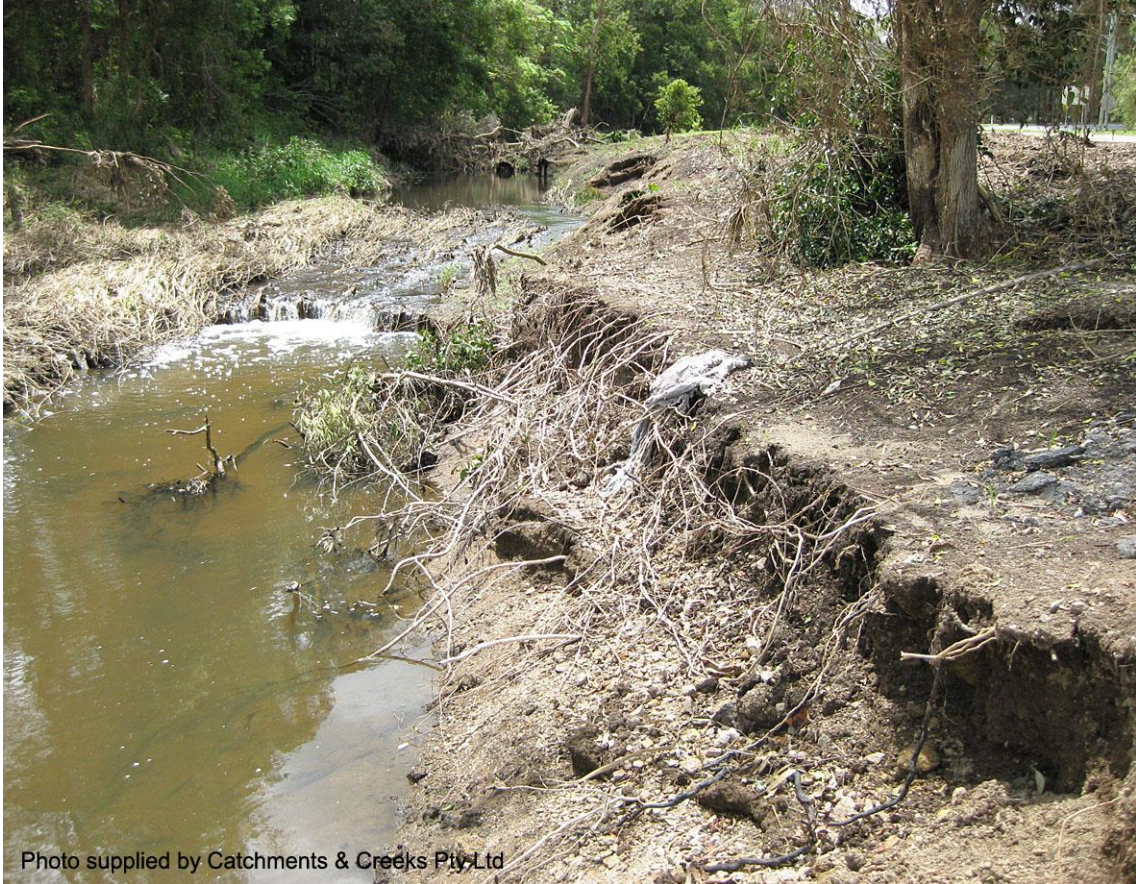
Looking upstream following removal of weeds from creek bank, November 2008

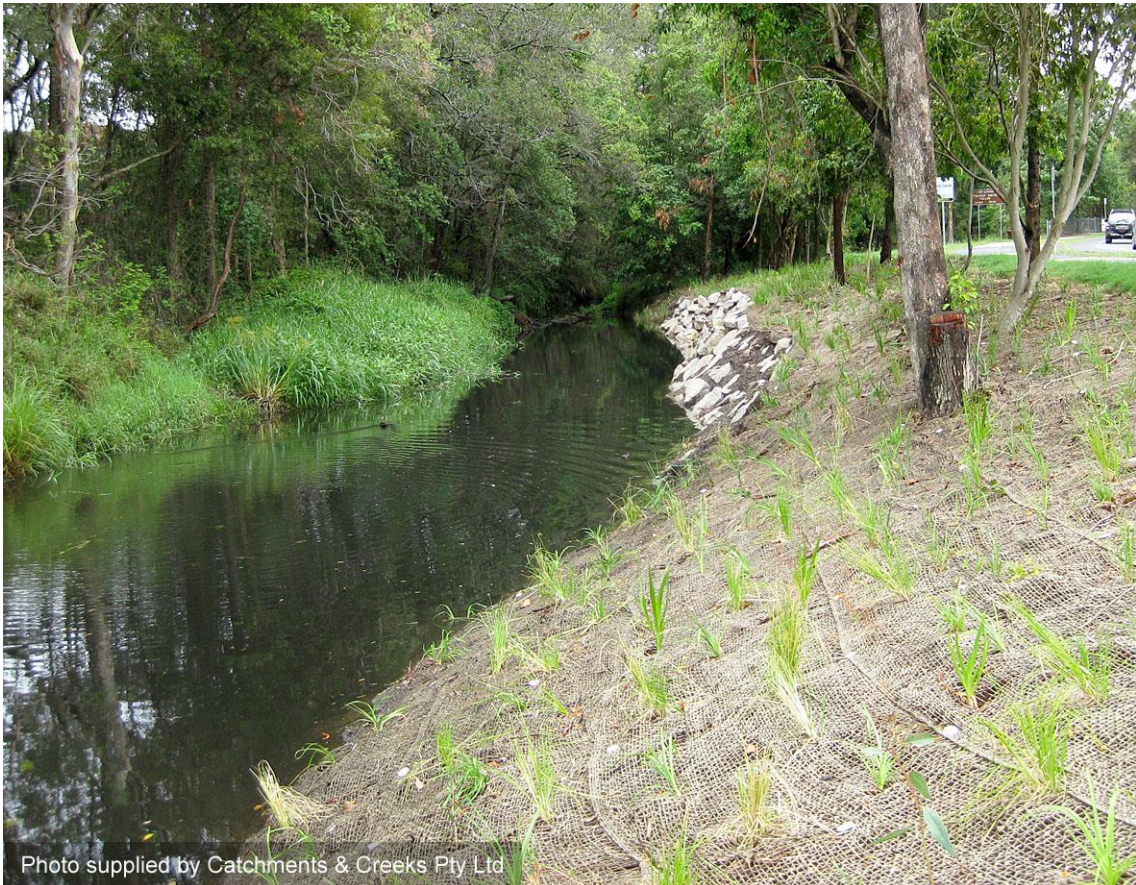
Looking upstream after bank rehabilitation, December 2014

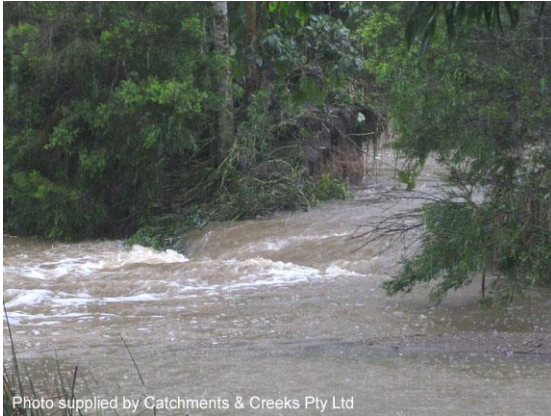
Flood spill-through (11 Oct 2010)

- On the 11 October 2010, flood waters passing down Kedron Brook reached and held a height of 'bankful flow' for an extended period of time.
- Floodwaters spilt from the main Kedron Brook channel into the stormwater treatment wetland causing significant damage to the connecting embankment.
- Floods during 2009, 2010, and 2011 had also caused significant erosion along the northern bank of Kedron Brook just upstream (to right) of the wetland.

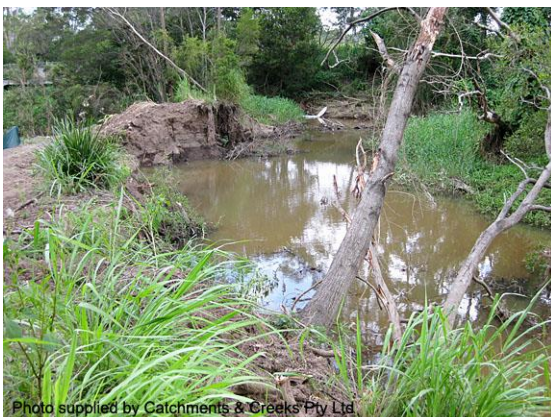
Bank erosion (28 January 2011)

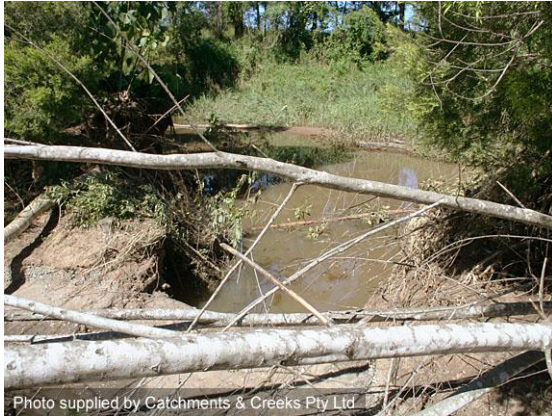
Post flood bank erosion (October, 2010)

- As a result of the extensive bank damage caused during 2010 and 2011, the northern creek bank (the outside bank of a sweeping channel bend) was stabilised with rock as part of the emergency, post-2011 flood works.
- The bank was lined with rock, all voids filled with soil, covered with jute mesh, and pocket planted with natives.
- The chosen native plants have low woody branches, which will add bank roughness.

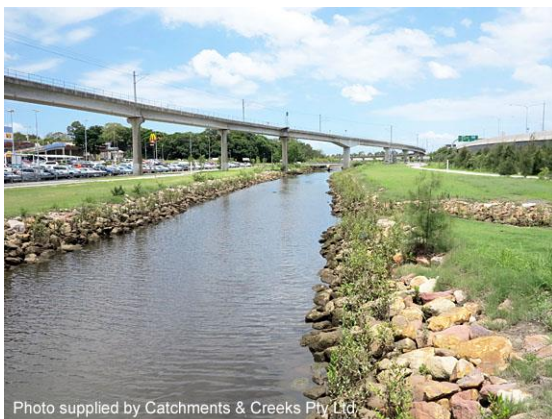
Looking downstream (2014)

- The 'natural' solution to the bank slumping is the growth of mangroves, which can be observed growing naturally along the southern bank.
- The establishment of mangroves along both sides of the channel was initially resisted by the local creek maintenance team because they preferred to retain open access along the channel to allow ongoing de-silting activities.

- The creek banks were stabilised with rock as part of the Airport Tunnel construction project.
- Mangroves have already begun to establish within the rocks.

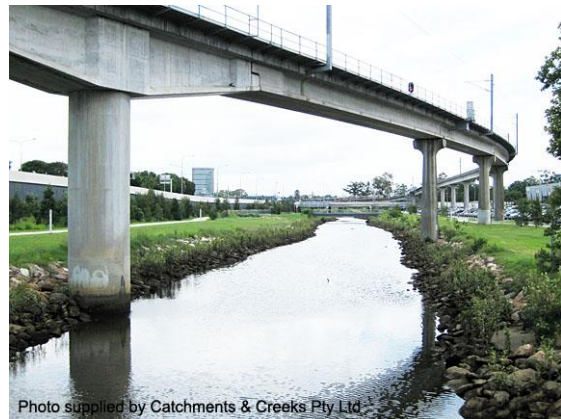
Looking upstream (2014)

- Mangroves are beginning to establish within the rock-lined creek banks.

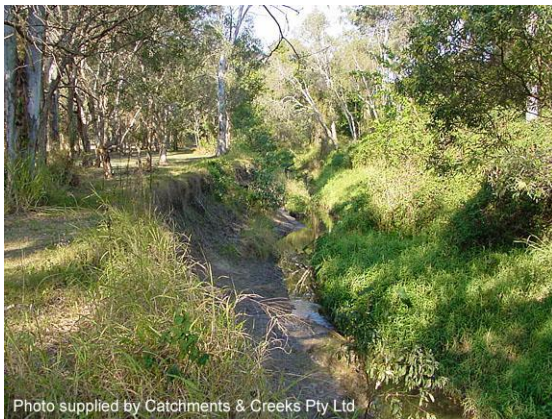
Similar erosion u/s of works area (2000)

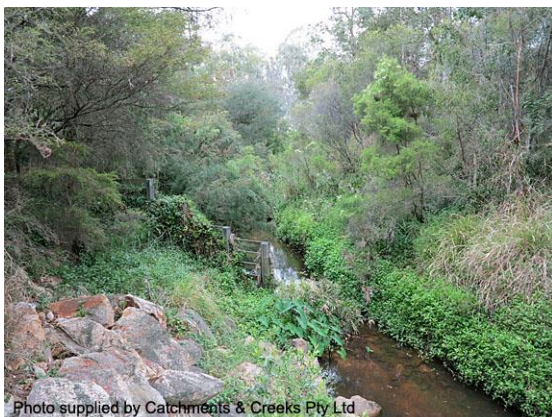
Looking upstream (2014)

- The project is considered highly successful and the channel stability has allowed significant recovery of native plants.
- The timber fences are only temporary, and will eventually rot away.

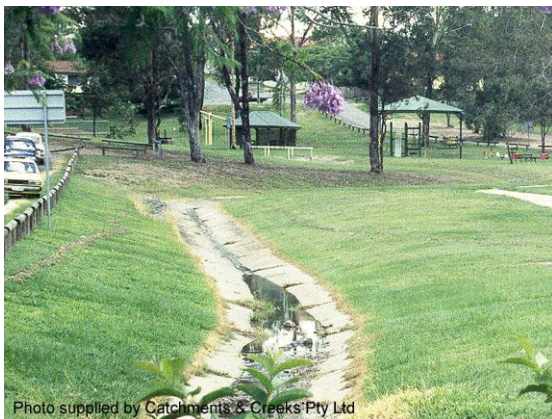
Original concrete drain (1998)

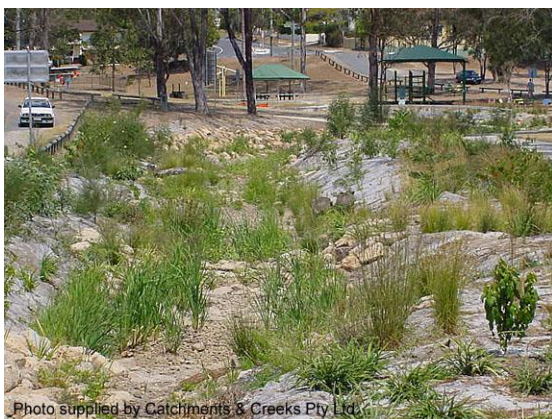
Rehabilitated drain (2000)

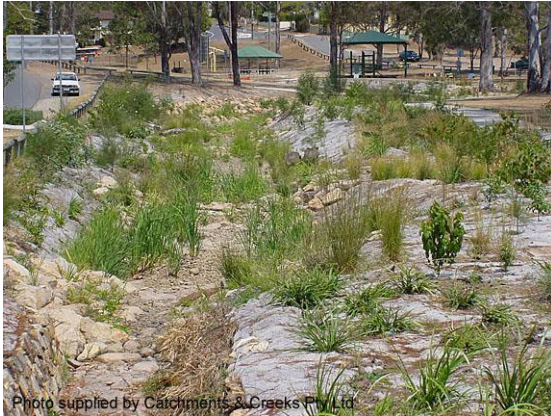
Main channel (looking south, 2000)

- Initial plant establishment within jute erosion and weed-control blankets.

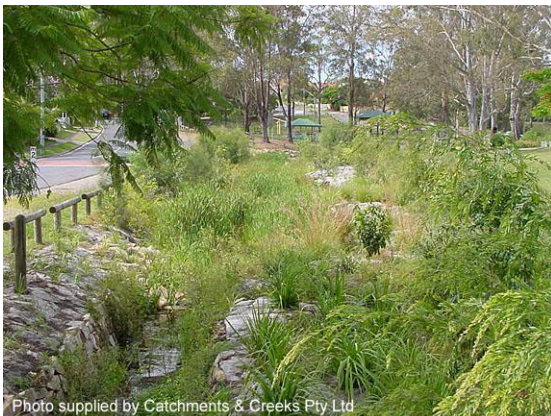
Main channel (looking south, 2001)

- Fully open canopy.
- Channel enters initial 'weedy' phase.
- Pools are almost completely filled with invading reeds.

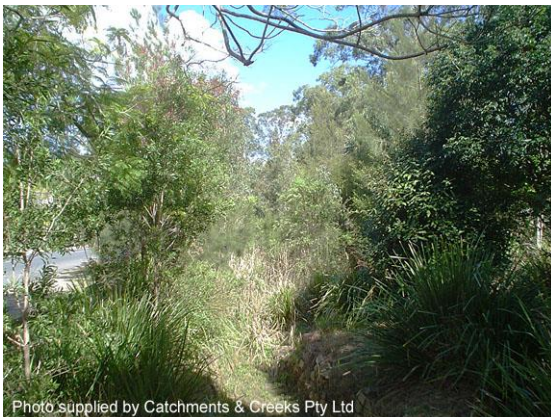
Main channel (looking south, 2005)

- Insufficient canopy cover still exists over the low-flow channel.
- Significant weed growth still exists within the channel.
- A dense cover of lower-storey native plants exists.

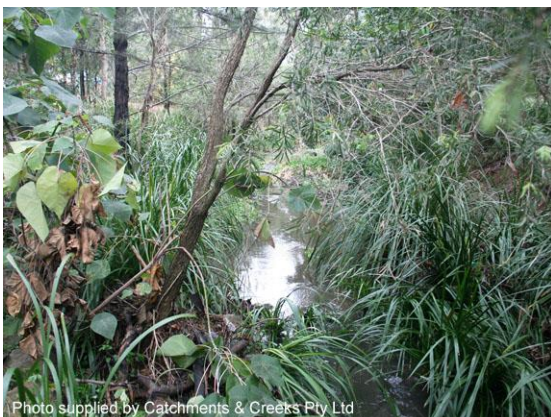
Main channel (looking south, 2010)

- Canopy has formed producing sufficient shade to thin plant density and allow the shading-out of weeds and the clearing of reeds from the pools.
- A pool is visible within the centre of the image.
- A riffle is also just visible in the foreground of the image.

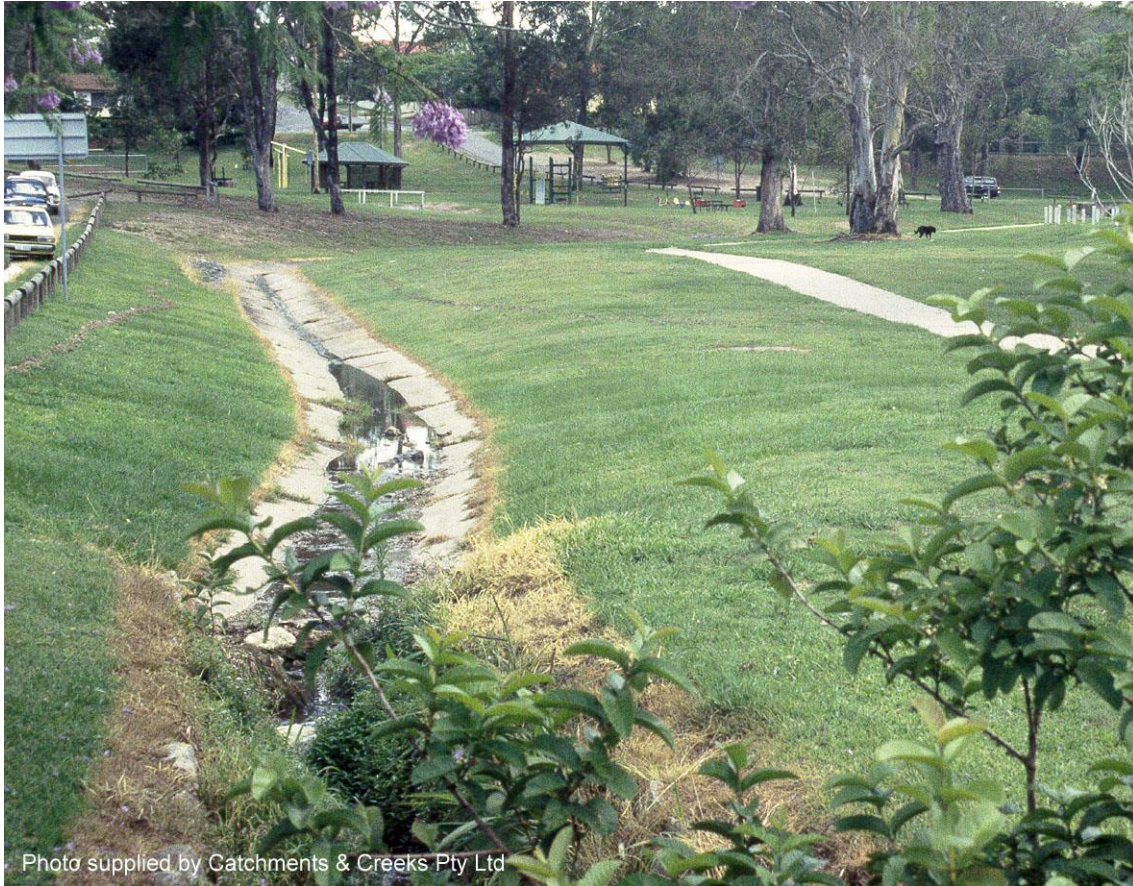
Original concrete drain looking upstream with sports oval to the right (1998)

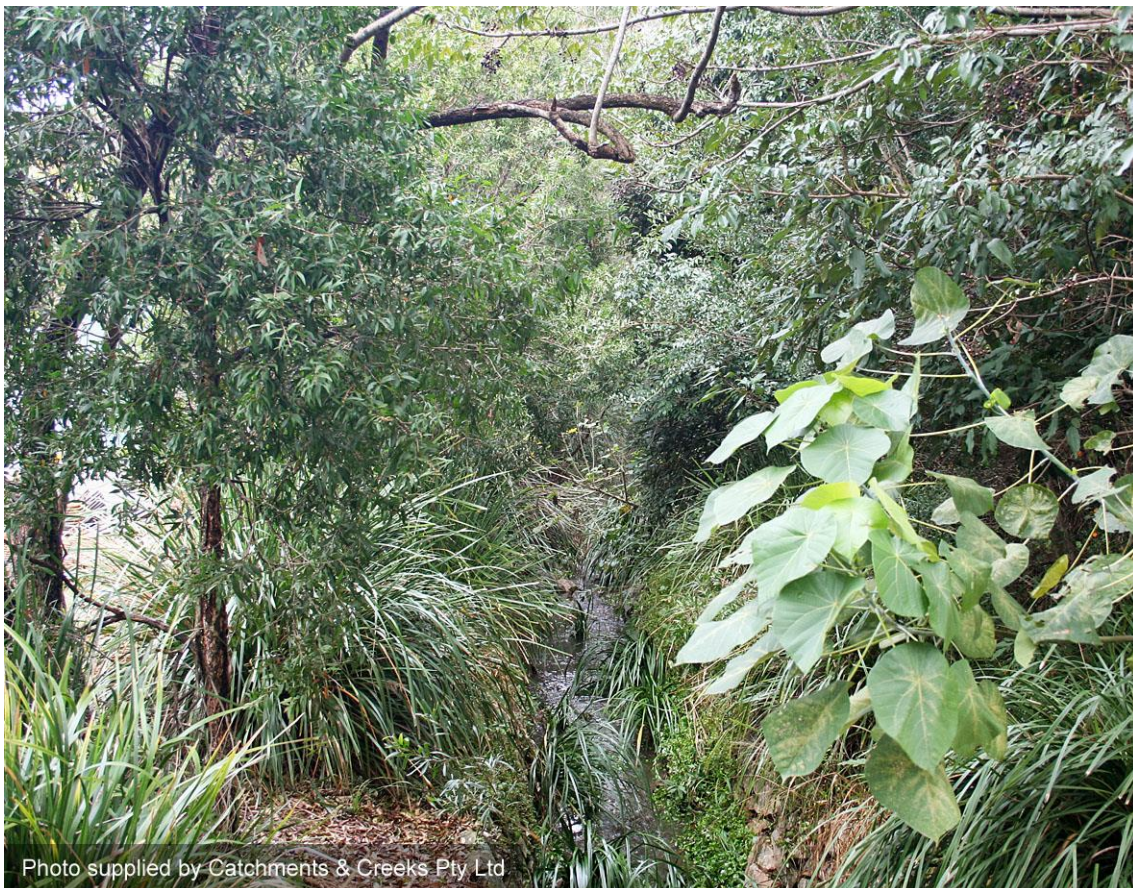
Rehabilitated waterway looking upstream with sports oval to the right (2010)

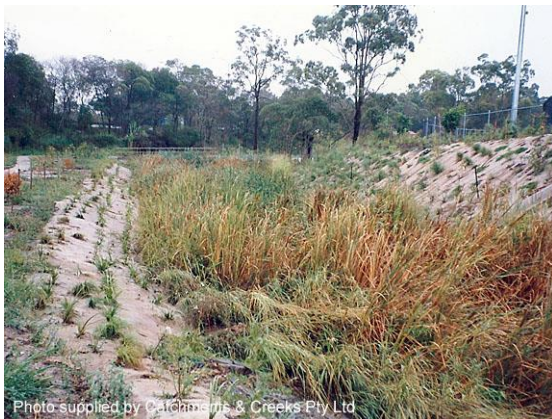
Looking upstream (1994)

- Channel revegetation as part of the bus depot development.

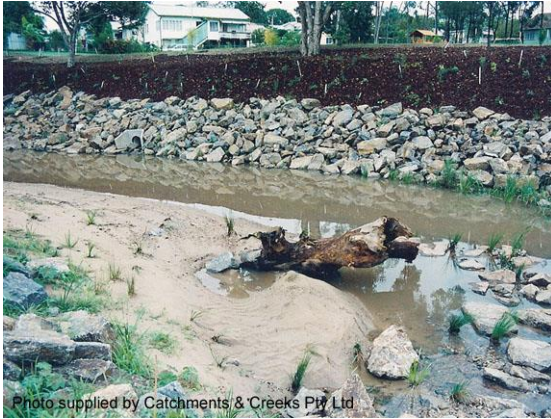
Log and sand bench (1997)

- Two habitat (roosting) logs were anchored into the channel.
- These logs provide habitat and shelter (from flood flows) for aquatic wildlife, and sunning perches for reptiles.
- Washed sand was introduced to the inside of channel bends to mimic the channel feature commonly found in alluvial river systems (now viewed as inappropriate within urban creeks).

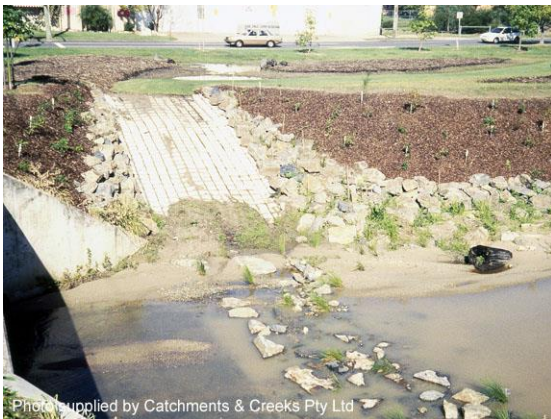
Maintenance access ramp (1997)

- Maintenance access ramps were installed into the channel both upstream and downstream of the Wardell Street culvert.
- These access ramps were formed from flexible geotextile/concrete mats (*Humes Flexmat*).
- Use of these mats allows vegetation (grasses) to grow between the concrete blocks to eventually hide the hard surfacing.

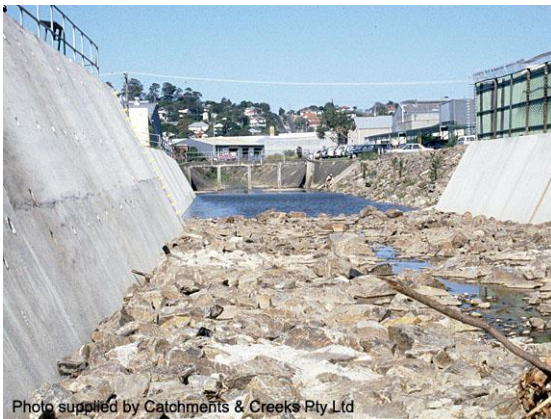
Grouted rock bed on concrete channel

- A deep sediment trap and habitat pool was established between the downstream end of the new concrete channel and the upstream end of the existing concrete channel, just upstream of the Magura Street footbridge.
- To enhance the environmental features of the concrete channel, rocks were grouted to the bed of the downstream end of the new concrete channel.
- The intent was to allow vegetation to establish over these rocks.

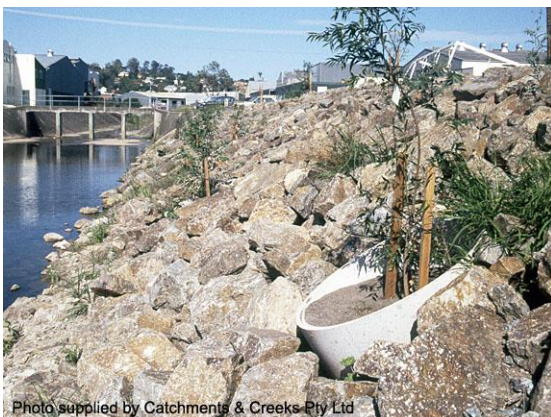
Tree planter boxes set into boulders

- To help shade the habitat pool, tree planter boxes (concrete pipe segments) were installed in the boulder-lined southern bank of the creek adjacent the Magura Street footbridge.

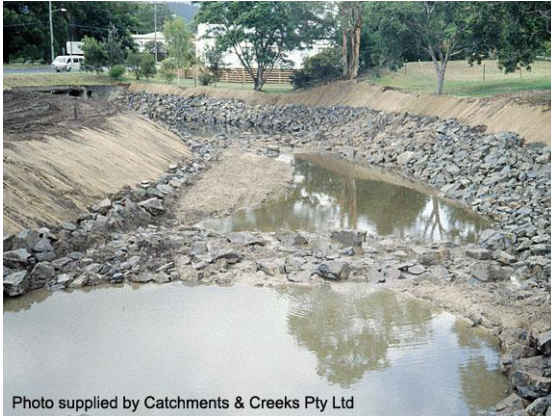
Looking upstream from Wardell St (1997)

- Pre-planting site conditions.
- Jute erosion control blankets placed over exposed soil banks prior to planting.

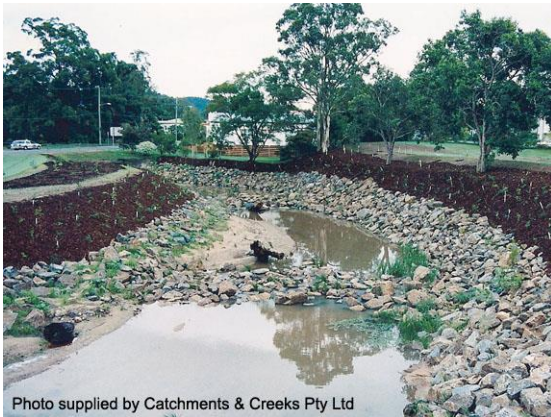
Looking upstream from Wardell St (1997)

- Site conditions just after initial plant establishment.
- Heavy loose mulching of the upper banks and over-bank areas.
- Limited pocket planting within the rock voids.

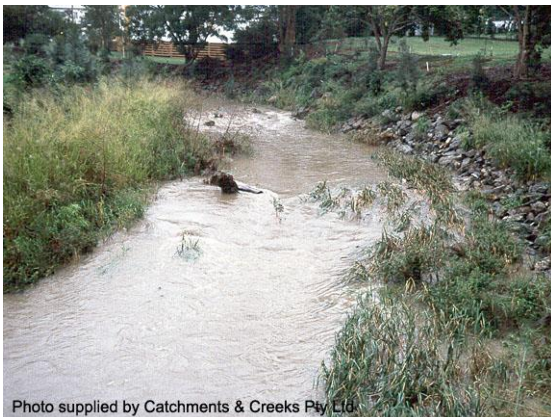
Looking upstream from Wardell St (1998)

- Significant weed (grass) growth within the bank vegetation.
- Channel bed effectively remains free of significant weed (reed) growth.

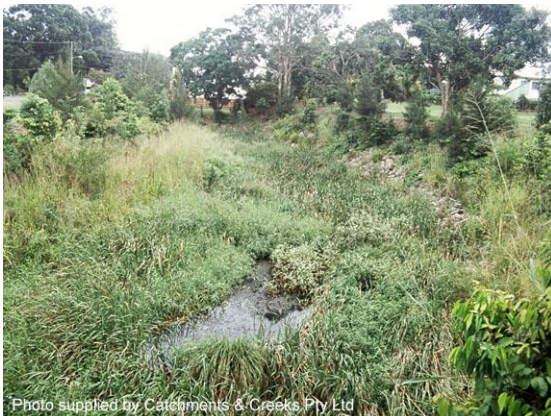
Looking upstream from Wardell St (1999)

- Significant weed growth along the banks and on the channel bed.
- A low-flow channel is beginning to establish in the centre of the channel bed.

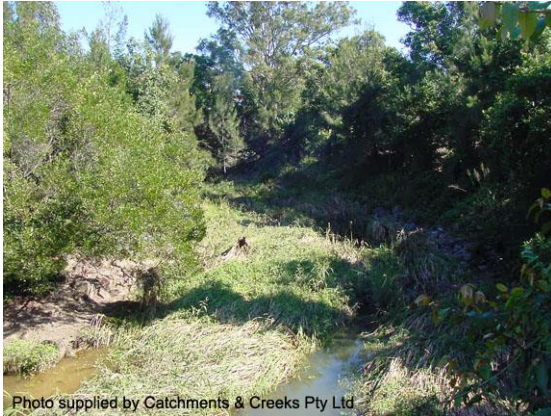
Looking upstream from Wardell St (2003)

- Upper-storey canopy trees are slowly beginning to shade the channel, but currently they are only controlling weeds on the banks.
- Dry-land grasses begin to invade the channel bed during the extended drought of 2000–2008.
- A well-defined low-flow channel still exists.
