Creek Erosion Control and Constructed Drainage Channel Case Studies

Version 2, 2022

Prepared by: Grant Witheridge, Catchments and Creeks Pty Ltd

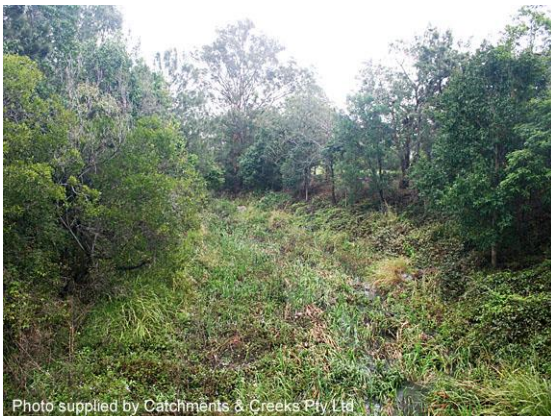
Looking upstream from Wardell St (2007)

- Riparian vegetation has thinned due to the past drought.
- Channel bed thick with weeds, mainly grasses.
- This image shows the channel just after a storm that caused the bed vegetation to fold in the direction of the flow.

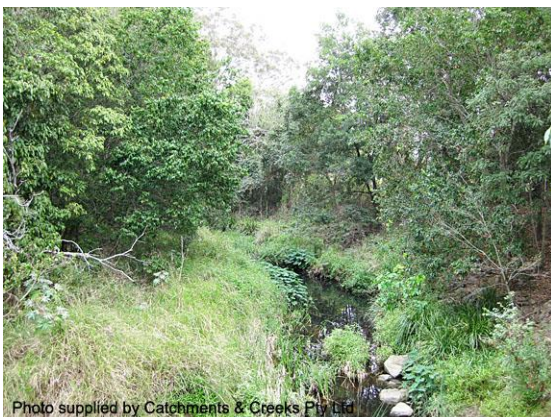
Looking upstream from Wardell St (2014)

- The low-flow channel is well defined.
- Excessive sediment deposition is occurring on the inside of the channel bend, and this sediment is being stabilised by weeds.

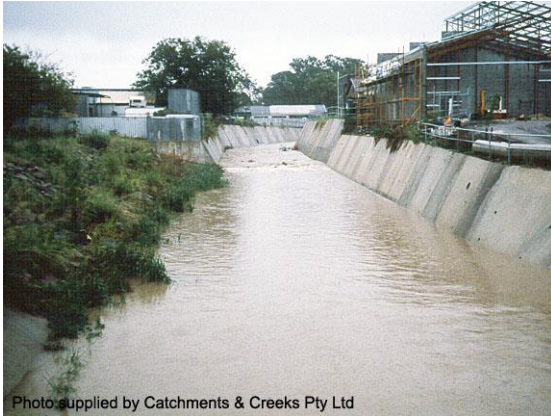
Looking upstream Magura St (1998)

- A habitat pool was established between the downstream end of the new concrete channel and the upstream end of the existing concrete channel.
- This habitat pond also acted as a sediment trap for the upper drainage catchment.

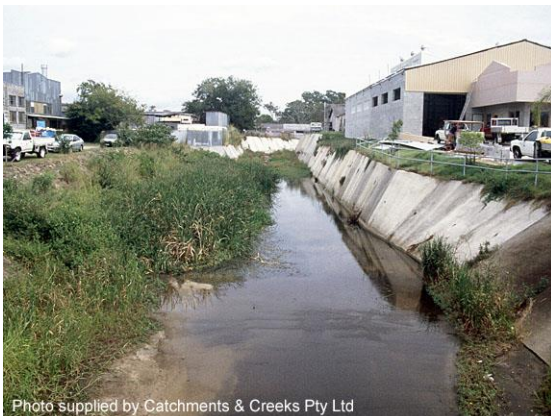
Looking upstream Magura St (1999)

- The rising bed level of the pond (due to sediment deposition) is allowing reeds to establish adjacent to the boulder wall.

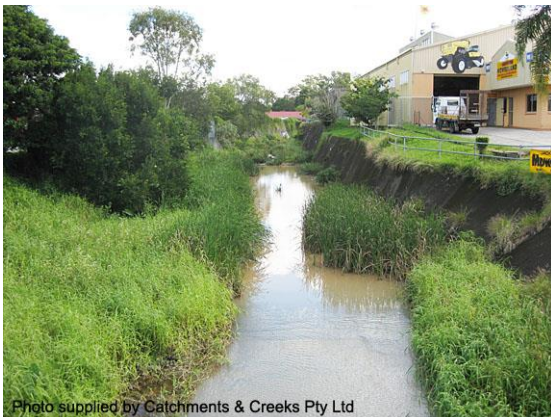
Looking upstream Magura St (2011)

- Significant sediment deposition has occurred within the habitat pond.

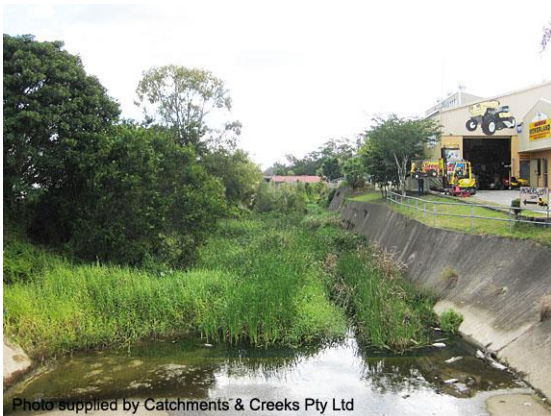
Looking upstream Magura St (2014)

- The habitat pond is now near-full of sediment resulting in the establishment of reeds and grasses across the full width of the pond.

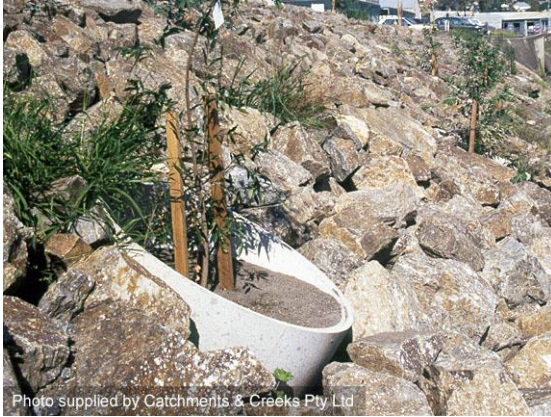
Tree planter boxes (1997)

- Tree planter boxes consisting of concrete pipe segments were installed in the boulder-lined southern bank of the creek to help shade the habitat pool.

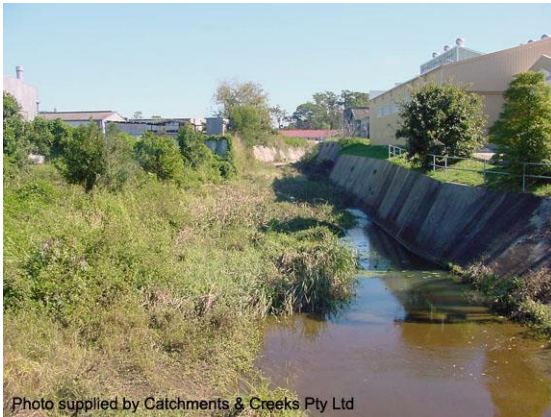
Looking upstream Magura St (2003)

- Canopy trees just beginning to appear above the weed-infested rock bank.

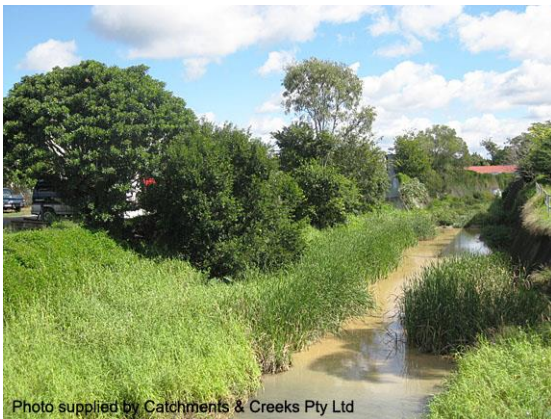
Looking upstream Magura St (2011)

- Limited shading is being provided over the habitat pond because sediment deposition has limited the extent (width) of the pond.

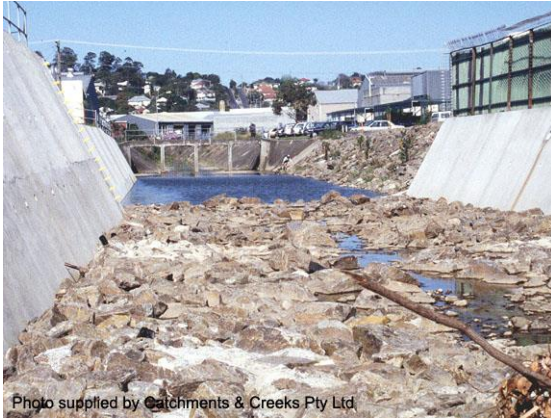
Looking d/s to Magura St footbridge

- At the request of a business located adjacent to the channel, 'ecological features' were designed into the concrete channel.
- These 'experimental' features included rocks being grouted to the channel floor.
- The intent was for vegetation to establish over these rocks to help establish a more-natural channel bed ecosystem.

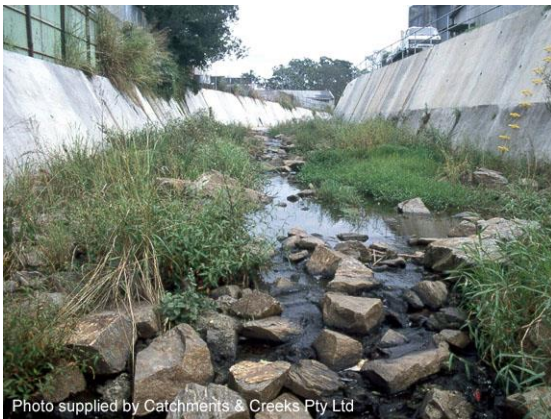
Looking upstream (1999)

- Sediment has settled between the rocks and plants are now beginning to establish on the channel bed.
- A low-flow channel has formed through the planted rocks.

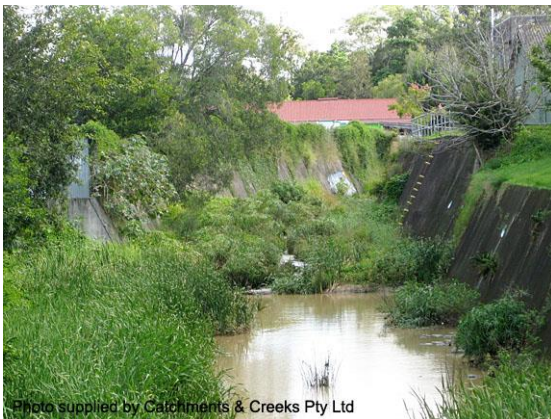
Looking upstream from footbridge (2011)

- Plants and an associated ecosystem have established on the bed of the grouted, rock-lined, concrete channel bed.
- The habitat pond is still visible in the foreground.

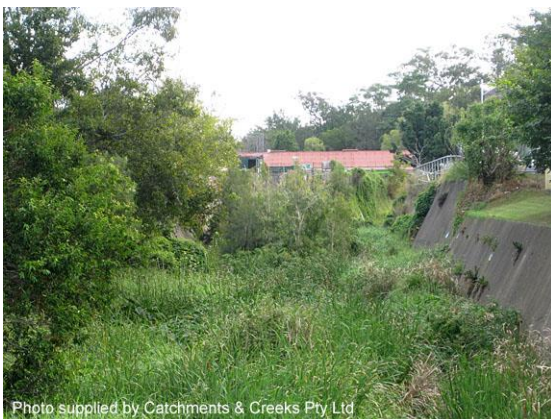
Looking upstream from footbridge (2014)

- Woody species (*Melaleuca*) are now becoming established within the rock-lined concrete channel.
- The growth of such woody species in the concrete channel would not be desirable from a flood control perspective, as well as there is the risk that the roots could dislodge the grouted rocks, which could result in all the plants being dislodged during the next flood.

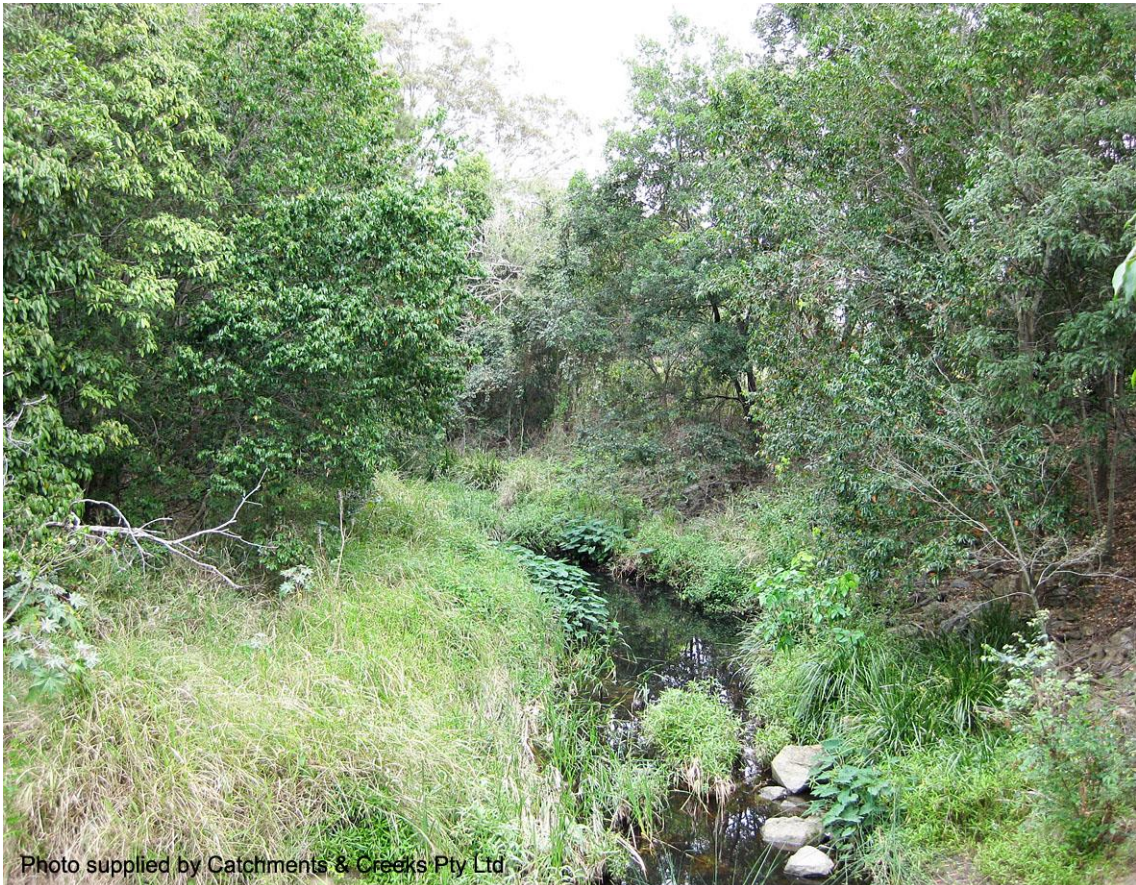
Looking upstream from Wardell Street culvert (2014)

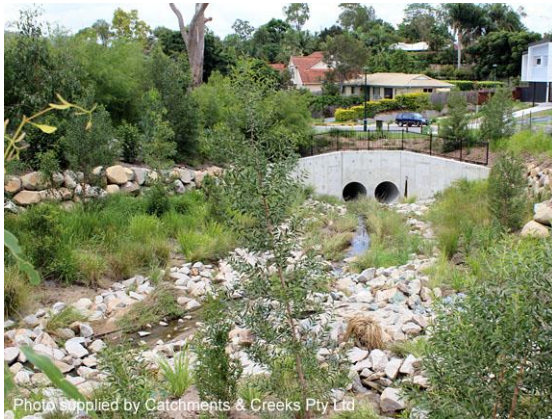
Existing creek upstream of the site (2012)

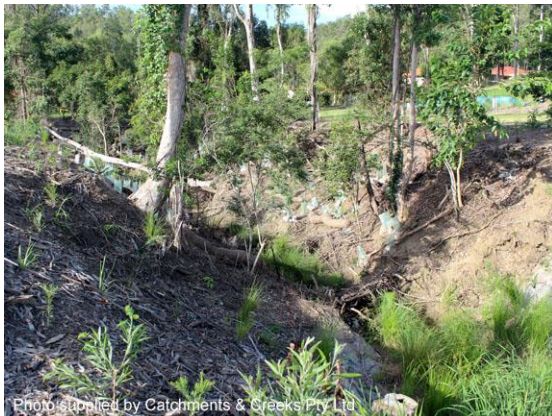
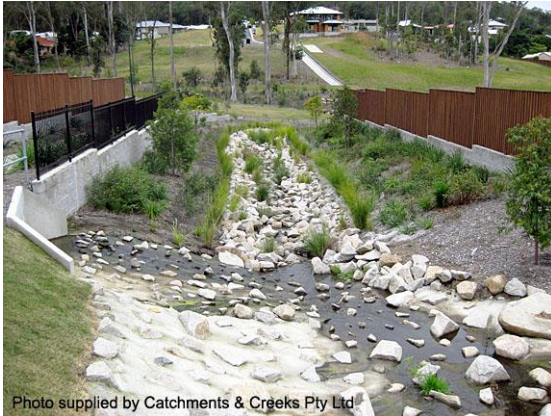
- The creek that passes through the subdivision is relatively steep.
- Prior to the modifications made during construction of the residential subdivision, the creek contained significant weed infestation and was subject to some ongoing bed and bank erosion.
- The developer was required to stabilise the creek and replace weeds with native plants.
- The site will be further monitored over the next few years.

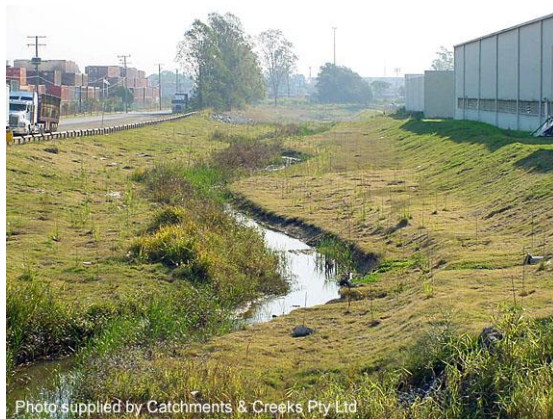
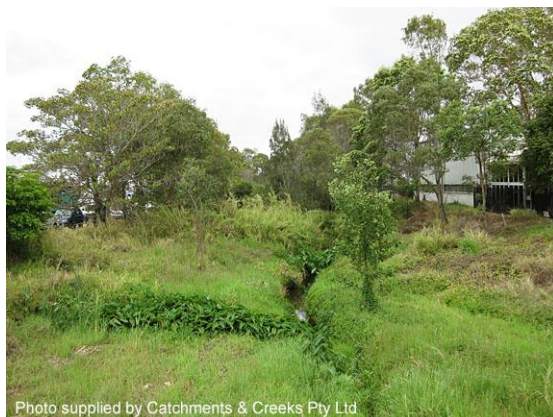
- As woody vegetation slowly established on either side of the low-flow channel, the hydraulic stresses placed on the low-flow channel during flood events increased.
- As a result of this increased shear stress, the low-flow channel suffered significant erosion problems until thick non-woody vegetation began to dominate along the banks of the low-flow channel.

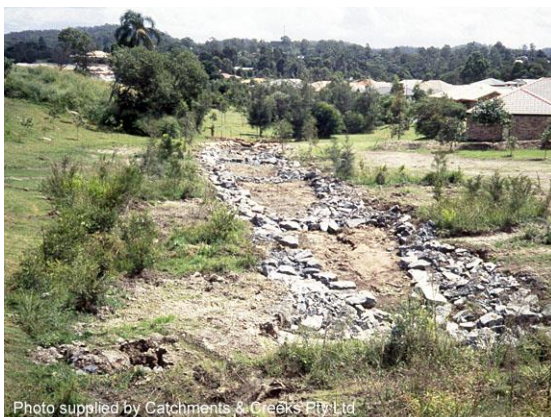
Looking downstream (1977)

- The basis problem was that it would take several years to achieve the required vegetation cover (channel roughness).
- In the mean time, excessive flow velocities caused gully erosion (head-cut) to migrate up through the channel.
- The early stages of this gully erosion can be seen here passing up the invert of the channel.

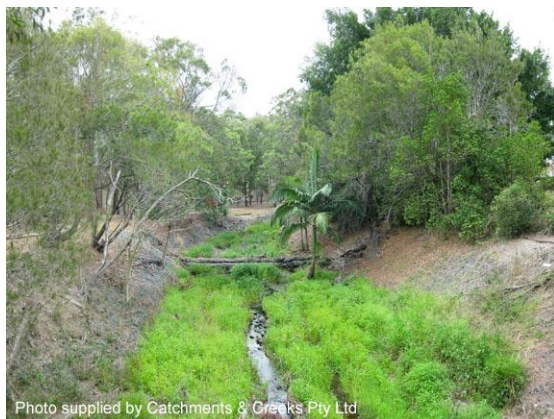
Looking u/s from Kameruka St (2014)

- Establishment of a partial canopy cover over the channel, and the resulting shading of the channel, has reduced the density of the in-channel weeds.
- Limited vegetation establishment has occurred on the mattress-lined channel banks, possibly as a result of the maintenance control of weeds.
- In the long-term, appropriate ground covers will need to be established over all the rock-filled mattresses.
