# **Creek Erosion Control and Constructed Drainage Channel Case Studies**

## **Creek Erosion Control and Constructed Drainage Channel Case Studies**

Version 2, September 2022

Prepared by: Grant Witheridge, Catchments and Creeks Pty Ltd

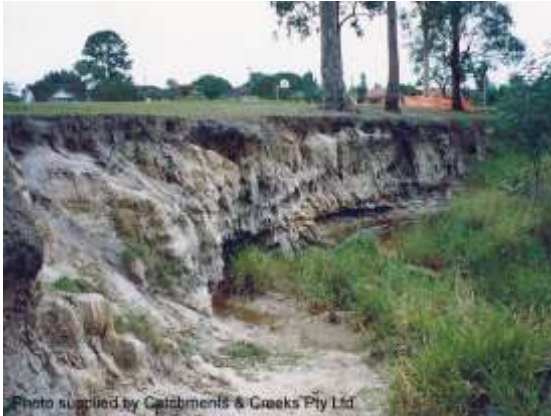
**Severe bank erosion, Inala, Qld**

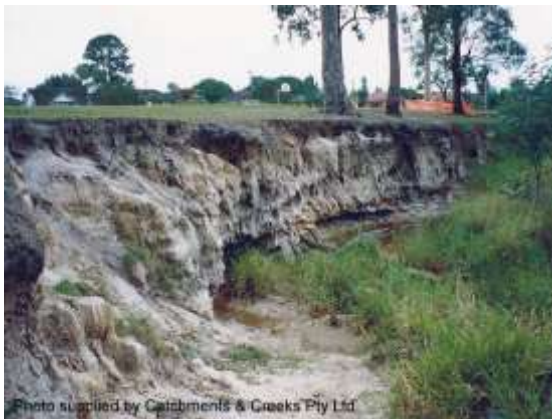
Bank erosion looking upstream (1993)

- This creek passes through a region of highly erodible dispersive subsoils.
- The creek had largely been cleared of riparian vegetation resulting in a weedy, open canopy waterway.
- In the past, parts of the creek had been stabilised with grouted rock, which is now failing largely due to the highly erodible underlying soils.

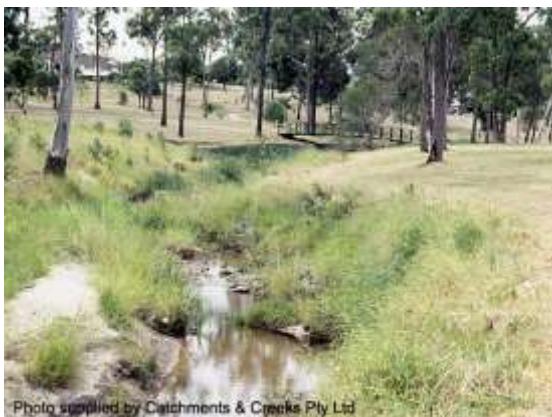
Early plant establishment (1996)

- The key feature of this project was the matching of the rehabilitated bank with the existing aesthetics of the creek.
- Covering the rocks with vegetation has helped to remove the 'constructed' appearance of the creek bank.
- In time the bank will be planted with natives in association with riparian restoration along the opposite bank.

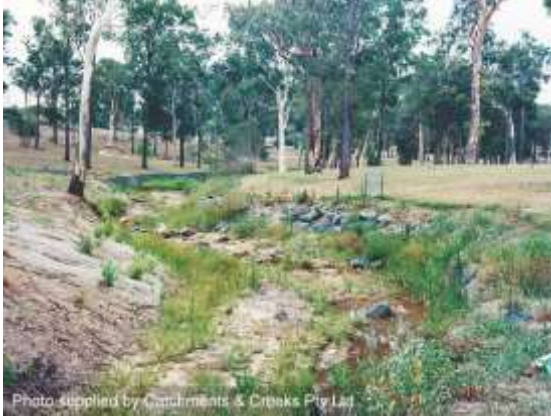
Looking d/s with works on right (1995)

- Most of the rock stabilisation was covered with soil and planted.

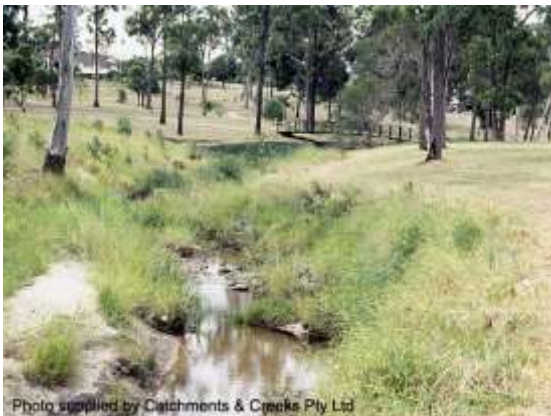
Looking d/s with works on right (1996)

- Weeds and grasses dominate the bank revegetation; however, these plants help the new bank to blend with the rest of the creek.

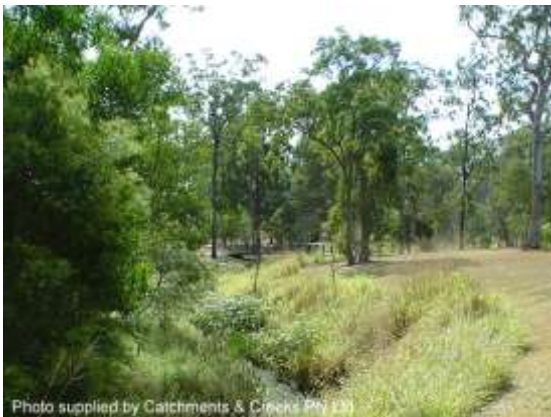
Looking d/s with works on right (2004)

- Significant loss of middle and upper-storey natives is obvious.
- Grasses dominate along the bank.

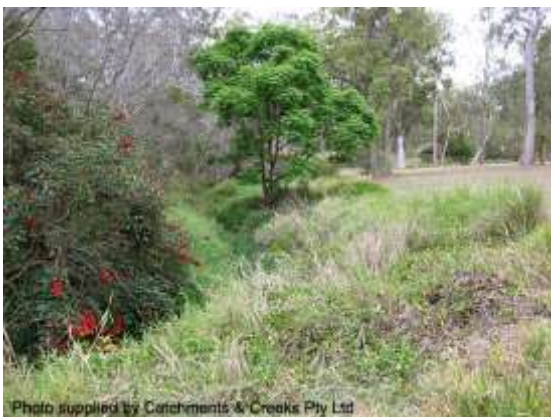
Looking d/s with works on right (2014)

- Grasses still dominate the bank vegetation, but the bank remains erosion-free and very stable.

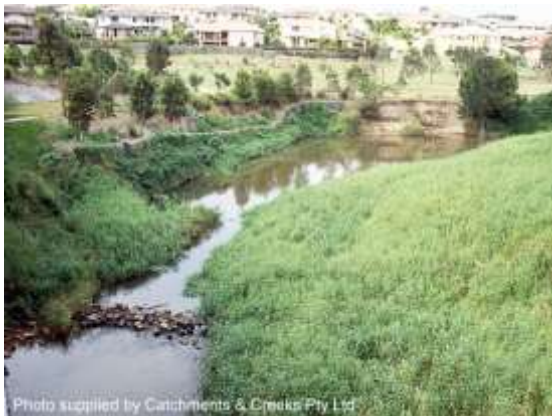
Looking upstream from bridge (2000)

- The problem caused by the placement of the gabion wall on the outside of a significant channel bend was that it induced high flow velocities to exist along the face of the gabion wall.
- As a result of this, high flow velocities also existed adjacent the creek bed causing a scour hole to form at the base of the gabion wall.
- Consequently, the gabion wall started to slide (slump) into the creek bed.

- One of the main problems associated with gabion structures in Brisbane waterways is their propensity to attract non-native vines.
- Once established within the gabions, these vines can then move into the adjacent riparian zone.
- By the year 2000, vines had already established along the gabion wall.

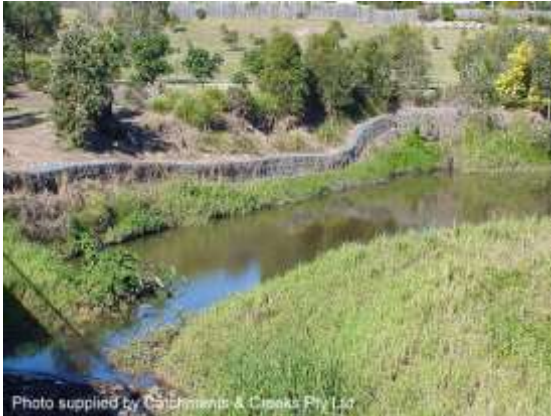
Looking upstream from bridge (2001)

- Maintenance work had cleared the gabions of the vines.
- The gabion wall continues to slump into the creek bed.

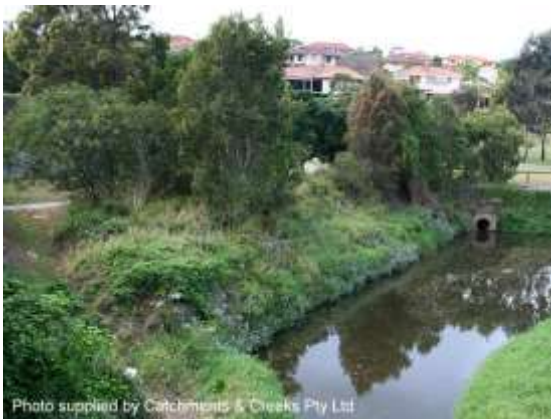
Looking upstream from bridge (2008)

- The gabion wall is now heavily vegetated, mainly with weed species.

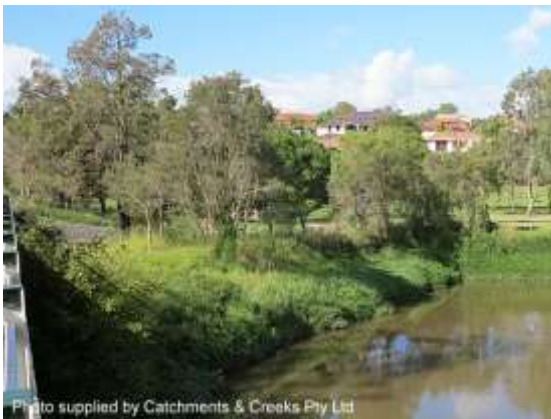
Looking upstream from bridge (2014)

- The ongoing slumping of the creek bank has allowed a lower bench to form at the base of the bank.
- The formation of this bench, and the ongoing establishment of woody species should see the creek bank achieve a more 'natural' profile and stability.

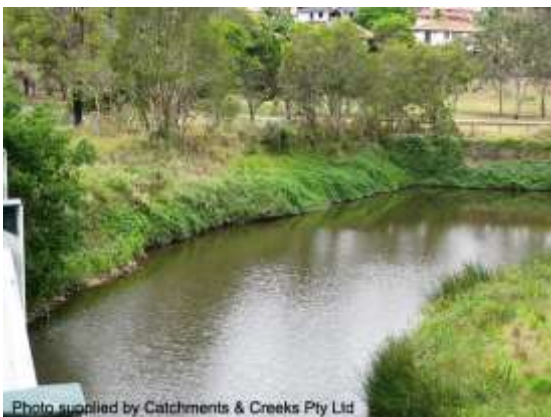
Looking upstream from bridge (2014)

- No visible indications left of the gabion wall.
- Weeds still dominate the bank vegetation.

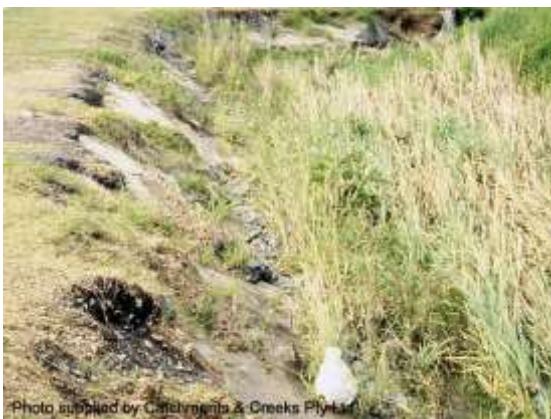
Downstream of footbridge (1997)

- In the absence of vegetation, rock-lined banks can induce high flow velocities to occur adjacent the rock-lined surface.
- These same high velocities can also exist adjacent the unprotected creek bed causing bed scour.
- Toe erosion at the base of the rock-lined bank, and the existence of a smooth filter cloth underlay, caused the rocks to slide down the face of the bank into the creek.

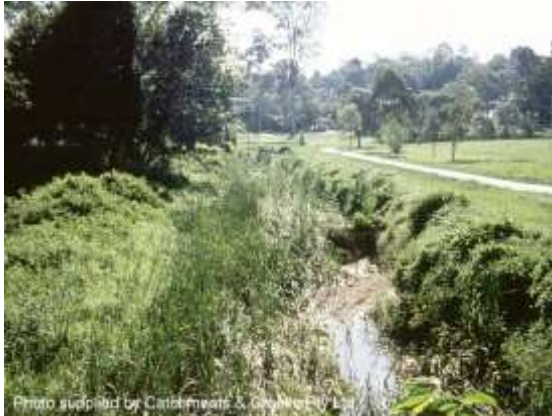
**Upstream of footbridge (1995)**

- In the absence of other controlling factors, there is a greater tendency for bank erosion to occur predominantly on the more-shaded northern banks of streams.
- This problem becomes less significant north of the Tropic of Capricorn.
- This 1995 photo shows the steep northern bank (right) and the heavily vegetated, more gradual southern bank (left) prior to the initiation of the bank erosion.

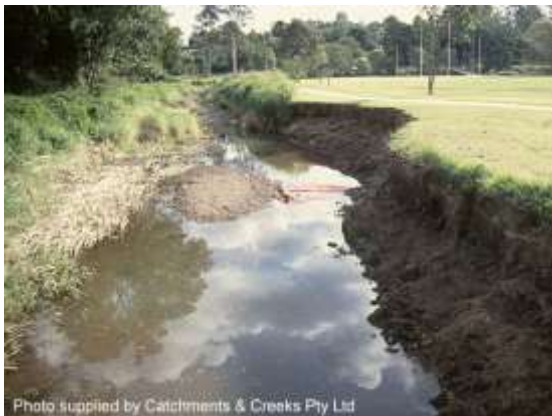
**Upstream of footbridge (1996)**

- Significant rainfall and flooding occurred in Brisbane during May 1996.
- This image shows the eroded northern bank of the creek after the May 1996 storm.
- Note that the eroded bank is in shade.
- Note also, the limited amount of erosion experienced on the more substantially vegetated southern bank.

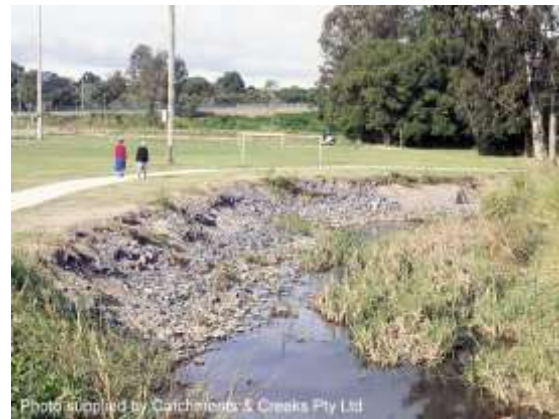
**Downstream of footbridge (1996)**

- Bed scour adjacent the rock-stabilised bank has undermined the creek bank.
- Having been placed on a ‘smooth’ geotextile mat, the rock simply slipped down the bank onto the creek bed.

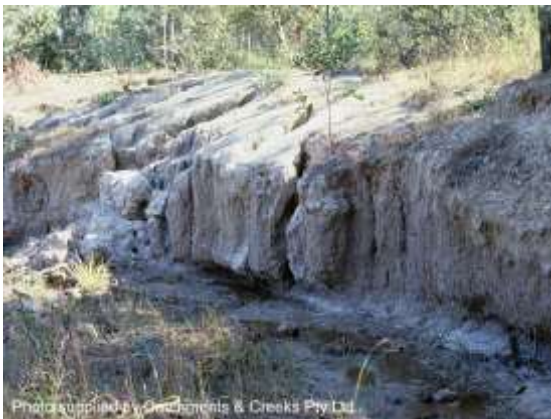
Eroded, dispersive soil bank (1991)

- Downfall Creek contains some of the most erodible soils in Brisbane.
- The subsoils found at the community centre are largely dispersive, meaning the soils contain a significant (>6%) quantity of sodium, which causes the soil to be unstable and disperse in water.
- A small tributary to the creek flows through the Bushland Centre and this tributary was experiencing significant bank erosion as a result of the exposure of these dispersive subsoils.

- Rehabilitation of the eroded creek bank became a demonstration project for the use of a new (in 1991) erosion control product, 'jute matting'.
- The eroded bank was re-profiled, stabilised with rock along the toe of the bank, seeded with grass, then covered with 'thin' jute matting.
- The bank was initially stabilised with grass before native plants were introduced to the stable bank over the following years.

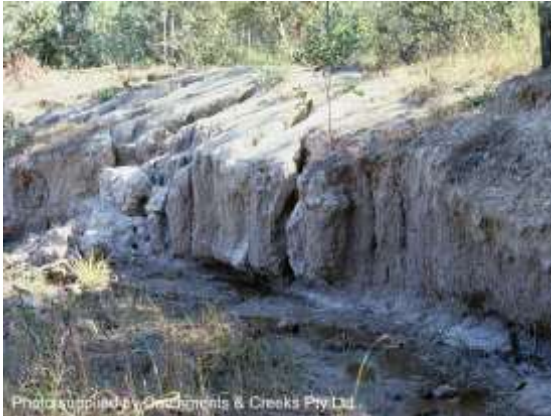
Tributary, looking upstream (1991)

- The exposed sodic subsoil on the northern bank experienced significant vertical rilling known as ‘fluting’.
- Tunnels had formed in the soil (tunnel erosion) passing from the base of the eroded bank up through the soil into the adjacent bushland.
- In a ‘misguided’ attempt to stop this tunnel erosion (the author’s error!), plastic sheeting was placed against the subsoil prior to placing the earth fill, rock and the jute matting.

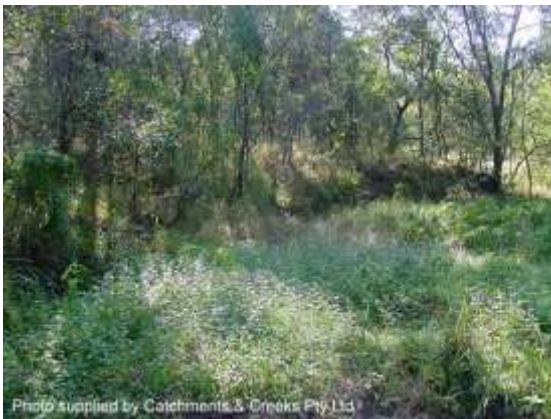
**Tributary, looking downstream (2001)**

- Some minor bed erosion is visible at the downstream end of the tributary at the point where the tributary spills into the main Downfall Creek channel (see photo below).

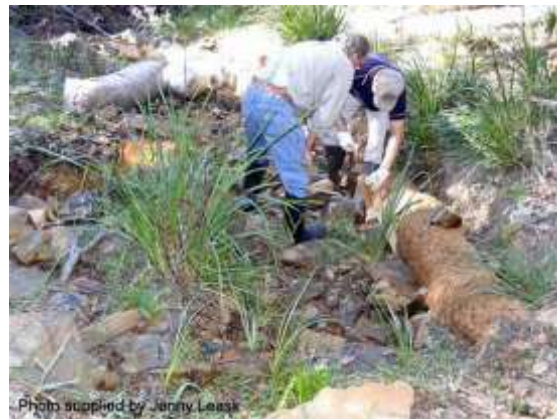
Toe stabilisation with jute logs (2012)

- On the southern bank of the tributary (opposite the eroded, dispersive soil bank) the soils are more stable, but high velocity flows discharging from the upstream culvert had caused significant toe erosion.
- The toe of the bank was stabilised with jute logs and planted with *Lomandra*.
- Both the jute log stabilisation of the *Lomandra* plants proved successful in stabilising the toe of the bank.

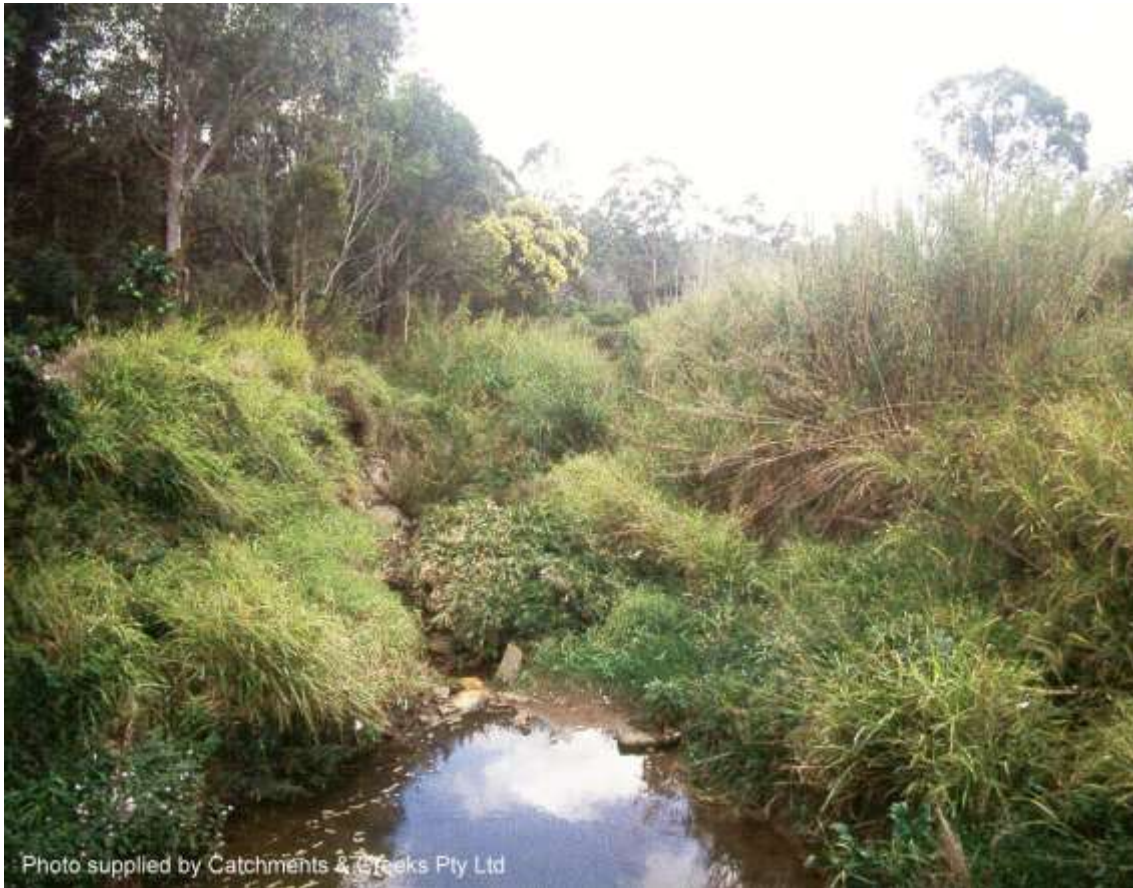
**Looking downstream from Rode Rd (1997)**

- With the weeds removed, and with the failed establishment of an effective native plant cover, the western bank (shown here to the left of the channel) experienced significant erosion (just visible in this 1997 image).
- Significant weed establishment along the bed of the creek also increased the erosion stress on the creek bank.

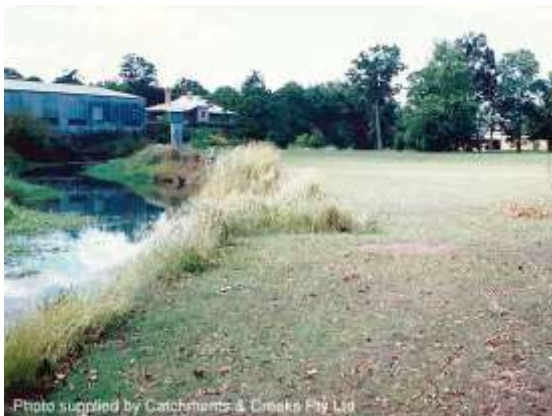
Looking downstream towards weir (1993)

- The Enoggera Creek weir is located at the creek bend just visible in the background of this 1993 image.
- The State Government's stream gauging station tower can be seen at the top of the creek bank adjacent the weir.
- Ongoing bank erosion had caused the formation of an unstable, steep creek bank that was seen as a safety risk to children playing in the adjacent park.

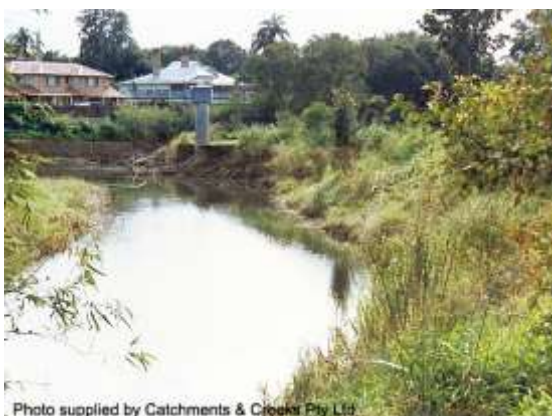
Looking downstream towards weir (1996)

- A good mix of ground covers, middle storey and upper storey plants was established along the creek bank.
- Significant bank erosion has occurred around the base of the abandoned stream gauging station tower (background).

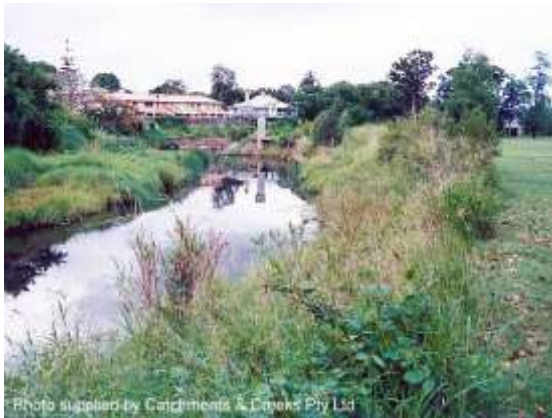
Looking downstream towards weir (1996)

- Significant loss of middle storey and upper storey plants has occurred.
- Non-woody ground cover grasses now dominate along the bank.
- Such a vegetation cover on the bank is likely to reintroduce high flow velocities along the toe of the bank, possibly leading to the return of bank erosion problems.

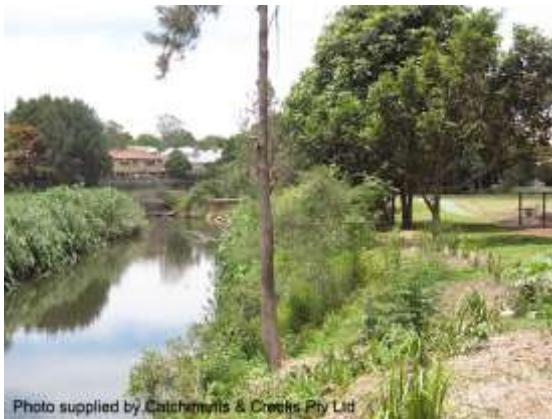
Looking downstream towards weir (2011)

- Native plants have increased in number, but the bank still lacks the required density of low woody branches that such a creek bank requires to prevent ongoing bank erosion.

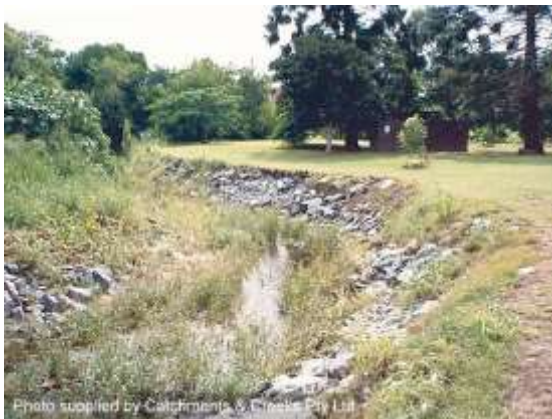
Looking downstream (1992)

- Erosion along the outer bank of this bend of Ithaca Creek was likely to have been initiated by the upstream concrete-lined channel works.
- The bank had previously been stabilised with rock, but appropriate vegetation had not been established within the rocks.

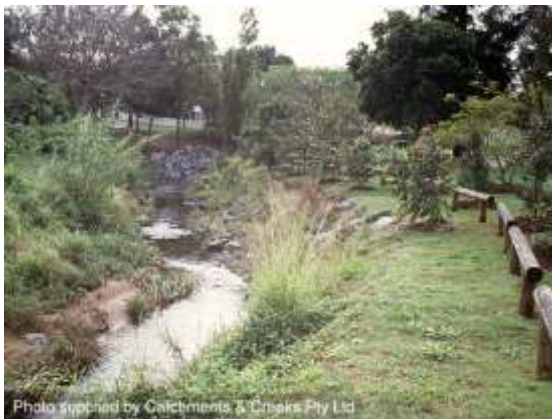
Looking downstream (1999)

- Woolcock Park had undergone significant enhancement by 1999, which had seen increased riparian planting both within the park and downstream of Waterworks Road.

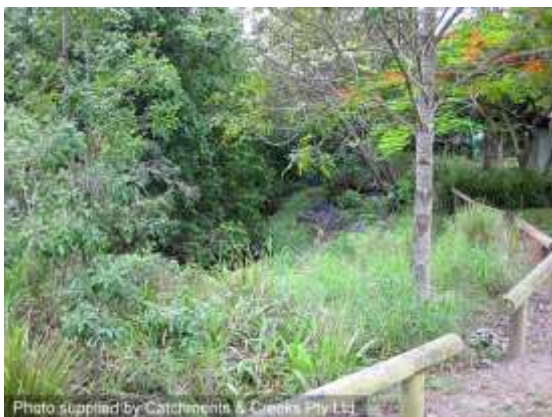
Looking downstream (2014)

- Riparian planting is fully established along the northern bank (left), but only partly established within the park (right).
- The establishment of a canopy cover over the low-flow channel along the northern bank has helped to maintain an open water low-flow channel.

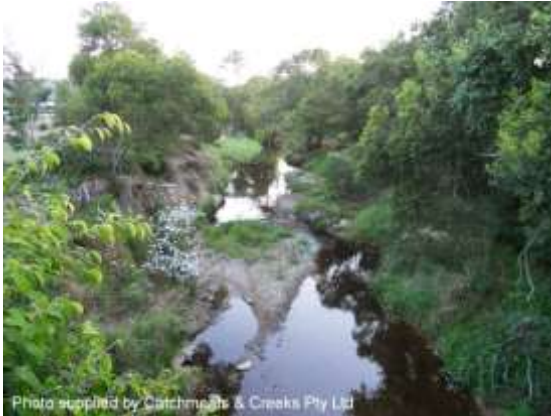
**Eroded bank on left, 28/9/12**

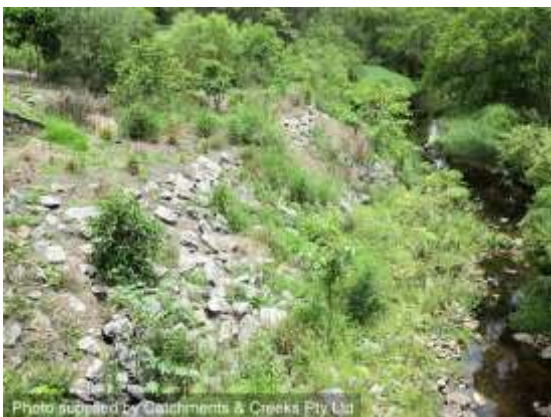
Establishment of vegetation (2014)

- Early stages of plant establishment in 2014.

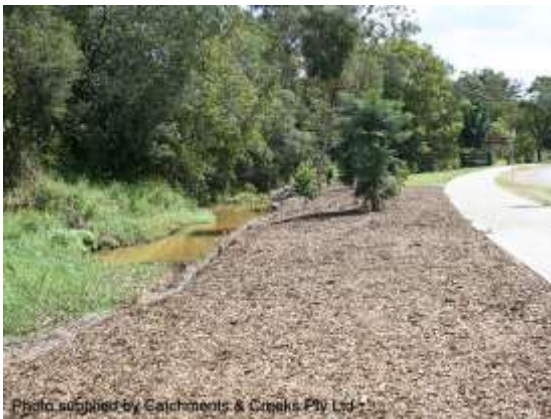
Overbank area looking upstream

- Sometime around 2006 the creek and over-bank riparian zone was cleared of weeds by the local council.
- The cleared area was heavily mulched and lightly planted in a manner that left the creek bank vulnerable to flood damage.

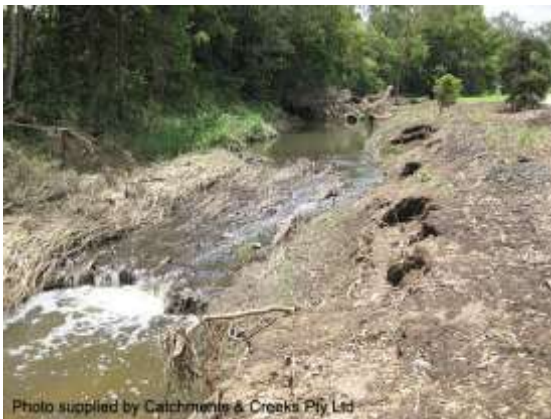
Looking upstream (2008)

- In 2008 a storm event caused significant bank erosion along the area previously cleared of weeds.
- Adding to the erosion problem was the fact that the eroded bank had a southern aspect resulting in the bank being heavily shaded once a near-vertical bank was formed through the creek erosion.
- The eroding creek bank progressively moved north towards the now established over-bank trees.

- In 2014 the bank was stabilised with rock at the same time the creek was de-silted.
- Final bank shaping consisted of exposed rock stabilisation in the lower third of the bank, with a vegetated upper two-thirds batter.
- The upper bank was initially stabilised with jute mesh prior to the establishment of plants.

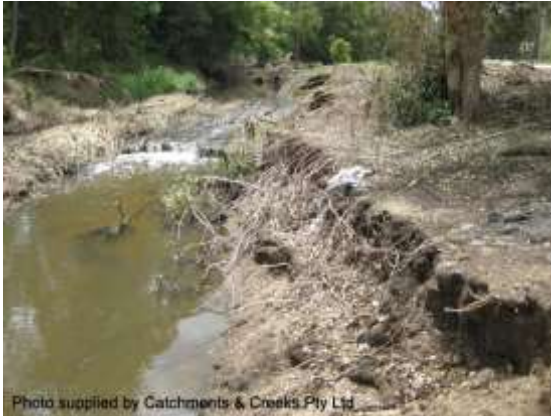
Looking upstream, November 2008

- Bank erosion commenced during the 2008 micro-storm that severely damaged the nearby suburb of The Gap.
- The top-of-bank is just 1 metre from the base of the tree (visible in top-right of image).

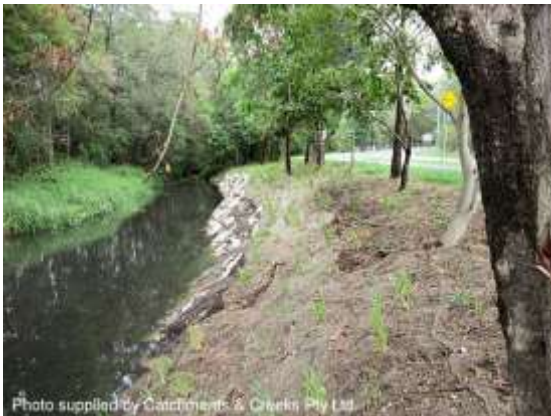
Looking upstream, December 2014

- Plants established within the erosion control mesh.
- This site has already experienced a near bankful event since September with no significant damage.

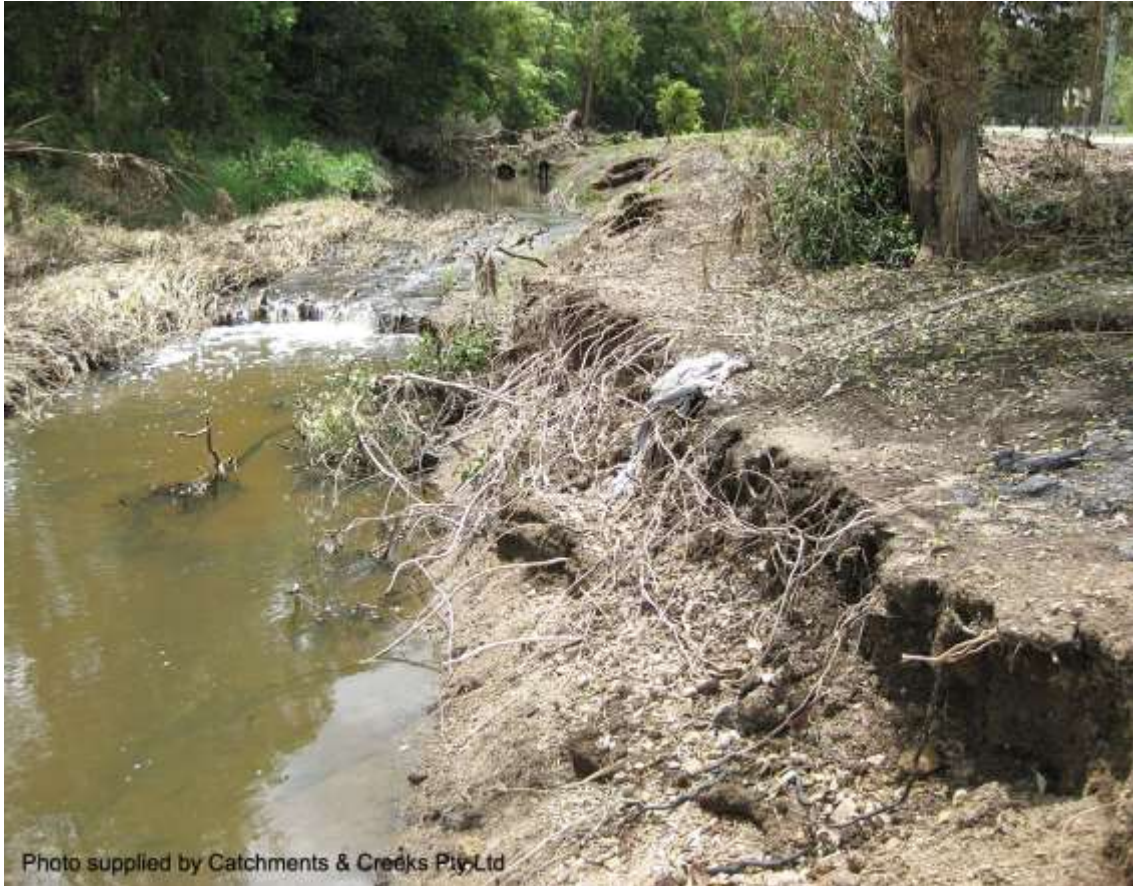
**Looking upstream following removal of weeds from creek bank, November 2008**

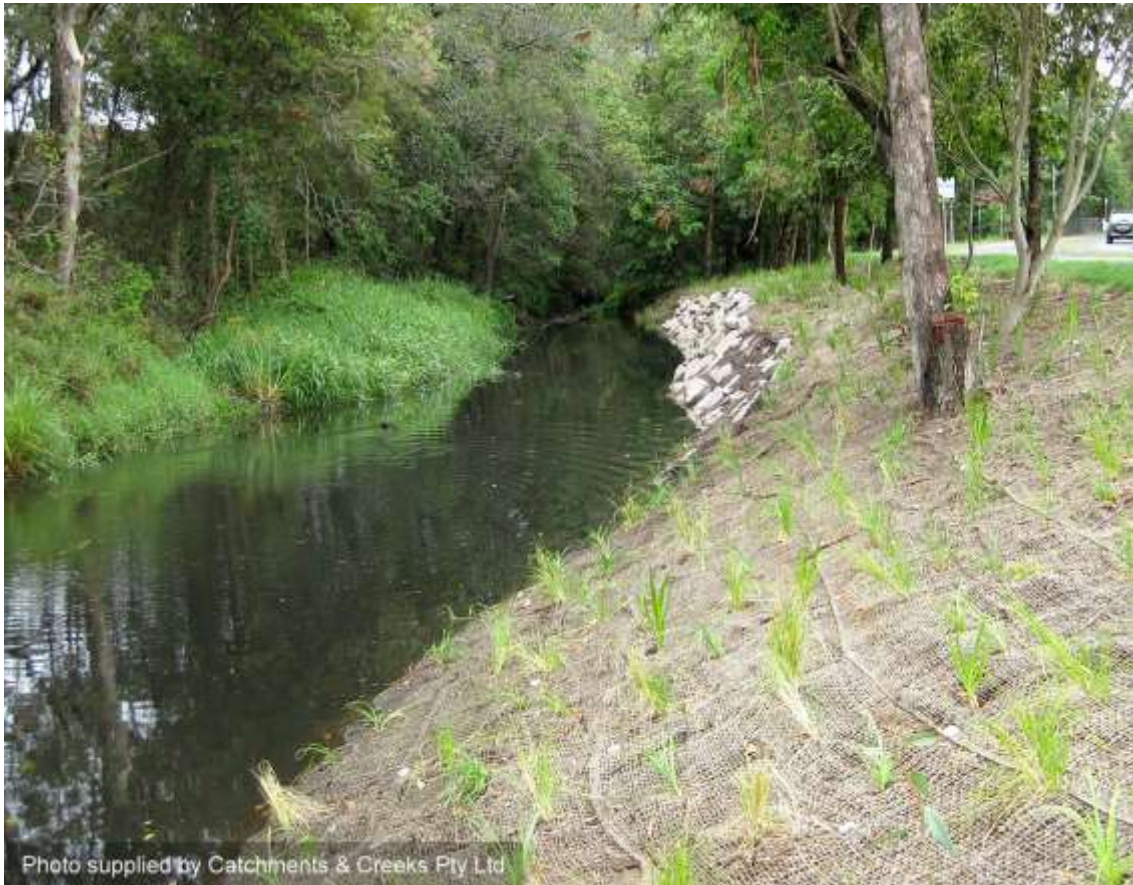
**Looking upstream after bank rehabilitation, December 2014**

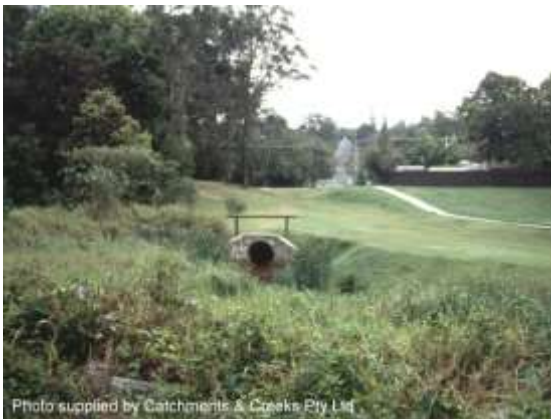
Previous stormwater outlet (1997)

- Prior to 2004, a stormwater pipe from Olankuna Crescent discharged directly into Kedron Brook at the park.
- In 2004 a stormwater treatment wetland was constructed at this outlet.
- Over the period 2009 to 2011 the creek experienced several near-bankful flows that caused erosion along the embankment that separated the stormwater treatment wetland from Kedron Brook.

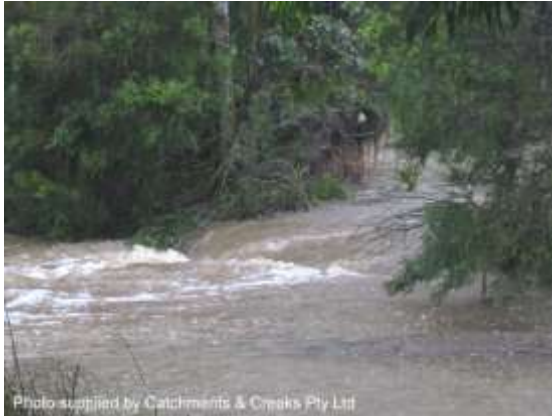
**Flood spill-through (11 Oct 2010)**

- On the 11 October 2010, flood waters passing down Kedron Brook reached and held a height of 'bankful flow' for an extended period of time.
- Floodwaters spilt from the main Kedron Brook channel into the stormwater treatment wetland causing significant damage to the connecting embankment.
- Floods during 2009, 2010, and 2011 had also caused significant erosion along the northern bank of Kedron Brook just upstream (to right) of the wetland.

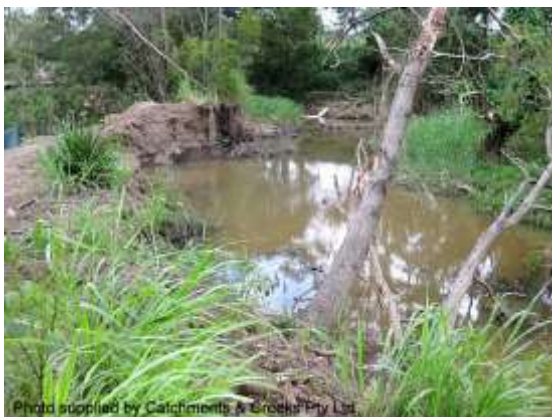
**Bank erosion (28 January 2011)**

- As a result of the extensive bank damage caused during 2010 and 2011, the northern creek bank (the outside bank of a sweeping channel bend) was stabilised with rock as part of the emergency, post-2011 flood works.
- The bank was lined with rock, all voids filled with soil, covered with jute mesh, and pocket planted with natives.
- The chosen native plants have low woody branches, which will add bank roughness.

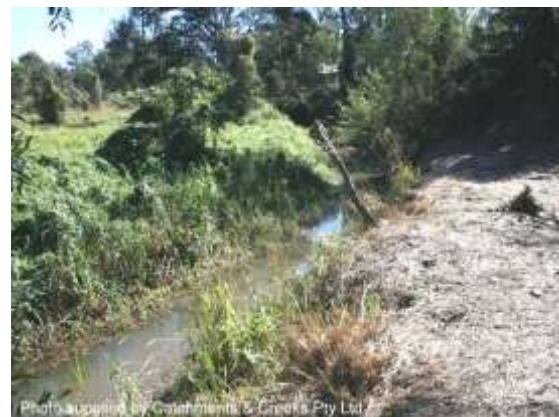
**Looking upstream (16 August 2010)**

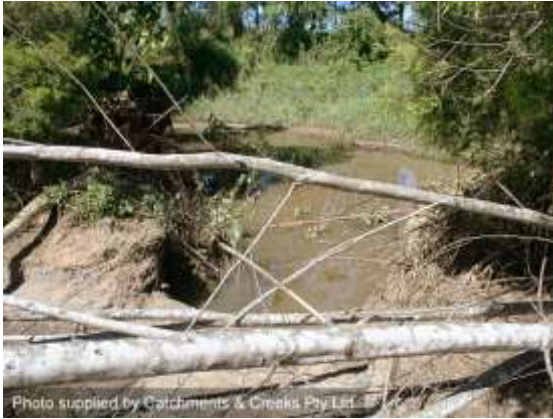
Post flood bank erosion (October, 2010)

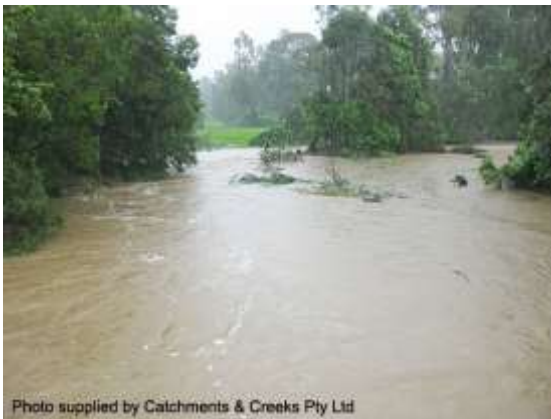
Looking u/s from Ferny Way (Oct, 2010)

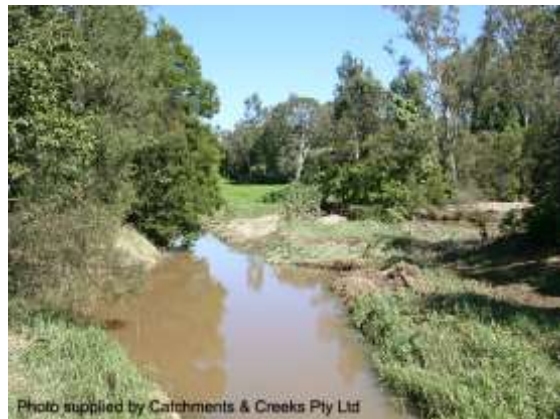
Looking u/s from Ferny Way (Oct, 2010)

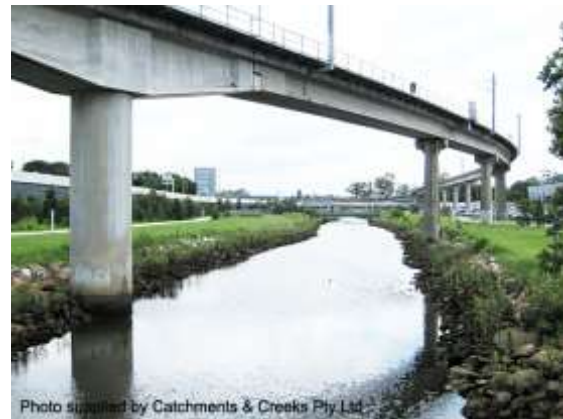
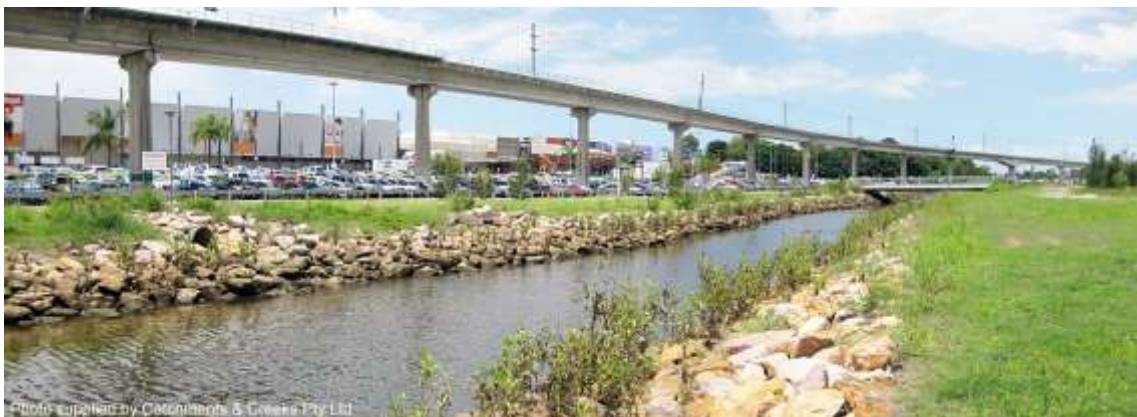
- Mangroves are beginning to establish within the rock-lined creek banks.

- The creek banks were stabilised with rock as part of the Airport Tunnel construction project.
- Mangroves have already begun to establish within the rocks.

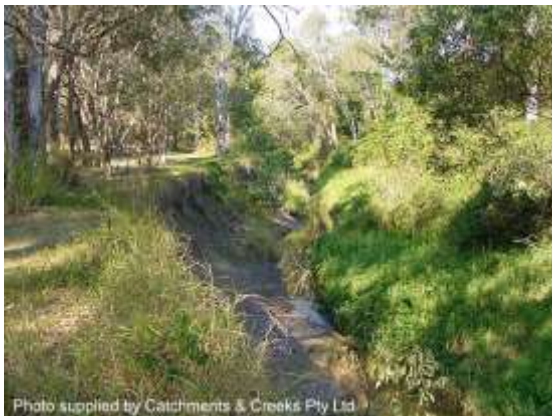
Similar erosion u/s of works area (2000)

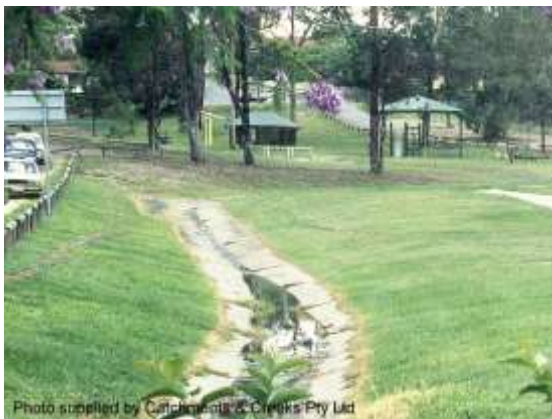
Original concrete drain (1998)

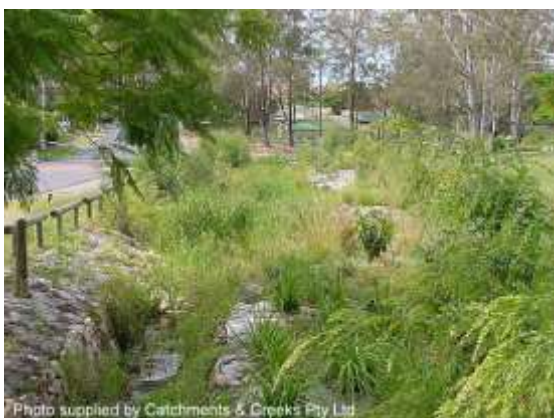
**Main channel (looking south, 2001)**

- Fully open canopy.
- Channel enters initial 'weedy' phase.
- Pools are almost completely filled with invading reeds.

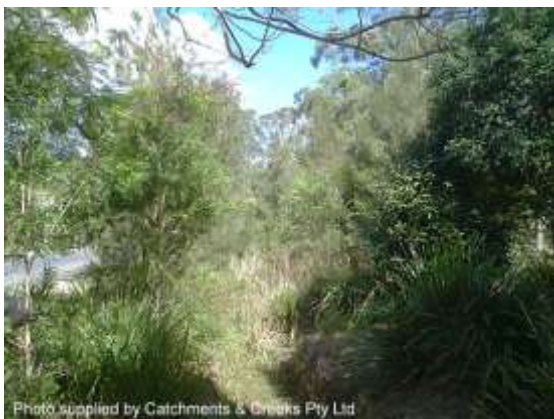
**Main channel (looking south, 2005)**

- Insufficient canopy cover still exists over the low-flow channel.
- Significant weed growth still exists within the channel.
- A dense cover of lower-storey native plants exists.

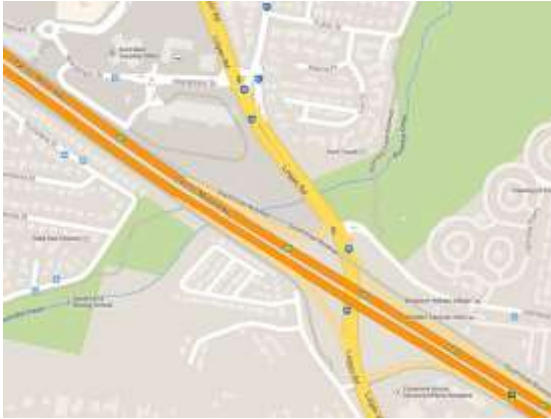
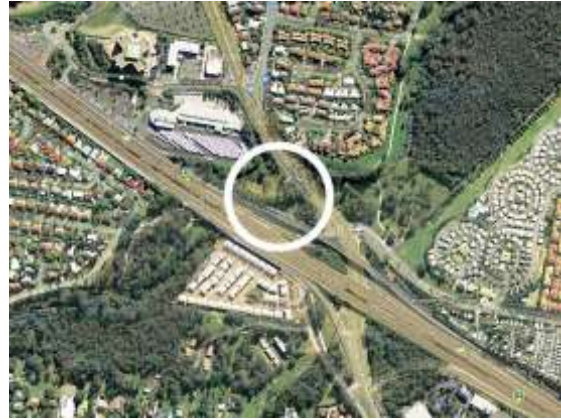
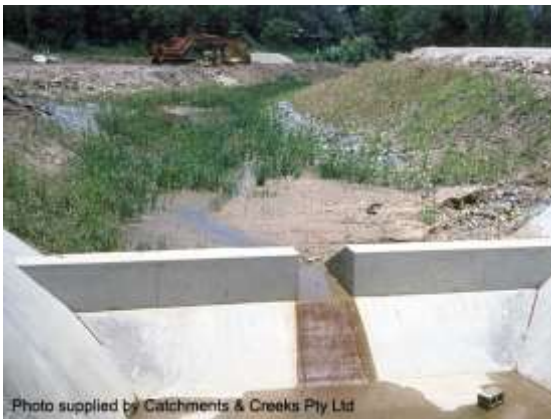
Looking upstream (1993)

- Creek channel was initially cleared and re-profiled as part of the Garden City Bus Depot construction.
- A non fish-friendly 'drop inlet' was formed at the inlet of the Logan Road culvert.

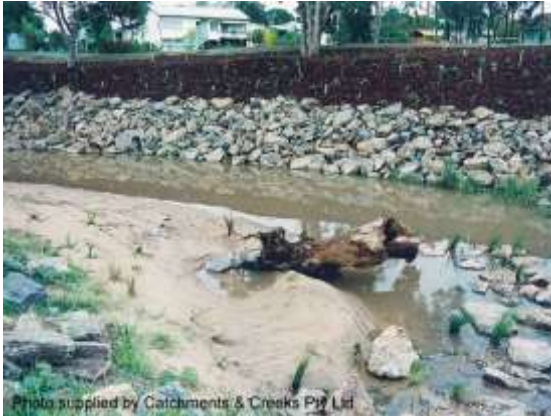
**Log and sand bench (1997)**

- Two habitat (roosting) logs were anchored into the channel.
- These logs provide habitat and shelter (from flood flows) for aquatic wildlife, and sunning perches for reptiles.
- Washed sand was introduced to the inside of channel bends to mimic the channel feature commonly found in alluvial river systems (now viewed as inappropriate within urban creeks).

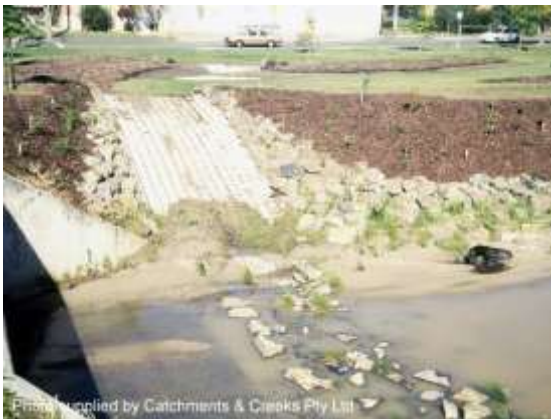
**Maintenance access ramp (1997)**

- Maintenance access ramps were installed into the channel both upstream and downstream of the Wardell Street culvert.
- These access ramps were formed from flexible geotextile/concrete mats (*Humes Flexmat*).
- Use of these mats allows vegetation (grasses) to grow between the concrete blocks to eventually hide the hard surfacing.

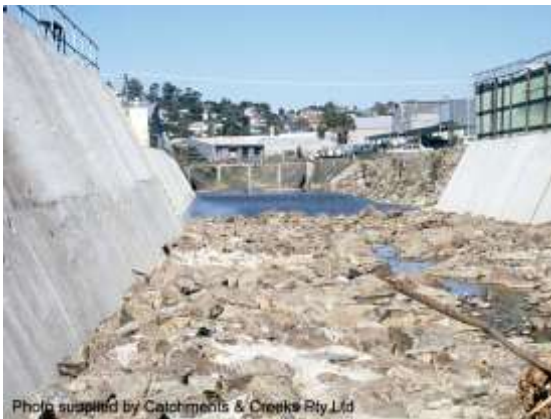
**Grouted rock bed on concrete channel**

- A deep sediment trap and habitat pool was established between the downstream end of the new concrete channel and the upstream end of the existing concrete channel, just upstream of the Magura Street footbridge.
- To enhance the environmental features of the concrete channel, rocks were grouted to the bed of the downstream end of the new concrete channel.
- The intent was to allow vegetation to establish over these rocks.

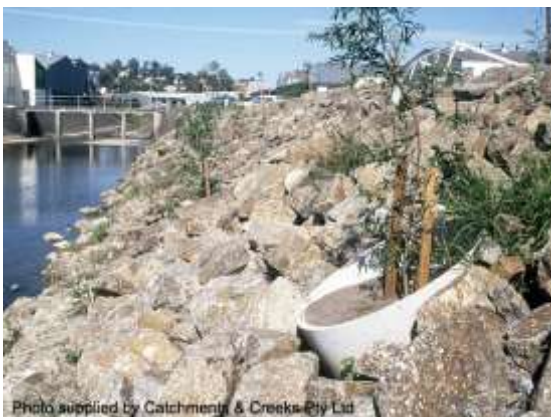
**Tree planter boxes set into boulders**

- To help shade the habitat pool, tree planter boxes (concrete pipe segments) were installed in the boulder-lined southern bank of the creek adjacent the Magura Street footbridge.

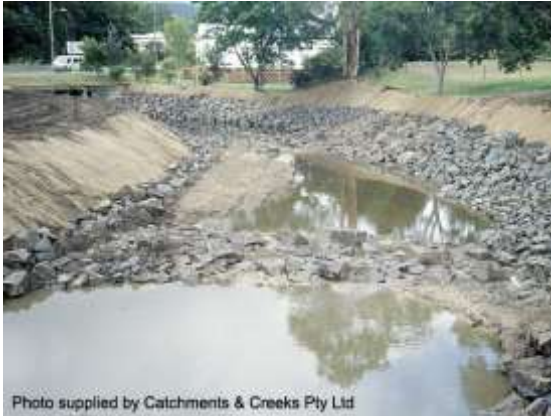
Looking upstream from Wardell St (1997)

- Pre-planting site conditions.
- Jute erosion control blankets placed over exposed soil banks prior to planting.

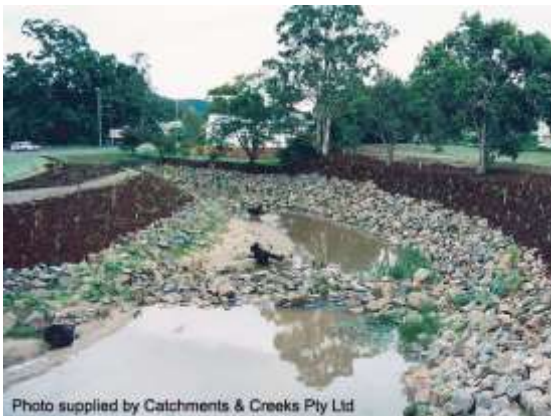
Looking upstream from Wardell St (1997)

- Site conditions just after initial plant establishment.
- Heavy loose mulching of the upper banks and over-bank areas.
- Limited pocket planting within the rock voids.

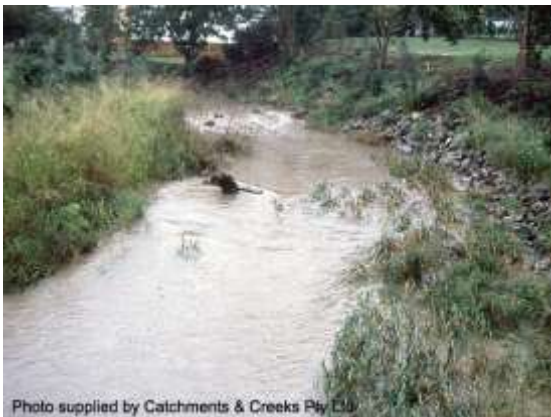
Looking upstream from Wardell St (1998)

- Significant weed (grass) growth within the bank vegetation.
- Channel bed effectively remains free of significant weed (reed) growth.

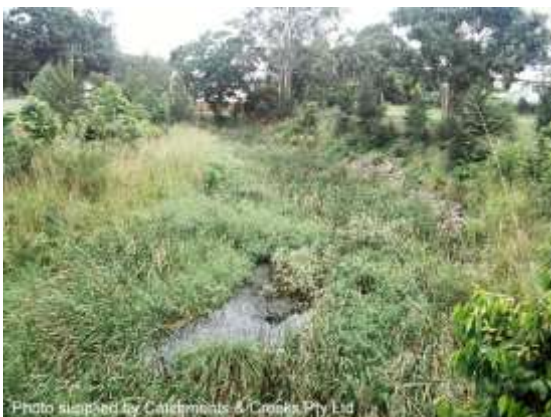
Looking upstream from Wardell St (1999)

- Significant weed growth along the banks and on the channel bed.
- A low-flow channel is beginning to establish in the centre of the channel bed.

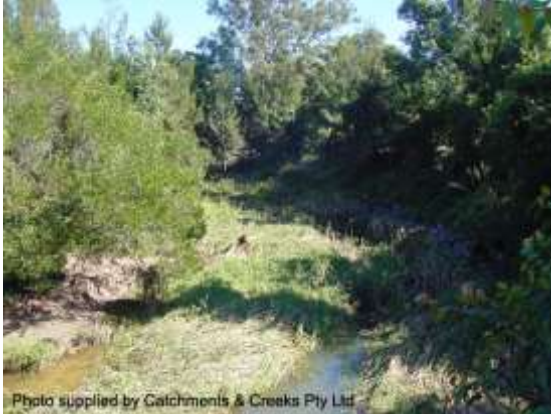
Looking upstream from Wardell St (2003)

- Upper-storey canopy trees are slowly beginning to shade the channel, but currently they are only controlling weeds on the banks.
- Dry-land grasses begin to invade the channel bed during the extended drought of 2000–2008.
- A well-defined low-flow channel still exists.

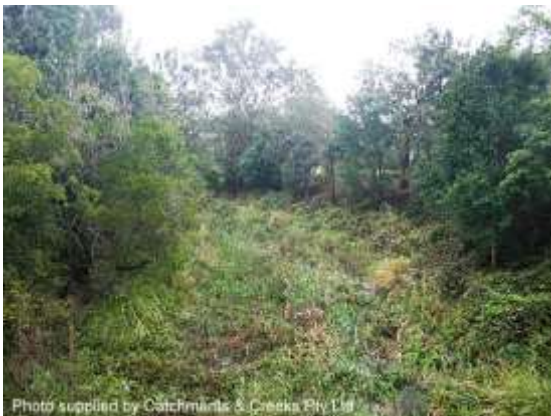
Looking upstream from Wardell St (2007)

- Riparian vegetation has thinned due to the past drought.
- Channel bed thick with weeds, mainly grasses.
- This image shows the channel just after a storm that caused the bed vegetation to fold in the direction of the flow.

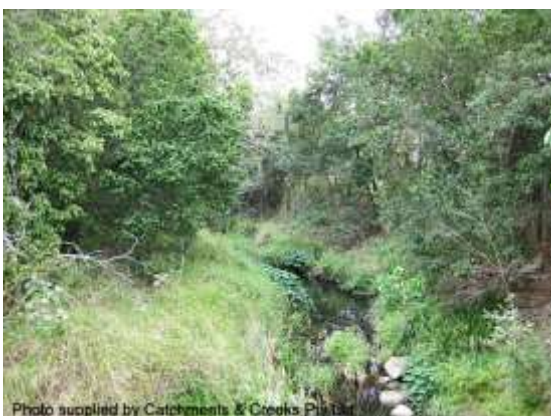
Looking upstream from Wardell St (2014)

- The low-flow channel is well defined.
- Excessive sediment deposition is occurring on the inside of the channel bend, and this sediment is being stabilised by weeds.

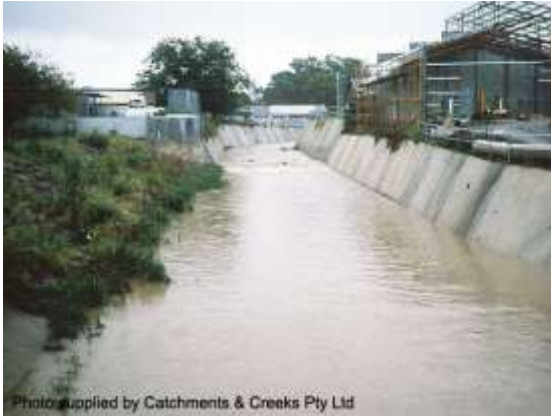
Looking upstream Magura St (1998)

- A habitat pool was established between the downstream end of the new concrete channel and the upstream end of the existing concrete channel.
- This habitat pond also acted as a sediment trap for the upper drainage catchment.

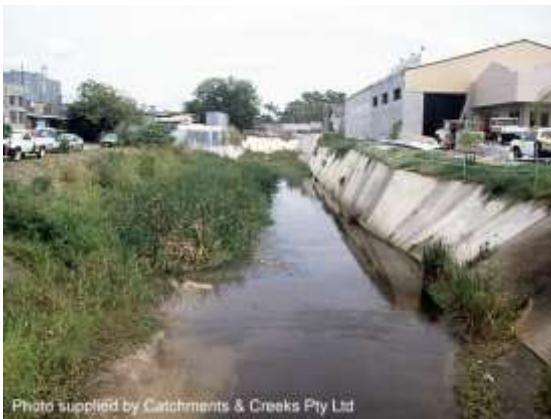
Looking upstream Magura St (1999)

- The rising bed level of the pond (due to sediment deposition) is allowing reeds to establish adjacent to the boulder wall.

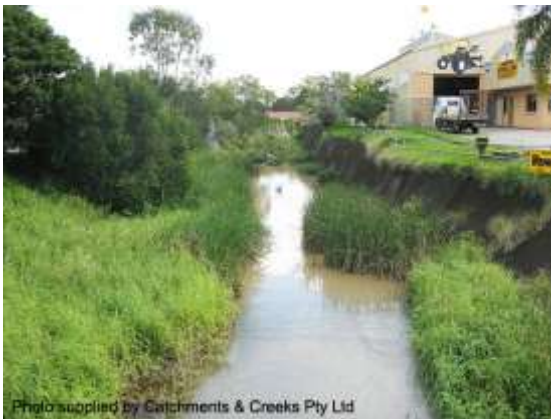
Looking upstream Magura St (2011)

- Significant sediment deposition has occurred within the habitat pond.

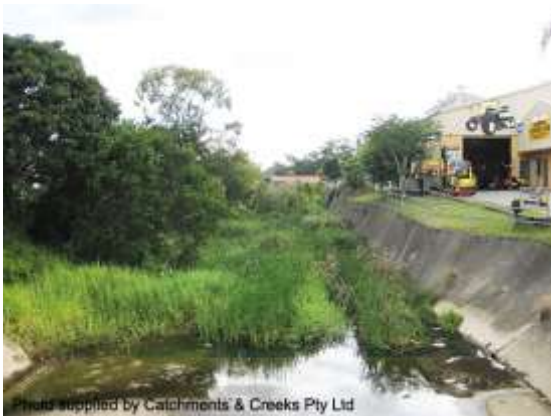
Looking upstream Magura St (2014)

- The habitat pond is now near-full of sediment resulting in the establishment of reeds and grasses across the full width of the pond.

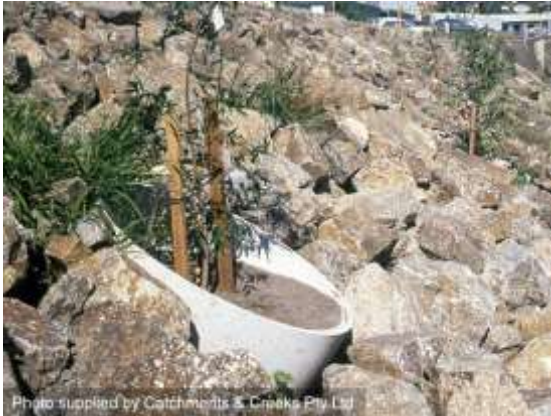
Tree planter boxes (1997)

- Tree planter boxes consisting of concrete pipe segments were installed in the boulder-lined southern bank of the creek to help shade the habitat pool.
