# **Creek Erosion Control and Constructed Drainage Channel Case Studies**

## **Creek Erosion Control and Constructed Drainage Channel Case Studies**

Version 2, September 2022

Prepared by: Grant Witheridge, Catchments and Creeks Pty Ltd

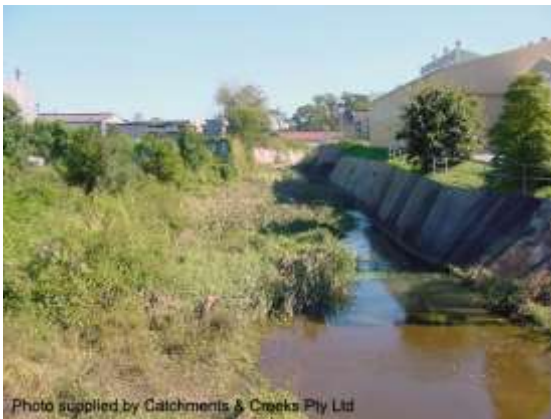
Looking upstream Magura St (2003)

- Canopy trees just beginning to appear above the weed-infested rock bank.

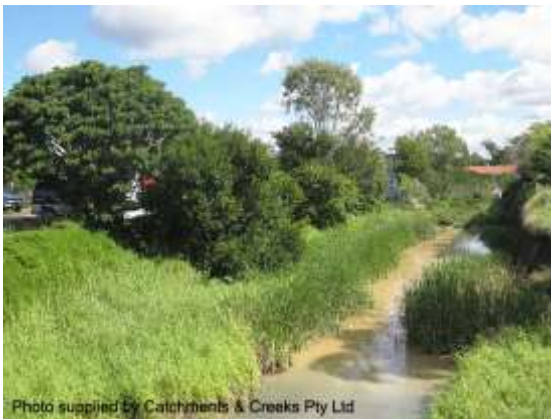
Looking upstream Magura St (2011)

- Substantial tree growth.

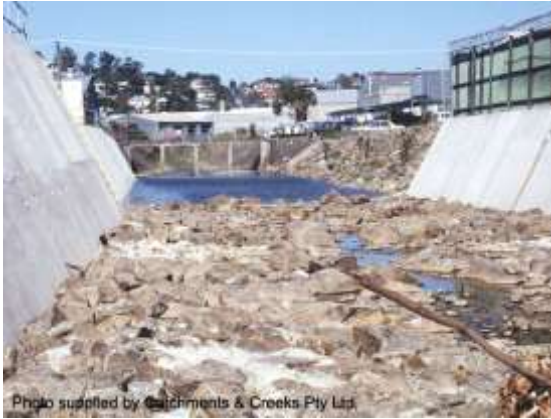
Looking d/s to Magura St footbridge

- At the request of a business located adjacent to the channel, 'ecological features' were designed into the concrete channel.
- These 'experimental' features included rocks being grouted to the channel floor.
- The intent was for vegetation to establish over these rocks to help establish a more-natural channel bed ecosystem.

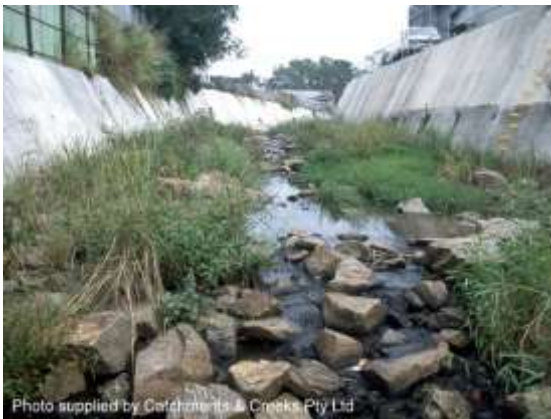
Looking upstream (1999)

- Sediment has settled between the rocks and plants are now beginning to establish on the channel bed.
- A low-flow channel has formed through the planted rocks.

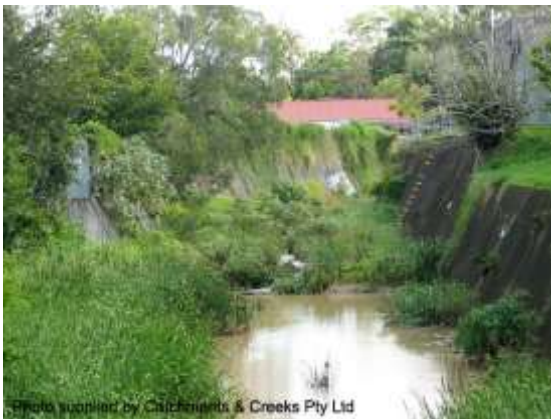
Looking upstream from footbridge (2011)

- Plants and an associated ecosystem have established on the bed of the grouted, rock-lined, concrete channel bed.
- The habitat pond is still visible in the foreground.

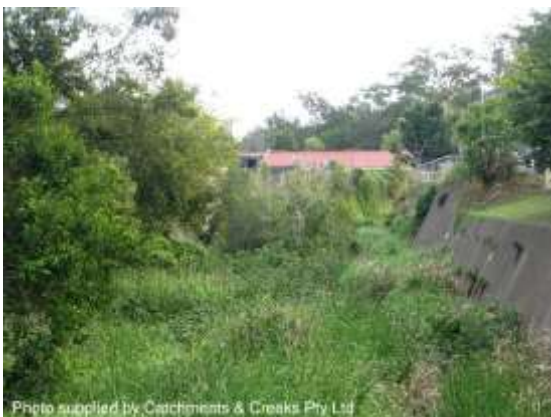
Looking upstream from footbridge (2014)

- Woody species (*Melaleuca*) are now becoming established within the rock-lined concrete channel.
- The growth of such woody species in the concrete channel would not be desirable from a flood control perspective, as well as there is the risk that the roots could dislodge the grouted rocks, which could result in all the plants being dislodged during the next flood.

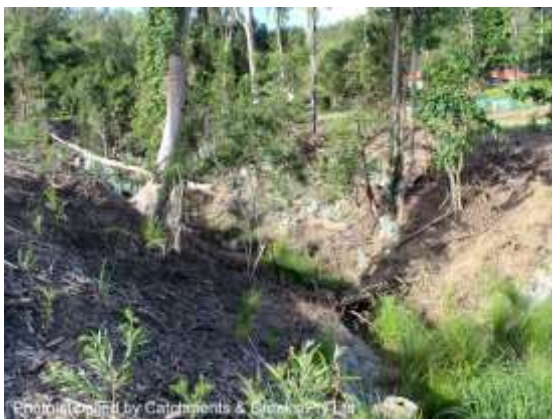
Existing creek upstream of the site (2012)

- The creek that passes through the subdivision is relatively steep.
- Prior to the modifications made during construction of the residential subdivision, the creek contained significant weed infestation and was subject to some ongoing bed and bank erosion.
- The developer was required to stabilise the creek and replace weeds with native plants.
- The site will be further monitored over the next few years.

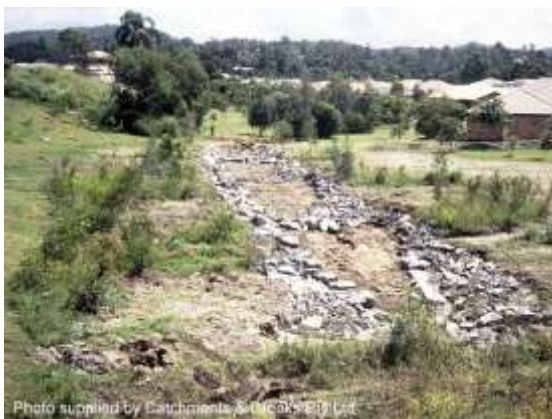
Looking downstream (1997)

- The basis problem was that it would take several years to achieve the required vegetation cover (channel roughness).
- In the mean time, excessive flow velocities caused gully erosion (head-cut) to migrate up through the channel.
- The early stages of this gully erosion can be seen here passing up the invert of the channel.

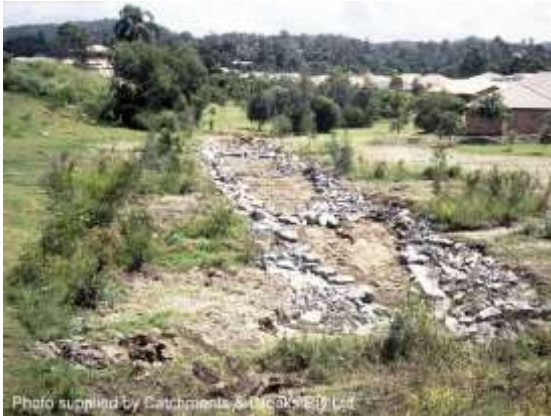
- In 1997 the site was taken over by Brisbane City Council and a series of recessed rock check dams were installed across the steep overland flow path.
- The recessed check dams extend well into the banks; however, in this image they are only visible as they pass across the low-flow channel.
- The outer edges of the channel were planted with trees and shrubs, but most of these plants were lost through aggressive maintenance mowing.

Looking downstream from culvert (1997)

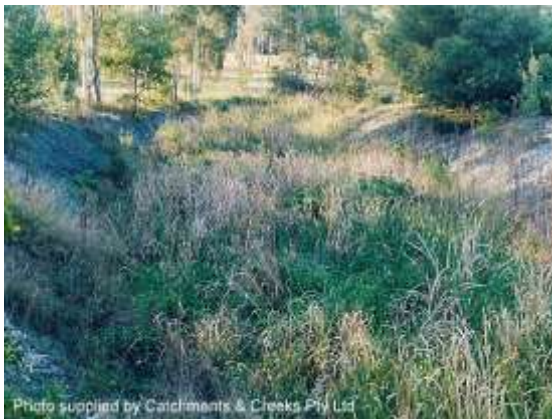
Looking d/s with works on right (2014)

- Grasses still dominate the bank vegetation, but the bank remains erosion-free and very stable.

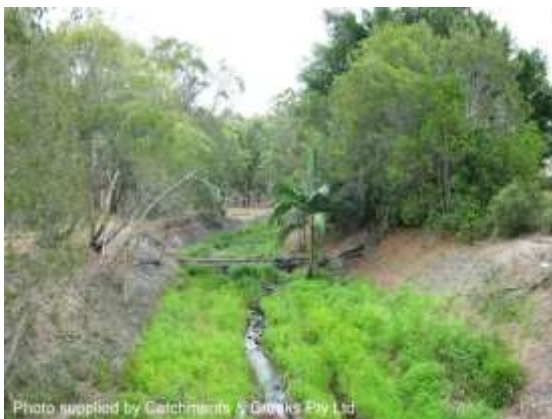
Looking upstream from bridge (1995)

Photo supplied by Catchments & Creeks Pty Ltd
