Creek Rehabilitation Case Studies

Version 1, December 2014

Prepared by: Grant Witheridge, Catchments and Creeks Pty Ltd

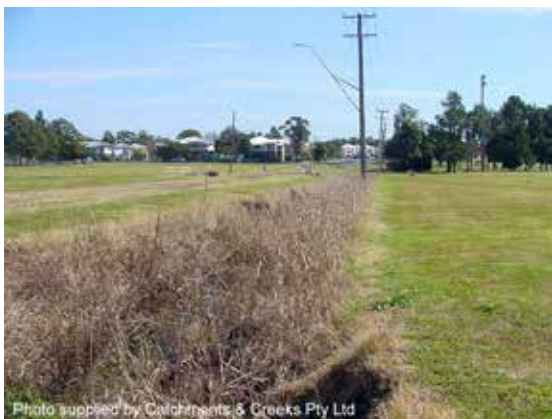
Pre-works site conditions (2003)

- The site was constrained by planned road works south of the drain, and the sports ovals on the northern side of the drain.
- It was also considered desirable to avoid the relocation of the telephone pole.
- The site contains a cracking clay soil that benefits greatly from suitable vegetation cover that can reduce soil drying.
- The visually unattractive, low-value stormwater drain was also subject to urban litter, including shopping trolleys.

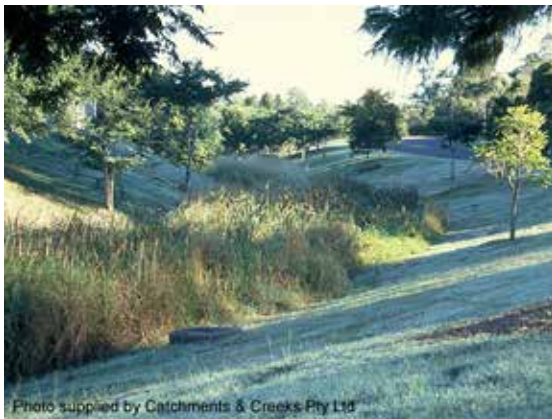
Grassed drain (pre-works, 1999)

- The original purpose of the channel works was to reduce the long-term soil saturation problems experienced by the channel bed.
- Soil saturation made mower access to the far bank difficult, and reduce the potential for the planting of native species.
- The original proposal involved forming a well-defined, 300 mm deep, low-flow channel by raising part of the bed at least 300 mm.
- A habitat pool was also constructed.

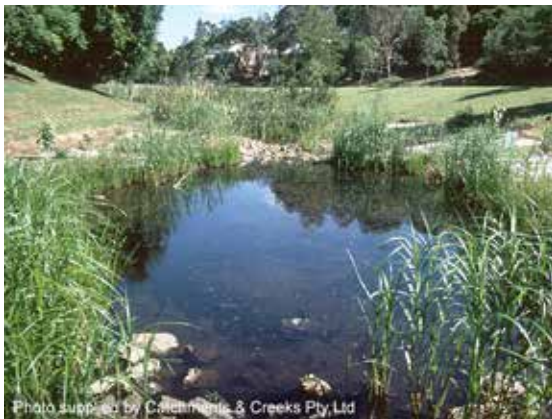
Constructed habitat pool (2000)

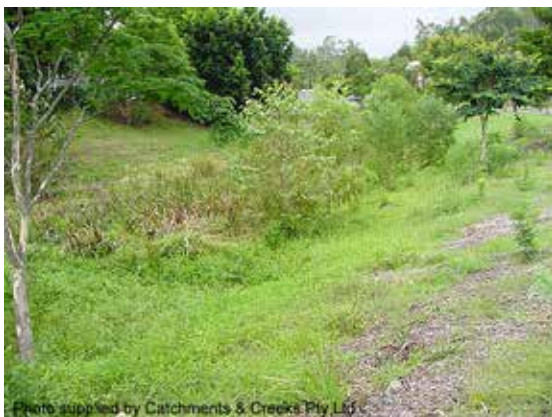
- Unfortunately, cost savings on this low budget project meant that the bed was not raised sufficiently above the low-flow channel—this meant the soil saturation problems continued.
- Also, the upstream reeds and weeds provided a seed source that invaded the habitat pool—this meant that the pool quickly filled with reeds and weeds.
- Ultimately, reed control will only be achieved through the development of a canopy cover.

Reed/weed invasion of pool (2001)

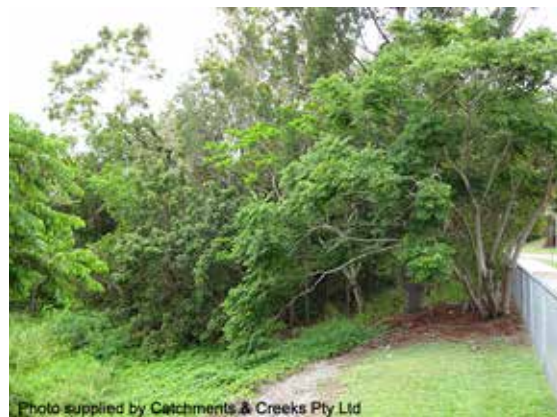
Established canopy cover (2014)

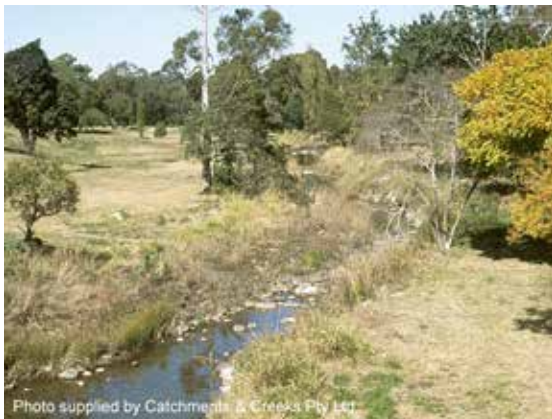
Looking d/s from Moggill Rd (1991)

- In the early 1990s the creek had poor aesthetic appeal due to the exposed, weedy banks.
- Construction waste, in the form of rock, broken concrete and earth, had been used to stabilise and protect the channel banks adjacent the various sewer pipe crossings and sewer inspection chambers (just visible on the right of this image).

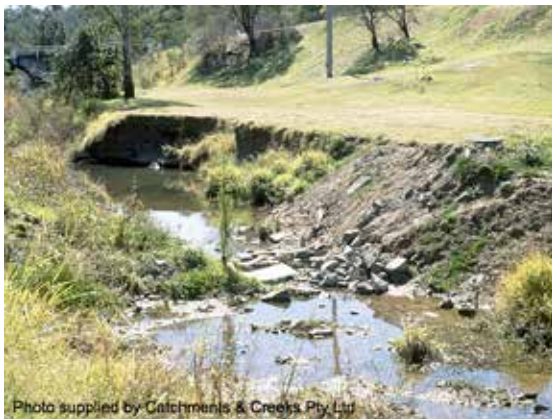
Protection of sewer with rubble (1991)

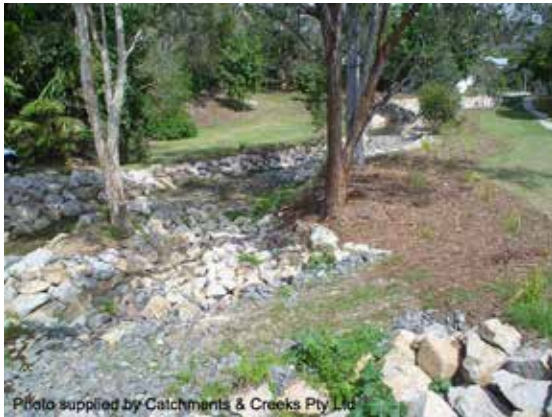
Looking upstream from Samford Rd (2005)

- This project involved the rehabilitation of a park drain back into a waterway.
- Significant quantities of rock stabilisation occurred along the banks of the waterway.
- An existing tree was retained as an 'island' in the middle of the channel.
- Soil was not placed within the rock voids, which delays the establishment of vegetation on the channel banks.

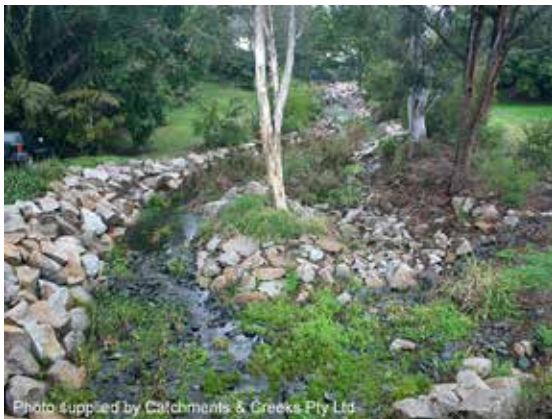
Looking upstream from Samford Rd (2007)

- Plants are beginning to establish on the channel bed, but with only limited plant establishment on the banks.
- A significant drought between 2005 and 2007 had delayed vegetation establishment along the waterway.

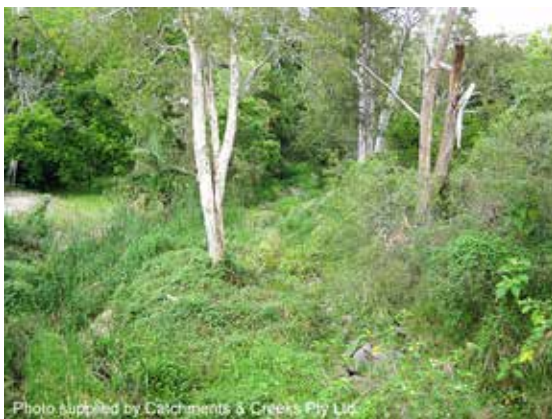
Looking upstream from Samford Rd (2014)

- Significant weed infestation along the channel bed.
- The north-south alignment of the creek, and the open canopy to the north of the creek produced by the existence of Samford Road, means this section of the creek will always experience a weed problem.
- The shading produced by the growing canopy cover should reduce weeds in the upstream section of the creek.

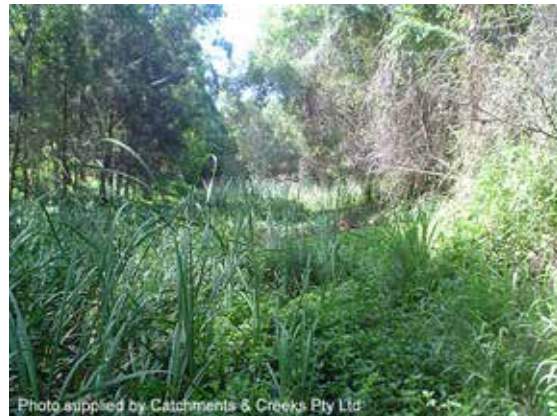
Weed infestation (2006)

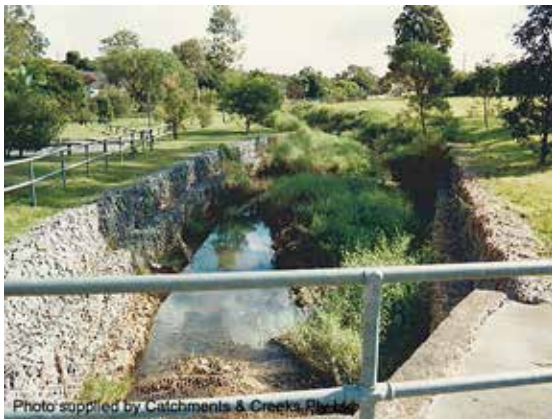
1996

- As was the case for many council parks, riparian vegetation had in the past been removed from the bank and over-bank areas of the creek to improve safety and the park's visual amenity.
- Parts of the creek had been piped to improve public safety and active recreational usage within the park.

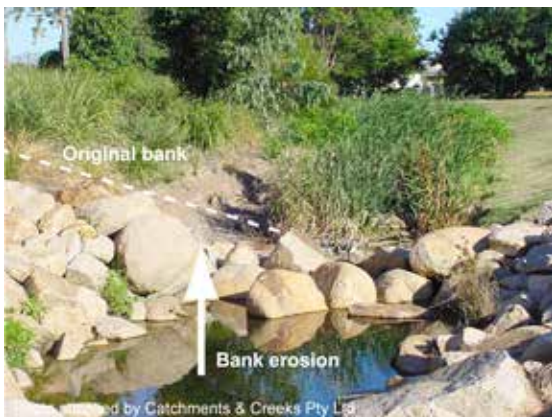
Bank erosion adjacent rock riffle (2002)

- Significant bank erosion occurred in locations where rock was not placed along the toe of the revegetated banks.
- This toe erosion (left) was primarily caused by the rapid growth of bed vegetation (reeds) which gained strength faster than the newly established bank vegetation.
- The establishment of reeds along the creek bed can cause significant problems in the early stages of creek rehabilitation.

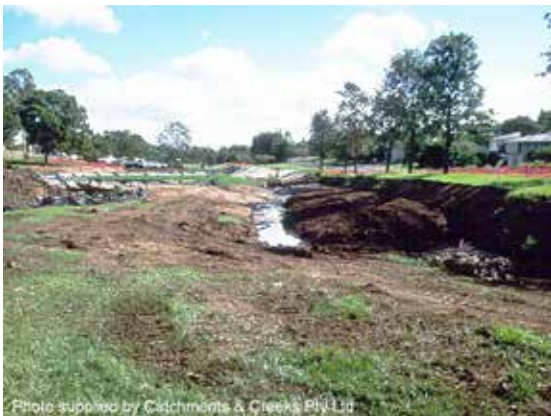
Year 2000

Looking downstream from outlet (2000)

- The channel was reshaped and revegetated.
- The banks were partly stabilised with rocks (toe stabilisation).
- The channel bed was stabilised with rock weirs plus some lower-gradient rock riffles.

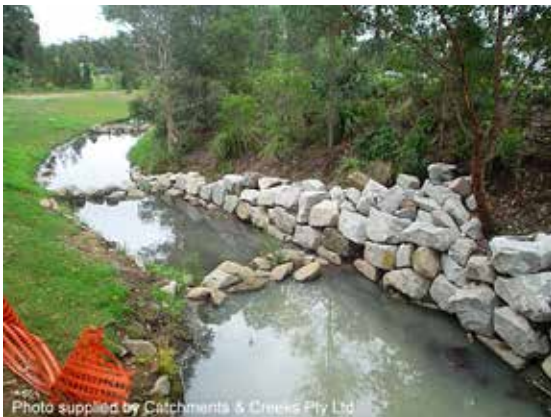
Year 2005

Looking downstream from outlet (2005)

- As was typical at this time, plants were not initially established within the rock voids.
- The rock weirs placed along the creek bed differ from rock riffles in their shape and hydraulic operation.

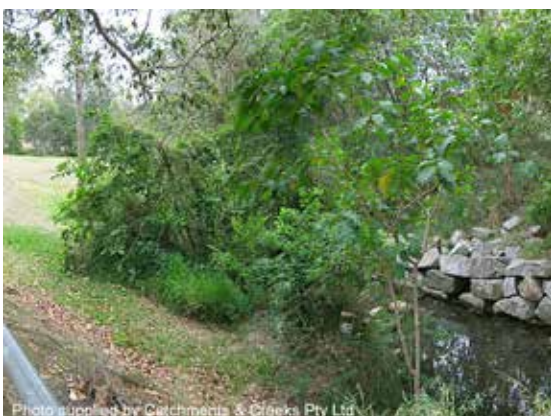
Year 2014

Looking downstream from outlet (2014)

- Riparian vegetation is well advanced along the eastern bank, but the canopy cover is not fully established.
- Some of the rock weirs have been damaged by flood flows.

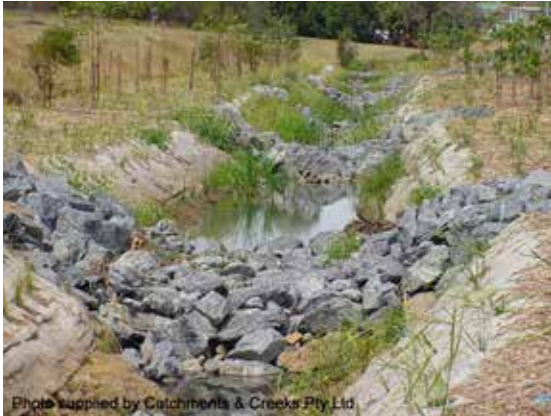
Constructed pool-riffle system (2001)

- Pool-riffle systems are not natural in all waterways, and thus should not be considered an essential element of all creek rehabilitation projects.
- In this case the riffles help to control channel erosion that would otherwise have occurred once the canopy cover began to shade-out the grass cover.
- The use of 'blue' quarry rock may not be ideal, but the rocks usually develop a more natural brown/green colour over time (see below).

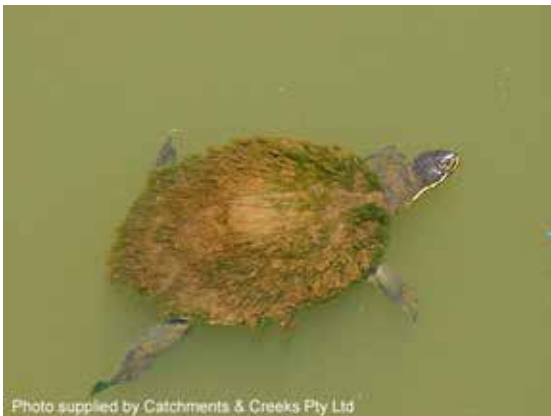
Nutrient-rich waters (2001)

- This image of an algae encrusted turtle was taken within the deep pool that exists upstream of the Arnwood Place bridge in 2001 just after the completion of the channel works.
- This algae problem contributes to a reduction in dissolved oxygen within the water.
- Improved shading of the water body and improved stormwater practices within the catchment should see a reduction in this algae problem.

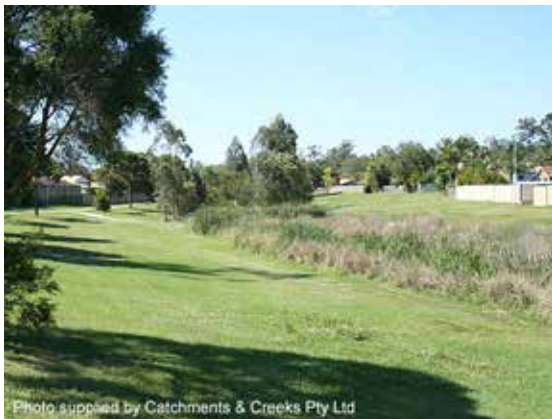
Looking downstream to footbridge (2008)

- The grass-lined trapezoidal waterway was originally constructed during the 1980s urban subdivision of the area.
- The channel was originally developed without a formed low-flow channel, but instead had a sub-surface Ag-pipe drainage system.
- Over time the Ag-pipe blocked with sediment causing a low-flow channel to form (erode) along the channel invert.

- This was a multi-stage project, commencing with the stabilisation and revegetation of the lower reach between the footbridge and Algester Road.
- This first stage consisted of removing highly erodible slaking soils and the sub-surface Ag-pipe drainage system, and then forming a series of rock-lined pools and riffles.
- The second stage consisted of channel works between Nottingham Road and Laurel Oak Drive.

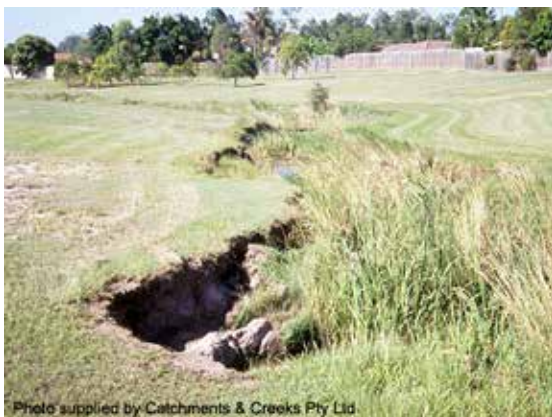
Channel erosion (1998)

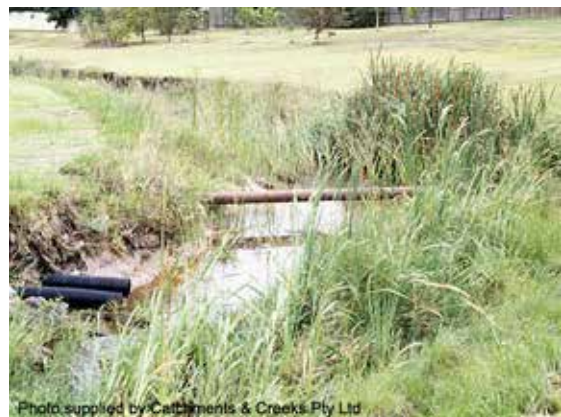
Exposed Ag-pipe & sewer crossing (1997)

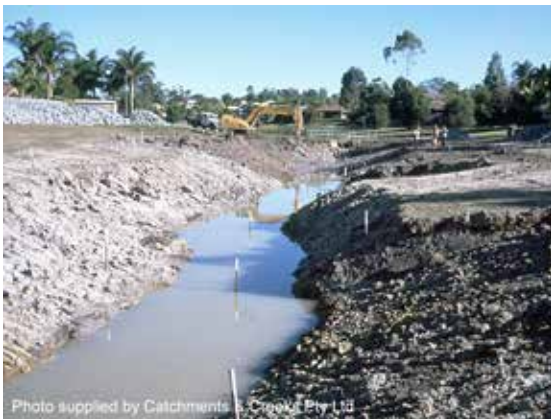
Looking upstream to footbridge (1999)

- Significant quantities of rubbish (burnt tree stumps) and highly erodible slaking soils were found in the stream banks adjacent the low-flow channel, which resulted in the need for this material to be removed.
- The channel was then lined with stable soil and a rock-lined pool-riffle system was constructed.

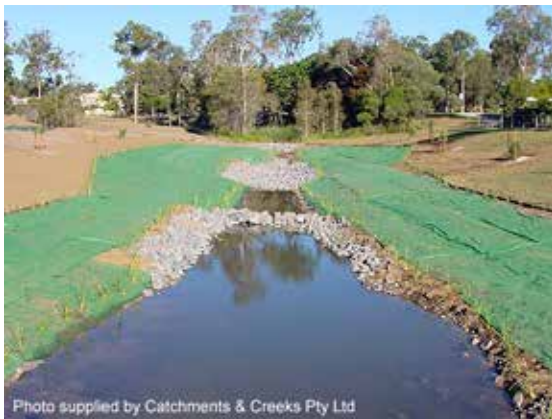
Upstream of Laurel Oak Dr (2001)

- Stage 2 of the project consisted of similar channel works being constructed between Nottingham Road and Laurel Oak Drive.
- The lower channel gradient allowed the use of erosion control mats on the battered banks as opposed to rock stabilisation.
- The Laurel Oak Driver culvert was also modified to reduce sediment and debris blockage problems.

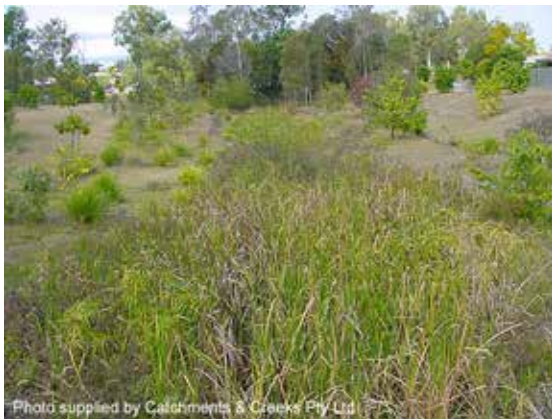
Upstream of Laurel Oak Dr (2004)

- During the early years, plant establishment was dominated by reeds and weeds within the moist low-flow channel.
- At this stage there is the risk of floods causing bank erosion on either side of the reed-infested low-flow channel.

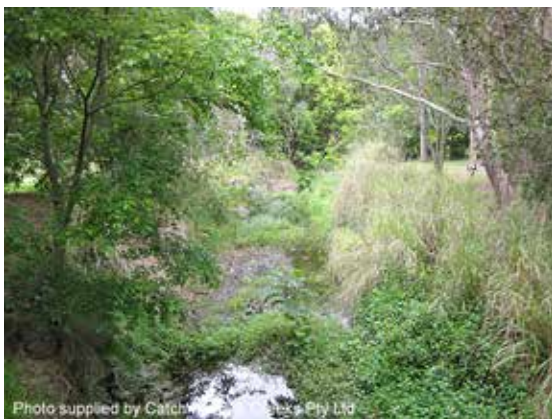
Looking upstream (2014)

- In the 2000s, riparian regeneration occurred along the banks of the creek.
- Significant flood flows during 2009 to 2011 caused sediment removal and bank erosion along the now-shaded channel.

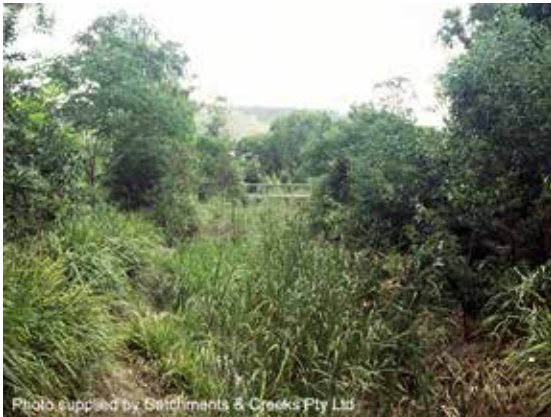
Looking u/s towards footbridge (1998)

- Planted riparian zones were established along both sides of this constructed stormwater drain that passed through the park.
- No works were conducted within the bed of the stormwater drain.

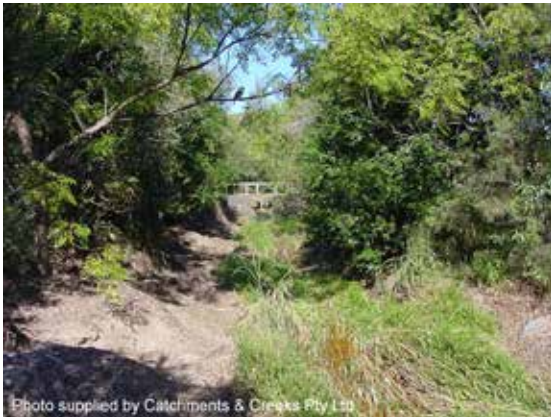
Looking u/s towards footbridge (2003)

- Establishment of a healthy canopy cover has caused significant shading of the channel banks leading to a reduction in the density of ground covers on the channel banks compared to that on the bed.
- In this condition the channel bed is **less** susceptible to erosion than the channel banks.
- Bank erosion can be seen each side of the well-grassed channel bed.

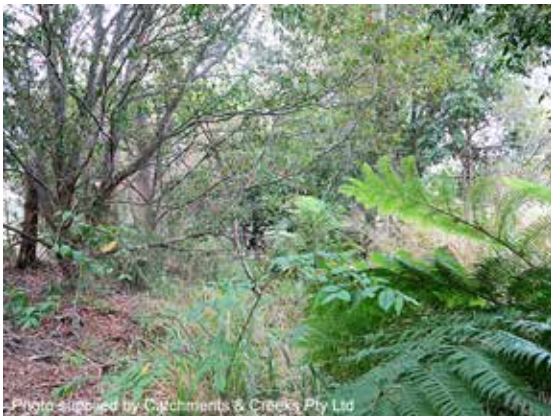
Looking u/s towards footbridge (2014)

- A partial canopy has established over the creek, but is insufficient in density to fully control weed growth.
- The channel erosion observed in 2003 appears to be under control.

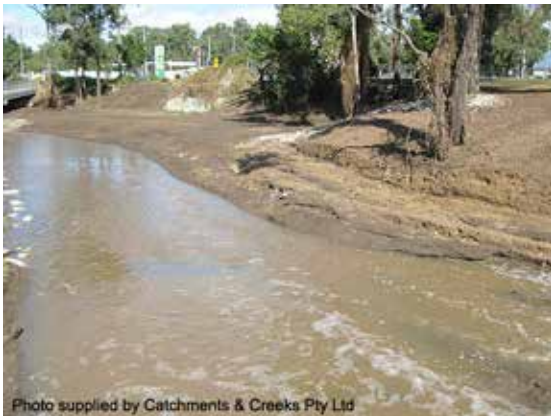
Downstream of Ferny Way (May, 2009)

- The local council followed appropriate procedures and commenced the channel works during the recognised 'dry' season.
- Unfortunately for the project, an unseasonal storm occurred in May 2009.
- This storm caused significant bank and bed erosion within the work area.

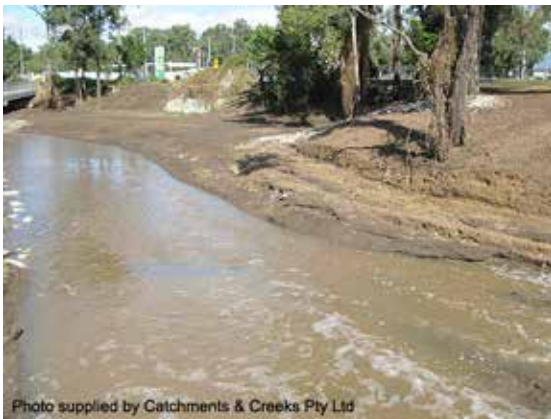
Looking downstream (May, 2009)

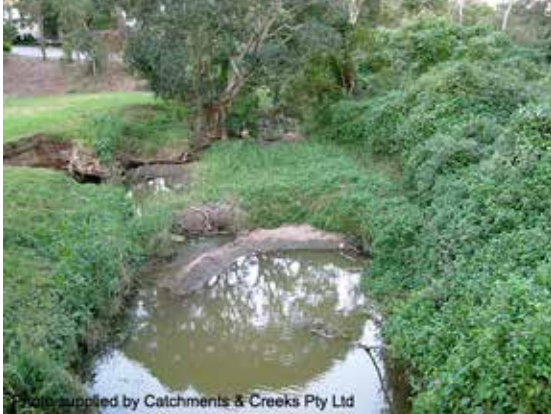
Looking d/s from footbridge (April, 2009)

- This image presents the creek conditions downstream of the footbridge during the period that the weed removal was occurring.
- Following weed removal, this region was stabilised with plants and erosion control mats, but no enhanced toe protection.

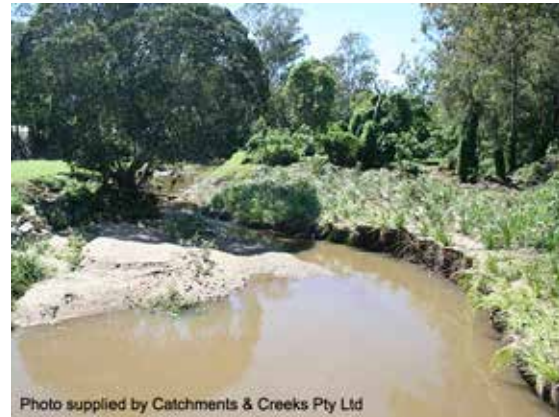
Looking d/s from footbridge (2010)

- The reduced channel roughness caused by the upstream weed removal has increased flow velocities within the creek.

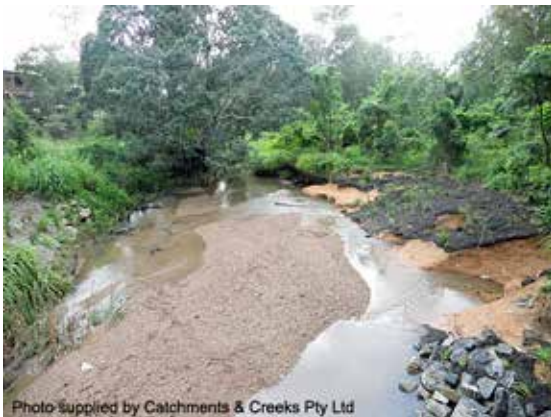
Looking d/s from footbridge (2013)

- Significant bank erosion has occurred during the wet years of 2010 to 2013.

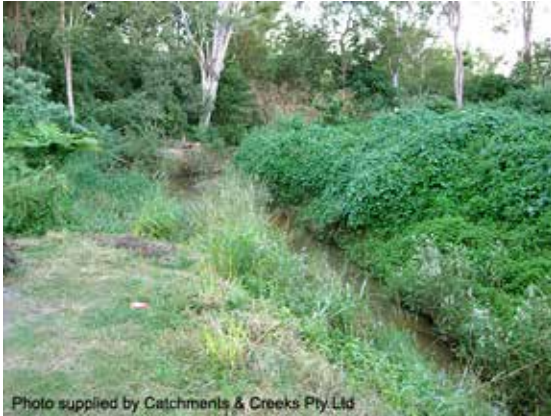
Downstream of park (April, 2009)

- Channel conditions downstream of the work area prior to the commencement of week removal.

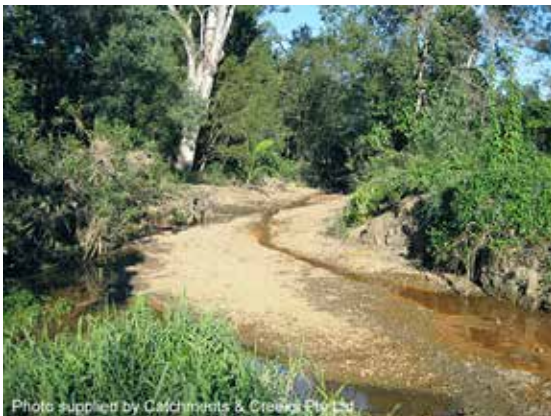
Downstream of park (Aug, 2009)

- Sediment removal from the upstream work area resulted in significant sediment deposition within this downstream reach.

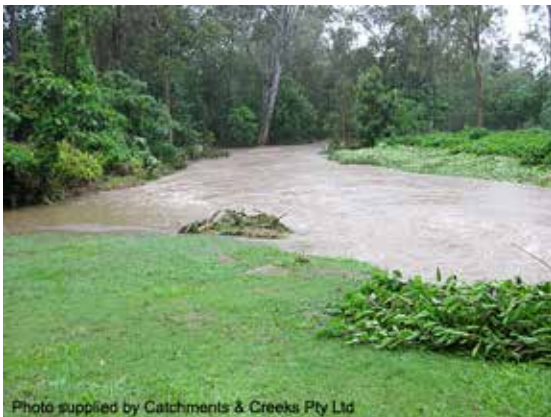
Downstream of park (Oct, 2010)

- Significant bankful channel flows occurred throughout 2009 to 2013.

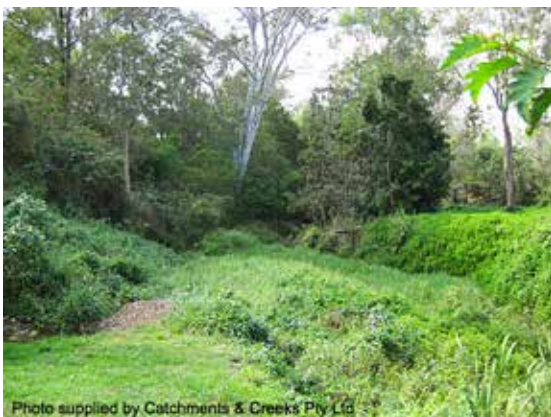
Downstream of park (2014)

- Without a substantial canopy cover, weeds have invaded and stabilised the deposited bed sediment.
- Bank erosion is likely to occur as a result of the growth of bed weeds.

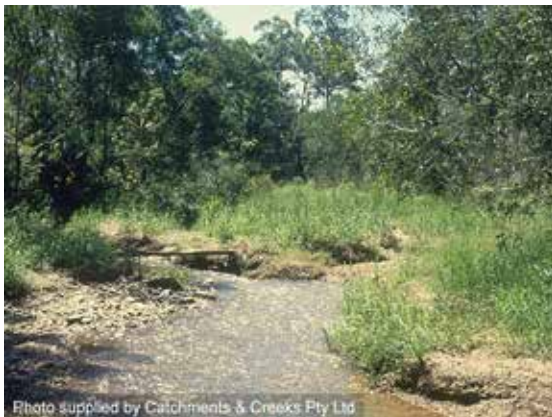
- This reach of Kedron Brook represents the upper most extent of urban development within the drainage catchment.
- Upstream of this reach the creek primarily consists of a rocky pool-riffle system.
- In the early 1990s a residential subdivision adjacent to Lanita Avenue resulted in significant sediment deposition within the creek.

Looking d/s at sediment deposit (1994)

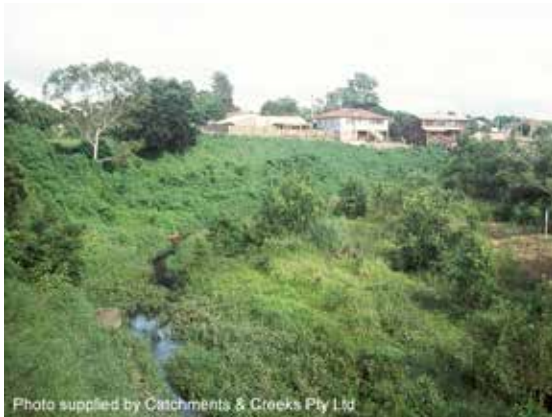
Upstream of Osborne Rd (1998)

- Significant weed infestation had occurred along this reach of Kedron brook while the land was held in private ownership.
- Brisbane City Council acquired control of the land in the 1990s and a local bushcare group commenced weed removal from the lower bank bench.

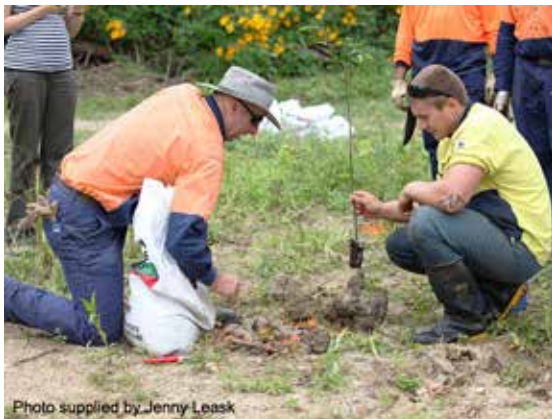
Long-stem planting in sandy soil

- Due to the high flow velocities in this area, long-stem planting was trialed.
- This form of tree planting provides the plants with increased resistance to being removed from the sandy soils during flood events.

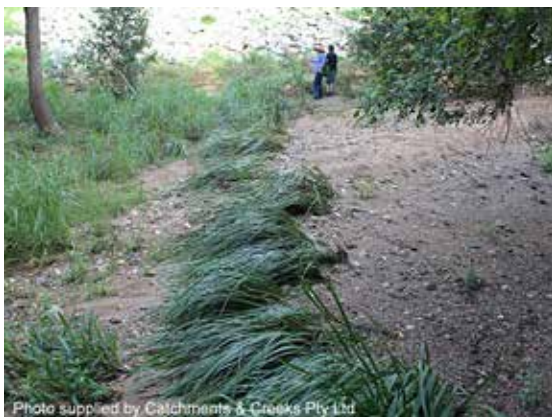
Plants used for floodplain erosion control

- Also trialed in this area was the use of *Lomandra*s planted in rows transverse to the direction of flood flow.
- The purpose of these plants is to reduce the risk of channel relocation and floodplain erosion during the establishment phase of the native plants.
