Natural Channel Design

Part 4: Case Studies

Part 4 – Case Studies

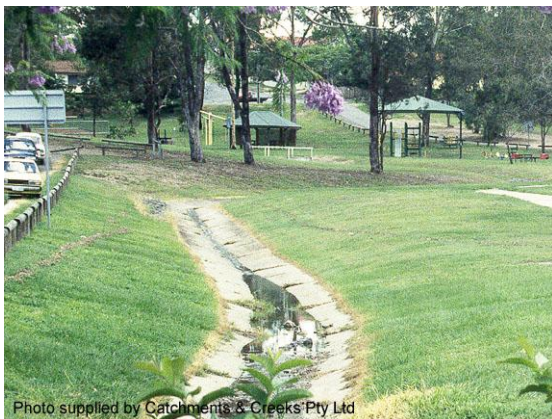
Original concrete drain (1998)

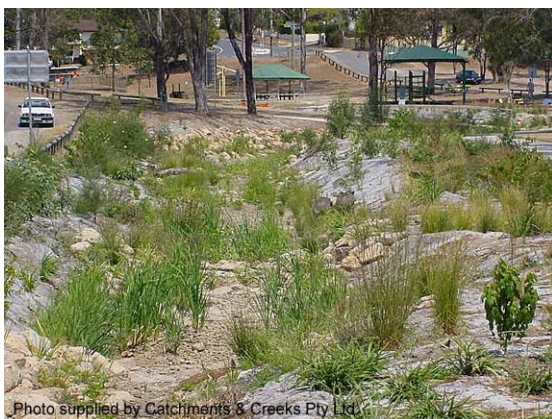
Rehabilitated drain (2000)

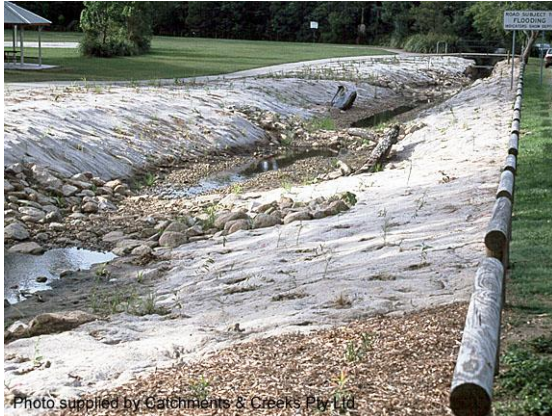
Pool-riffle system (2000)

- In theory, pool-riffle systems should only be constructed within waterways that would normally contain such a system.
- The adjacent Ithaca Creek is a waterway that does contain similar pools and riffles.
- To maintain sufficient trickle flow through the pools, a clay lining was placed under the channel to minimise the infiltration of water into the subsoil.
- The pool-riffle dimensions were based on information gained from local waterways.

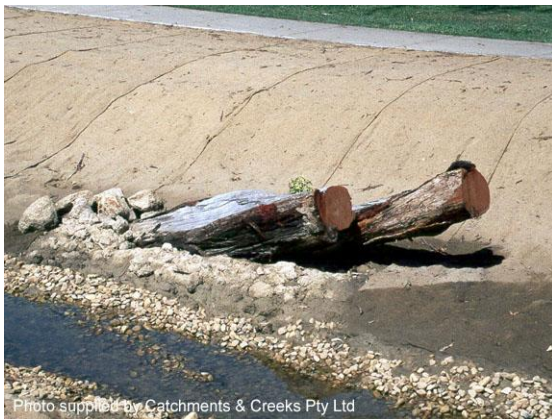
Anchored habitat logs (2000)

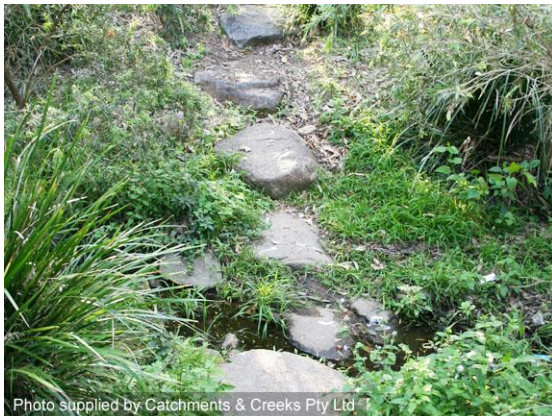
Stepping stone pathways (2008)

- In a world of increasing public safety and risk management, the days of constructing stepping stone crossings of waterways maybe becoming a thing of the past.
- Fortunately, this channel rehabilitation project has incorporated numerous recreational features that enhance a child's ability to access and explore the waterway.

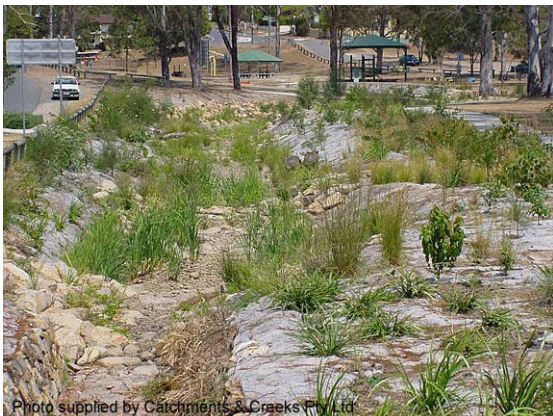
Main channel (looking south, 2000)

Year 2000

- Initial plant establishment within jute erosion and weed-control blankets.

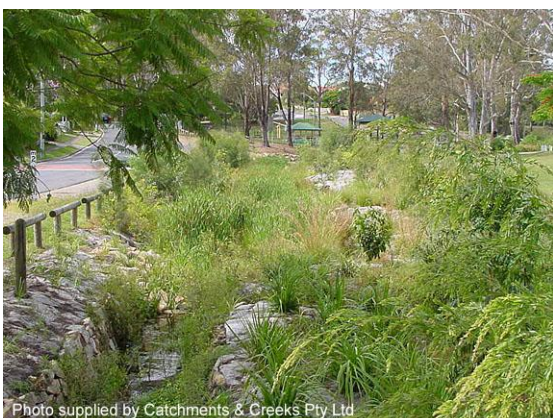
Main channel (looking south, 2001)

Year 2001

- Fully open canopy.
- Channel enters its initial 'weedy' phase.
- Pools are almost completely filled with invading reeds.

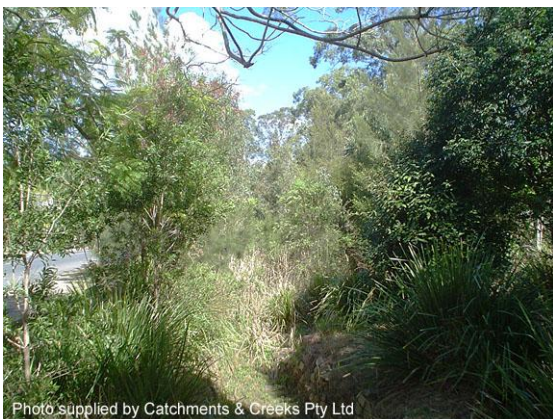
Main channel (looking south, 2005)

Year 2005

- Insufficient canopy cover still exists over the low-flow channel.
- Significant weed growth still exists within the channel.
- A dense cover of understorey native plants exists.

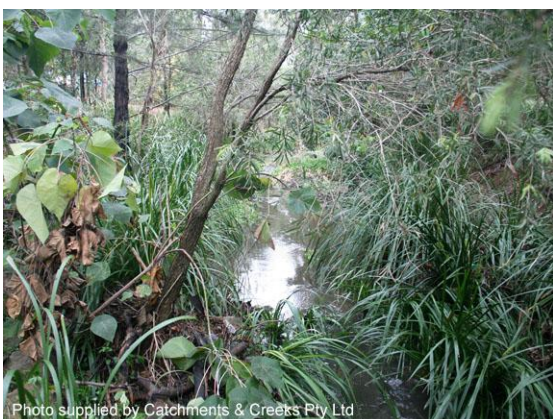
Main channel (looking south, 2010)

Year 2001

- Canopy has formed producing sufficient shade to thin plant density and allow the shading-out of some weeds.
- The pools are becoming clear of reeds.
- A pool is visible in the centre of this image.
- A riffle is just visible in the foreground of the image.

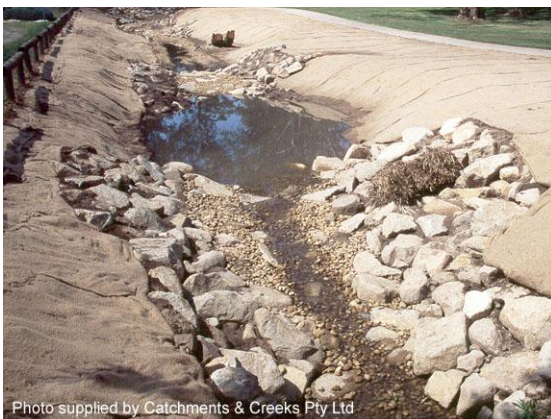
Pool-riffle system (2000)

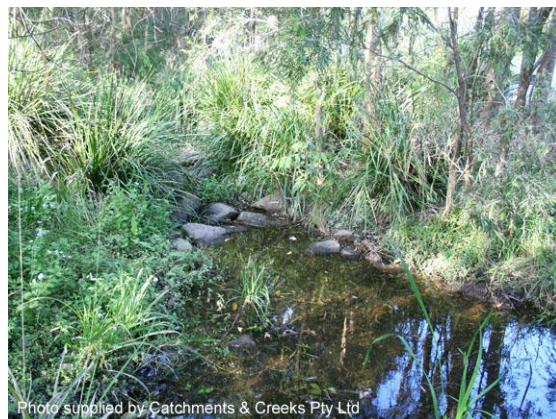
Pool-riffle system (2008)

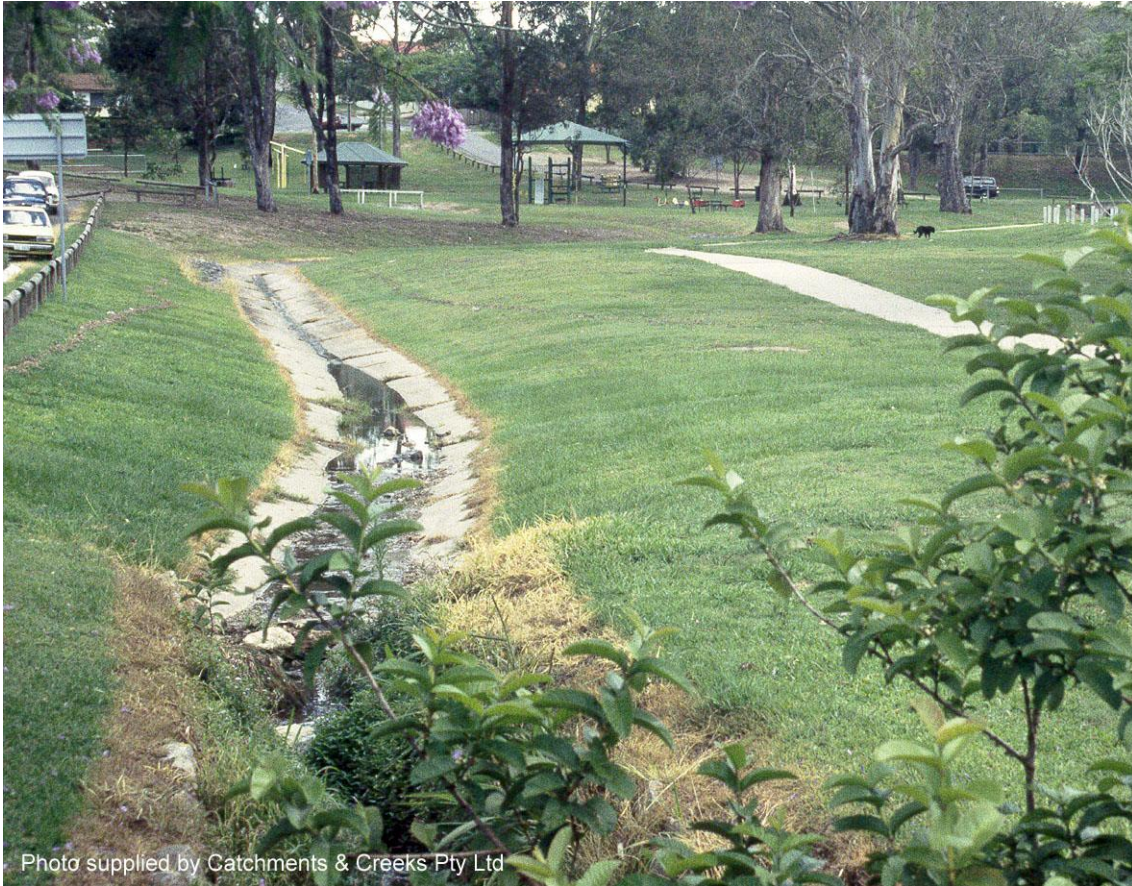
Original concrete drain looking upstream with sports oval to the right (1998)

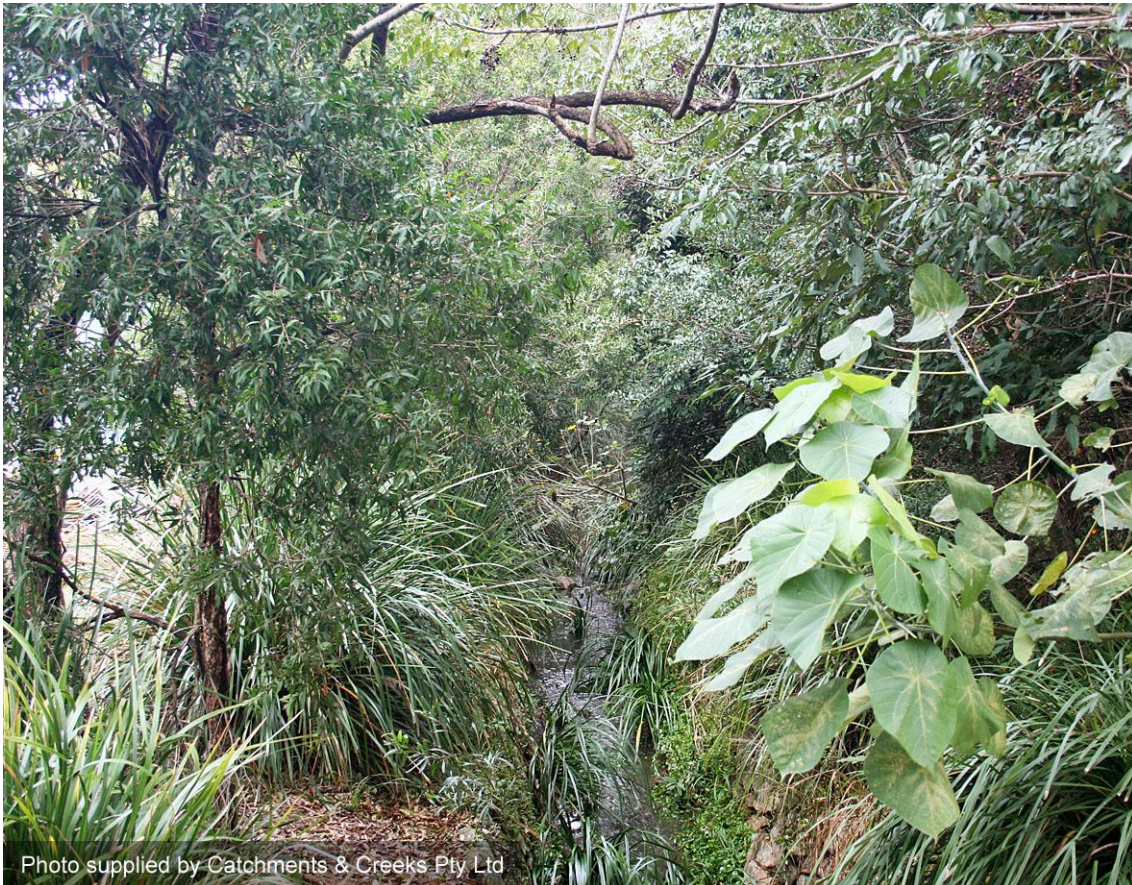
Rehabilitated waterway looking upstream with sports oval to the right (2010)

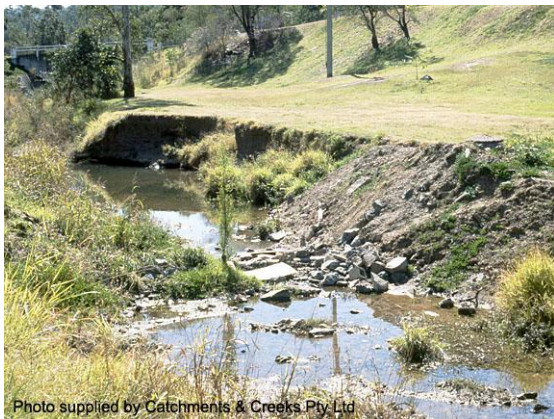
Protection of sewer with rubble (1991)

- In the early 1990s the creek had poor aesthetic appeal due to the exposed, weedy banks.
- Construction waste, in the form of rock, broken concrete and earth, had been used to stabilise and protect the channel banks adjacent the various sewer pipe crossings and sewer inspection chambers (just visible on the right of this image).

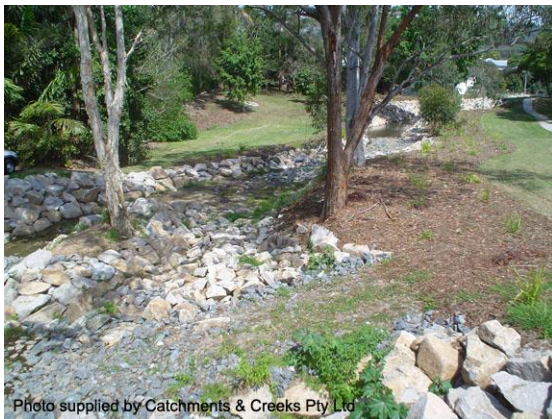
Year 2005

Looking upstream from Samford Rd (2005)

- This project involved the rehabilitation of a park drain.
- Significant quantities of rock stabilisation occurred along the banks of the waterway.
- An existing tree was retained as an 'island' in the middle of the channel.
- Unfortunately, soil was not placed within the rock voids, which delayed the establishment of vegetation on the channel banks.

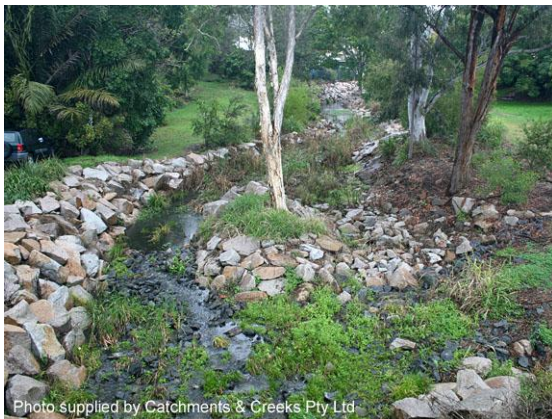
Year 2007

Looking upstream from Samford Rd (2007)

- Plants are beginning to establish on the channel bed, but with only limited plant establishment on the banks.
- A significant drought between 2005 and 2007 had delayed vegetation establishment along the waterway.

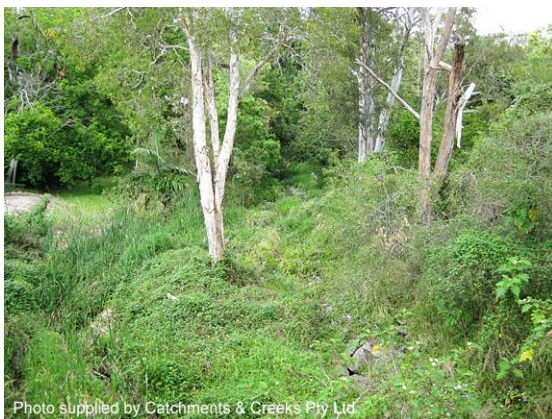
Year 2014

Looking upstream from Samford Rd (2014)

- Significant weed infestation along the channel bed.
- The north-south alignment of the creek, and the open canopy to the north of the creek produced by the existence of Samford Road, meant that this section of the creek will always experience a weed problem.
- The shading produced by the growing canopy cover should reduce weeds within the upstream section of the creek.

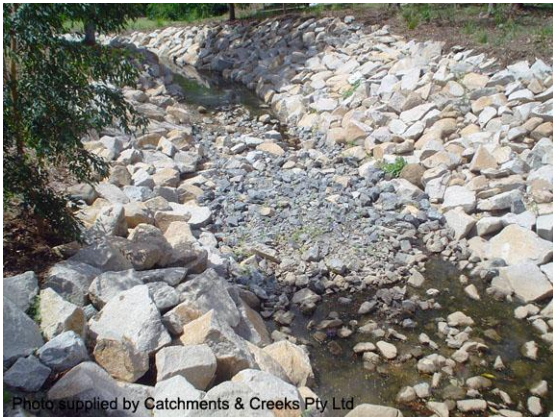
Riffle (2005)

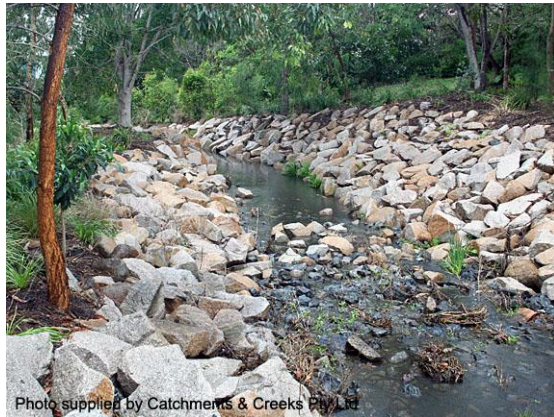
Riffle (2007)

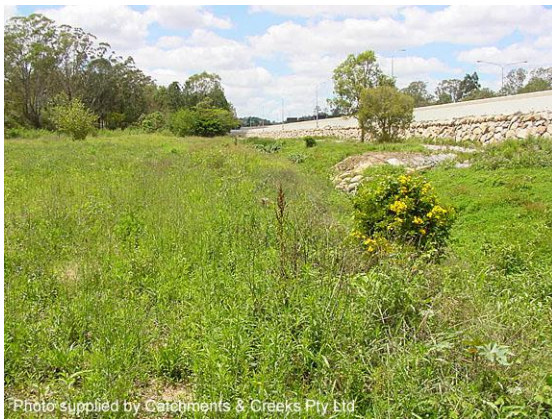
Looking downstream from culvert (2000)

- Riparian vegetation was largely cleared along the creek to provide flood mitigation.
- In the 1990s Norman Creek in this area resembled little more than an open storm drain passing through a grassy field.

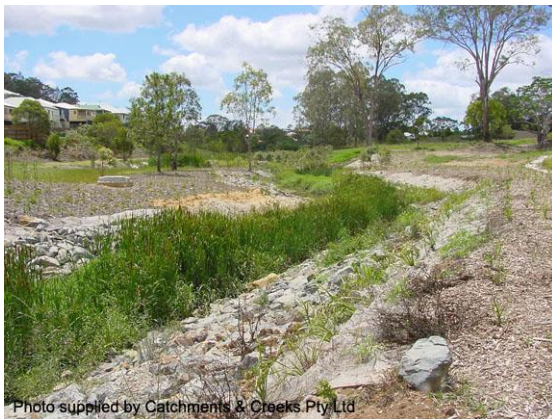
Upstream reach (2001)

- Construction of the busway adjacent to the South East Freeway resulted in a second phase of creek rehabilitation.

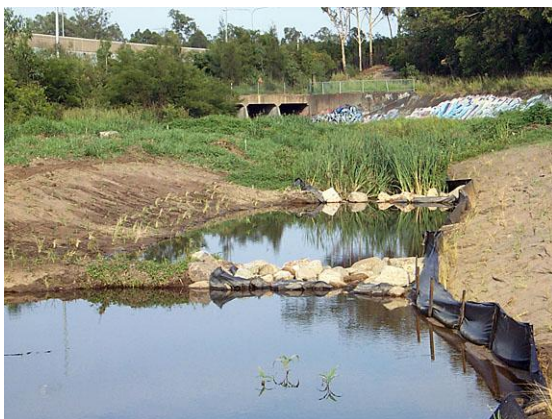
Looking downstream to culvert (2001)

- Lobbying by the Norman Creek Catchment Coordinating Committee (N4C) resulted in the proposal for more substantial creek rehabilitation.
- A series of pools and riffles were formed along the creek based on the past success of a similar creek rehabilitation project adjacent to Willis St, Tarragindi (Ekibin).

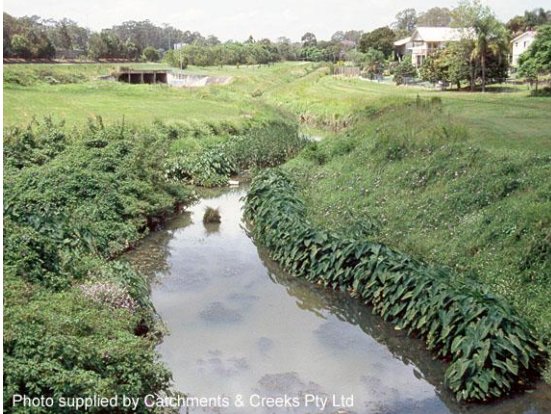
Looking upstream from bridge (1999)

Year 1999

- Site conditions prior to the works.
- Creek channel has significant weed infestation

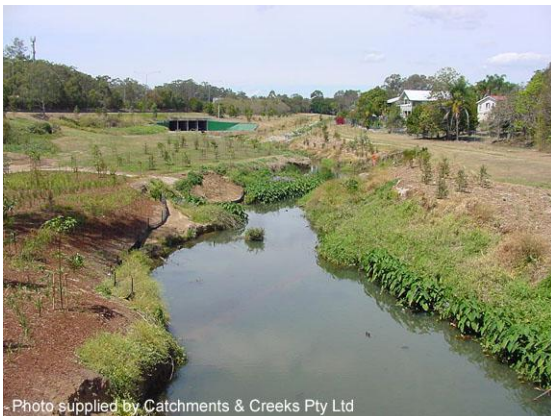
Following first stage of works (2001)

Year 2001

- Site conditions after channel modifications.
- Pools and riffles established within the tributary, with some planting within over-bank areas.
- Creek is nutrient-rich with heavy algae growth.

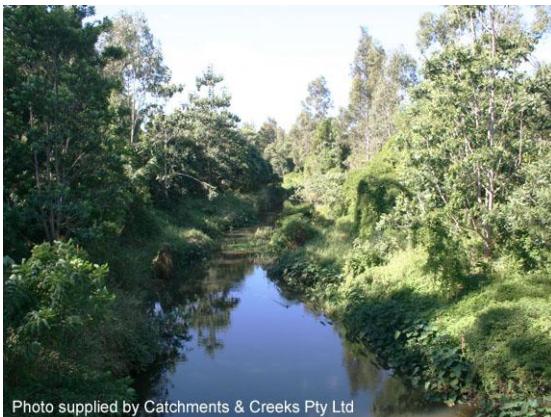
Looking upstream from bridge (2010)

Year 2010

- Canopy trees have achieved significant height, but not full maturity.
- Significant weed cover exists within the understorey.
- Tree establishment along the northern bank (visible to the left) is now beginning to shade the waterway.

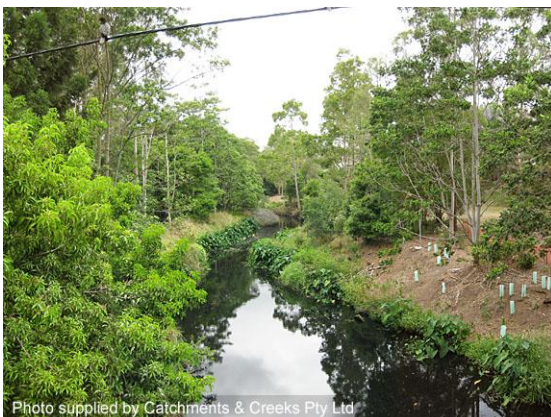
Looking upstream from bridge (2014)

Year 2014

- Weeding and partial removal of grass cover within the riparian zone by the local community group.
- Shading from the established canopy cover also helps to thin the understorey and groundcover plants.
- The creek experienced significant flood flows during 2009, 2010 and 2011.

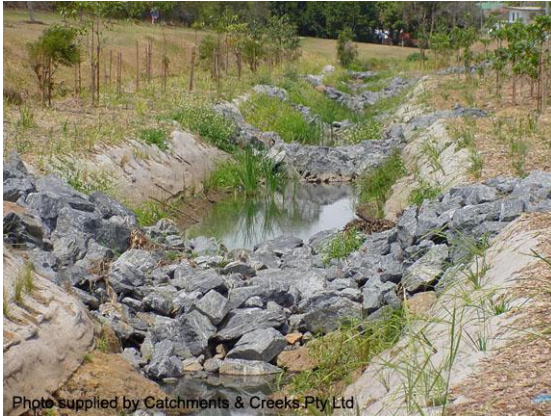
Constructed pool-riffle system (2001)

Pool-riffle system

- Pool-riffle systems are not natural in all waterways, and thus should not be considered an essential element of all creek rehabilitation projects.
- In this case the riffles help to control channel erosion that would otherwise have occurred once the canopy cover began to shade-out the grass cover.
- The use of 'blue' quarry rock may not be ideal, but the rocks usually develop a more natural brown/green colour over time.

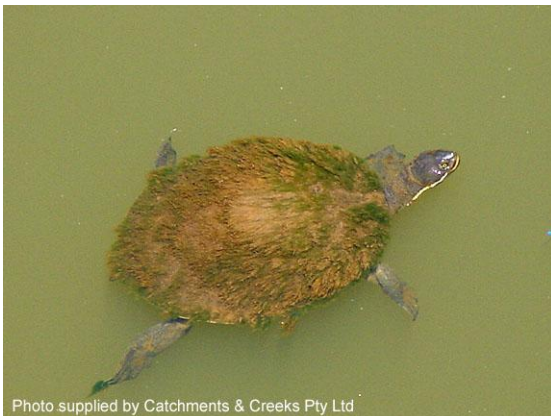
Nutrient-rich waters (2001)

Algae problem

- This image of an algae encrusted turtle was taken within the deep pool that exists upstream of the Arnwood Place bridge in 2001 just after the completion of the channel works.
- This algae problem contributes to a reduction in dissolved oxygen within the water.
- Improved shading of the water body and improved stormwater practices within the catchment should see a reduction in this algae problem.

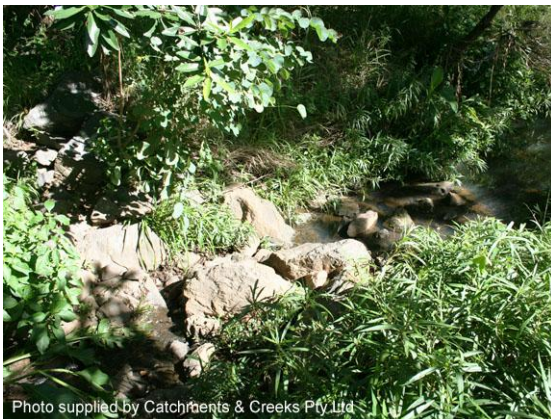
Downstream riffle (2010)

Stepping stones

- The most downstream riffle has been adopted by locals as a stream crossing point.
- The riffle rocks substitute as stepping stones.

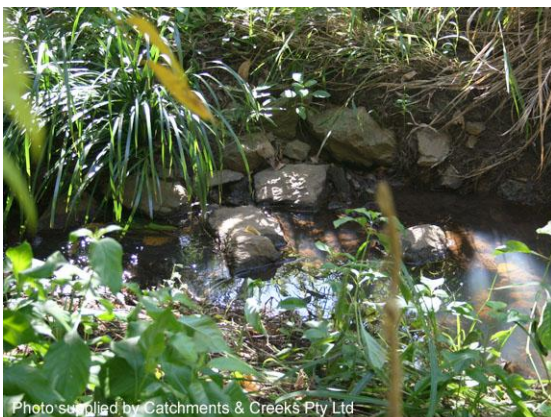
Upstream riffle (2010)

Fish passage

- The riffles have established desirable flow conditions that would encourage fish passage up the waterway.

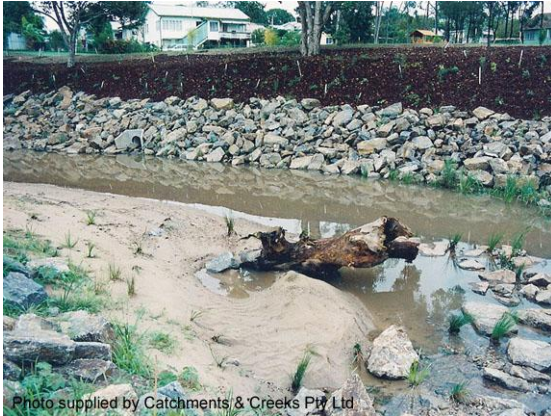
Log and sand bench (1997)

Habitat log and sand bench

- Two habitat (roosting) logs were anchored into the channel.
- These logs provide habitat and shelter (from flood flows) for aquatic wildlife, and sunning perches for reptiles.
- Washed sand was introduced to the inside of channel bends to mimic the channel feature commonly found in alluvial river systems (now viewed as inappropriate within urban creeks).

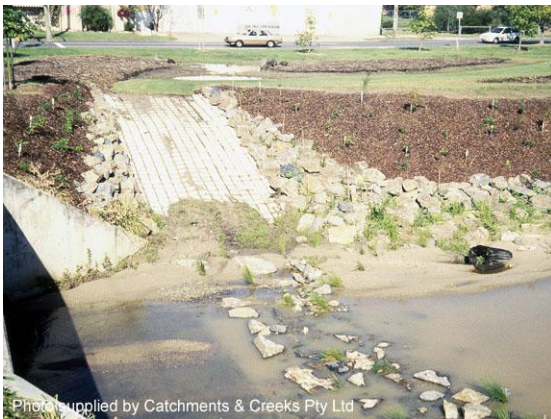
Maintenance access ramp (1997)

Maintenance access ramps

- Maintenance access ramps were installed into the channel both upstream and downstream of the Wardell Street culvert.
- These access ramps were formed from flexible geotextile/concrete mats (Humes *Flexmat*).
- Use of these mats allows vegetation (grasses) to grow between the concrete blocks to partially hide the hard surfacing.

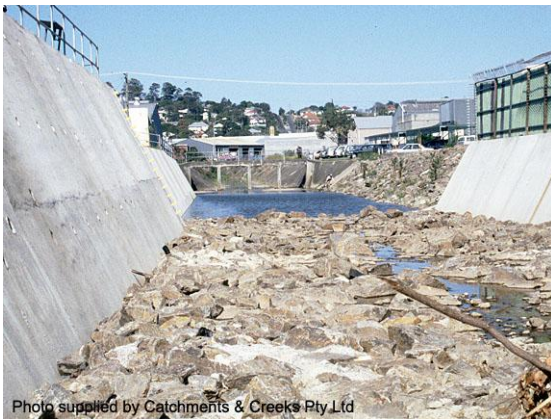
Grouted rock bed on concrete channel

Habitat pool and grouted rock roughness

- A deep sediment trap and habitat pool was established between the downstream end of the new concrete channel and the upstream end of the existing concrete channel, upstream of the Magura Street footbridge.
- To enhance the environmental features of the concrete channel, rocks were grouted to the bed of the downstream end of the new concrete channel.
- The intent was to allow vegetation to establish over these rocks.

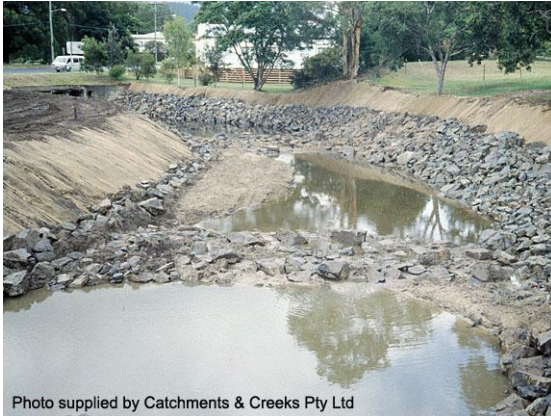
Looking upstream from Wardell St (1997)

Year 1997, February

- Pre-planting site conditions.
- Jute erosion control blankets placed over exposed soil banks prior to planting.

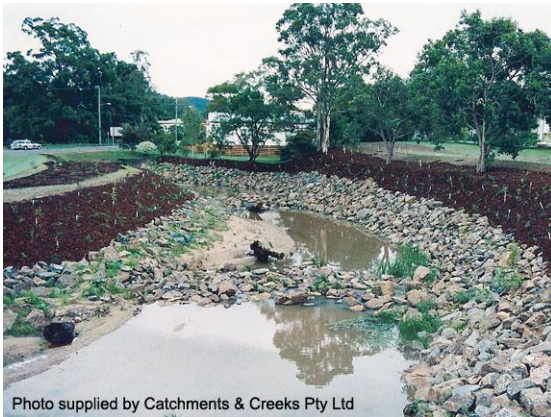
Looking upstream from Wardell St (1997)

Year 1997, June

- Site conditions just after initial plant establishment.
- Heavy loose mulching of the upper banks and over-bank areas.
- Limited pocket planting within the rock voids.

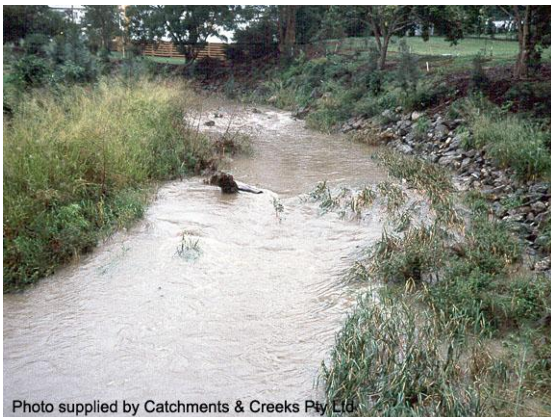
Looking upstream from Wardell St (1998)

Year 1998, April

- Significant weed (grass) growth within the bank vegetation.
- Channel bed effectively remains free of significant weed (reed) growth.

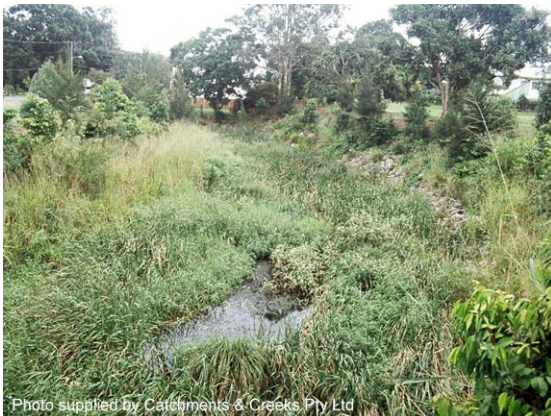
Looking upstream from Wardell St (1999)

Year 1999, April

- Significant weed growth along the banks and on the channel bed.
- A low-flow channel is beginning to establish in the centre of the channel bed.

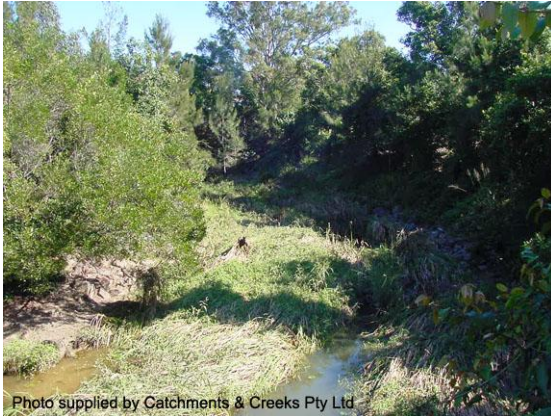
Looking upstream from Wardell St (2003)

Year 2003

- Upper-storey canopy trees are slowly beginning to shade the channel, but currently they are only controlling weeds on the banks.
- Dry-land grasses are beginning to invade the channel bed during the extended drought of 2000–2008.
- A well-defined low-flow channel still exists.

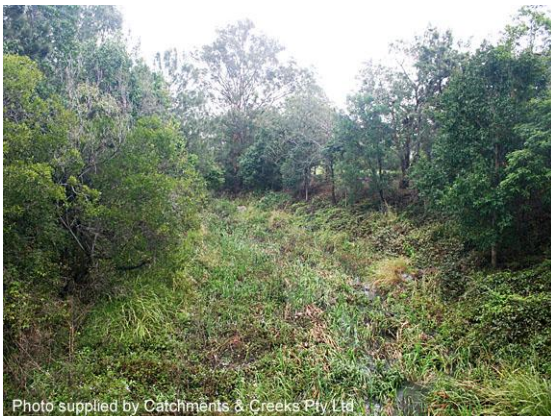
Looking upstream from Wardell St (2007)

Year 2007

- Riparian vegetation has thinned due to a past drought.
- Channel bed thick with weeds, mainly grasses.
- This image shows the channel just after a storm that caused the bed vegetation to fold in the direction of flow.

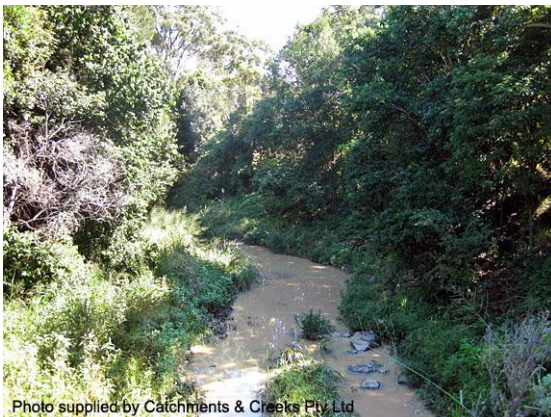
Looking upstream from Wardell St (2011)

Year 2011

- Canopy trees are beginning to shade the channel bed and limit weed growth.
- The low-flow channel is now more pronounced within the wide channel bed.
- The original riffle rocks are now becoming exposed and forming a riffle.

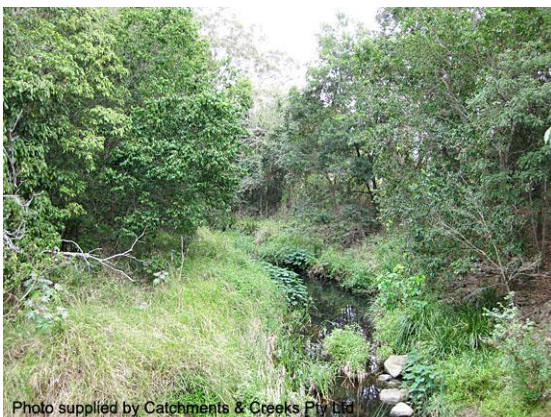
Looking upstream from Wardell St (2014)

Year 2014

- The low-flow channel is well-defined.
- Excessive sediment deposition is occurring on the inside of the channel bend, and this sediment is being stabilised by weeds.

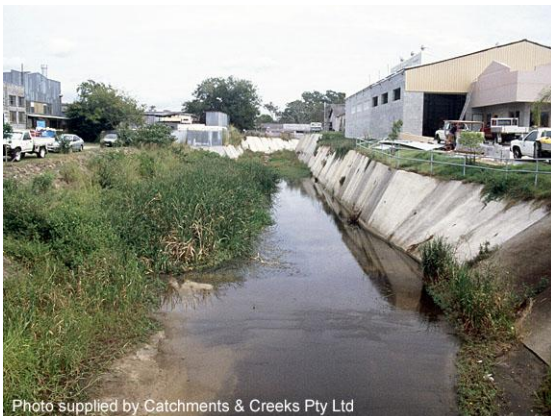
Looking upstream Magura St (1999)

Year 1999

- The rising bed level of the pond (due to sediment deposition) is allowing reeds to establish adjacent to the boulder wall.

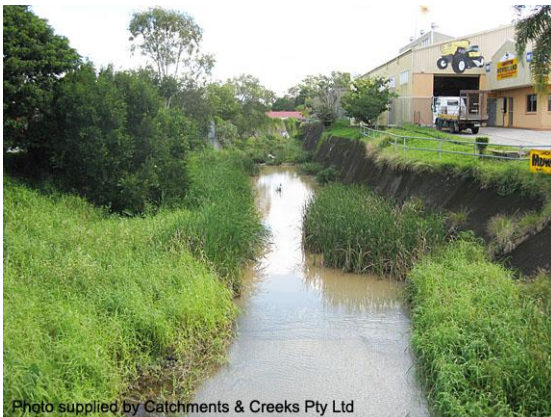
Looking upstream Magura St (2011)

Year 2011

- Significant sediment deposition has occurred within the habitat pond.

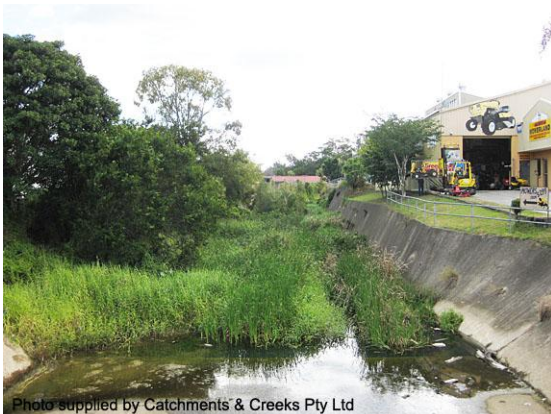
Looking upstream Magura St (2014)

Year 2014

- The habitat pond is now near-full of sediment resulting in the establishment of reeds and grasses across the full width of the pond.

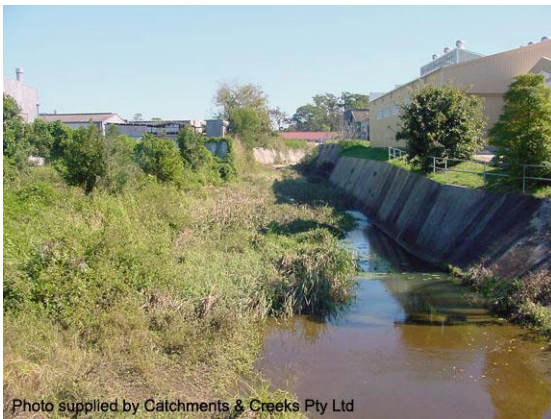
Looking upstream Magura St (2003)

Year 2003

- Canopy trees just beginning to appear above the weed-infested rock bank.

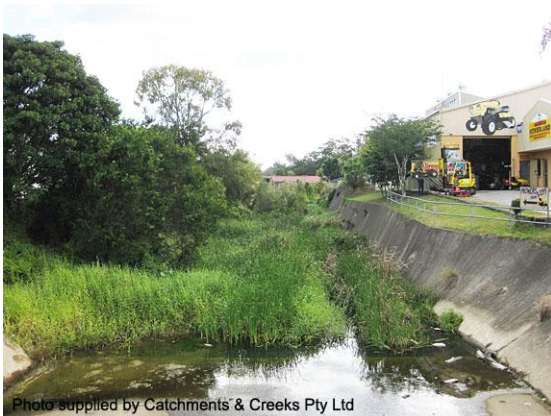
Looking upstream Magura St (2014)

Year 2014

- Limited shading is being provided over the habitat pond because sediment deposition has limited the extent (width) of the pond.

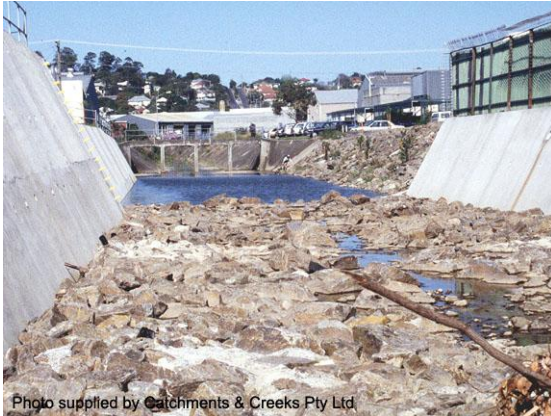
Looking d/s to Magura St footbridge

Year 1997

- At the request of a business located adjacent to the channel, 'ecological features' were designed into the concrete channel.
- These 'experimental' features included rocks being grouted to the channel floor.
- The intent was for vegetation to establish over these rocks to help establish a more-natural channel bed ecosystem.

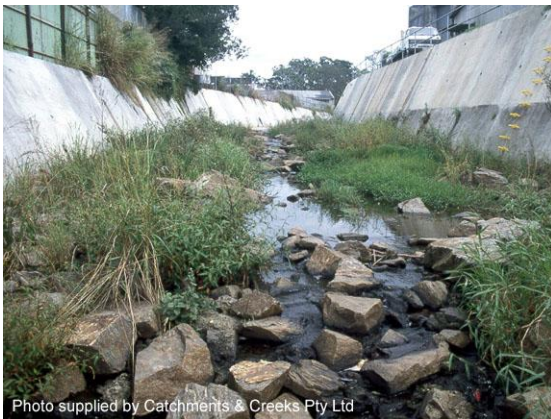
Looking upstream (1999)

Year 1999

- Sediment has settled between the rocks and plants are now beginning to establish on the channel bed.
- A low-flow channel has formed through the planted rocks.

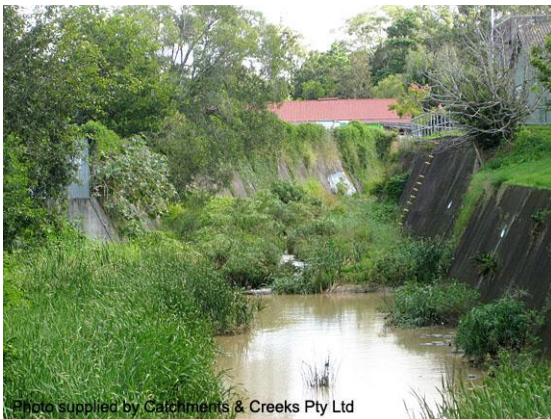
Looking upstream from footbridge (2011)

Year 2011

- Plants and an associated ecosystem have established on the bed of the grouted, rock-lined, concrete channel bed.
- The habitat pond is still visible in the foreground.

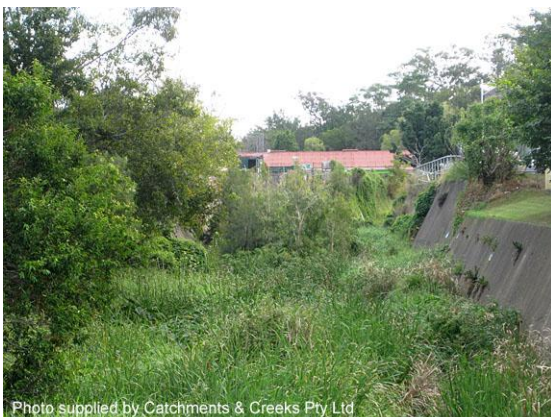
Looking upstream from footbridge (2014)

Year 1999

- Woody species (*Melaleuca*) are now becoming established within the rock-lined concrete channel.
- The growth of such woody species in the concrete channel would not be desirable from a flood control perspective, as well as there is the risk that the roots could dislodge the grouted rocks, which could result in all the plants being dislodged during a flood event.

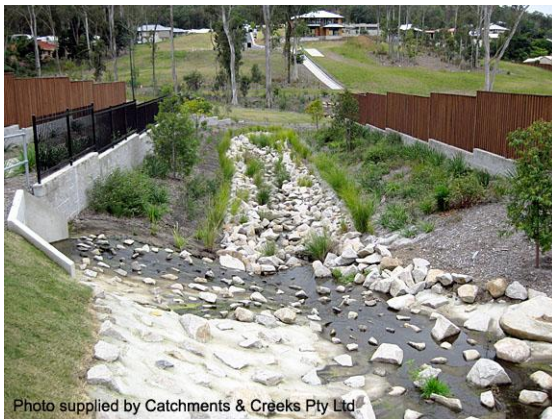
Constructed drainage channel

- The project involved:
 - constructing a vegetated drainage channel in a location where no creek or concentrated flow path had previously existed, and
 - modifying an existing creek channel upstream of Tilquin Street.
- Aspects of this project were closely aligned with the principles of *Natural Channel Design*.

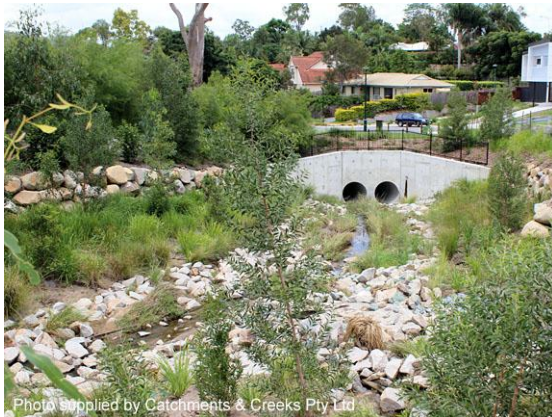
Modified creek channel u/s of Tilquin St

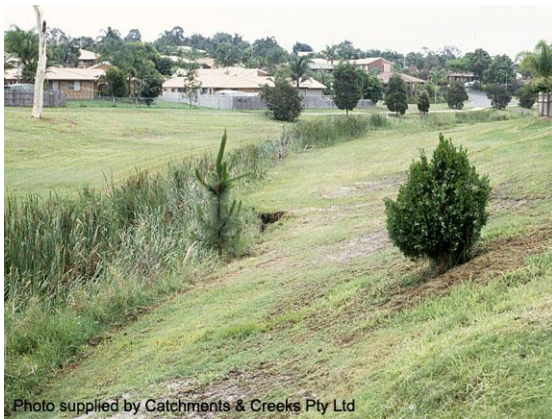
Original grassed trapezoidal channel

- The grass-lined trapezoidal waterway was originally constructed during the 1980s urbanisation of the area.
- The channel was originally developed without a formed low-flow channel, but instead had a sub-surface Ag-pipe drainage system.
- Over time the Ag-pipe blocked with sediment causing a low-flow channel to form (erode) along the channel invert.

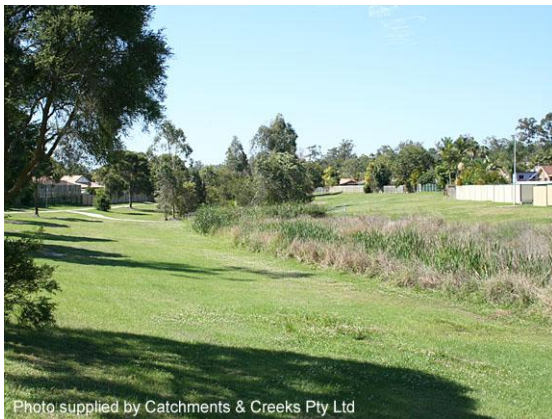
Looking downstream to footbridge (2008)

- This was a multi-stage project, commencing with the stabilisation and revegetation of the lower reach between the footbridge and Algester Road.
- This first stage consisted of removing highly erodible slaking soils and the old sub-surface drainage pipe, and then forming a series of rock-lined pools and riffles.
- The second stage consisted of channel works between Nottingham Road and Laurel Oak Drive.

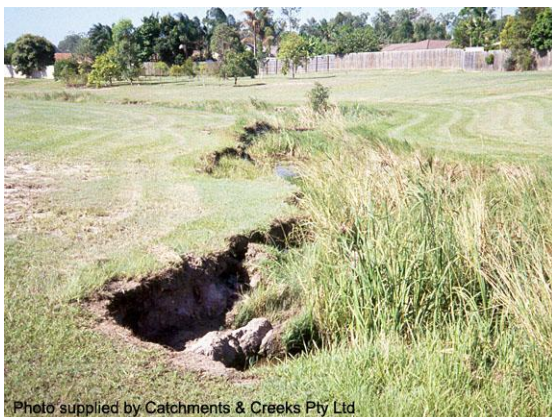
Channel erosion (1998)

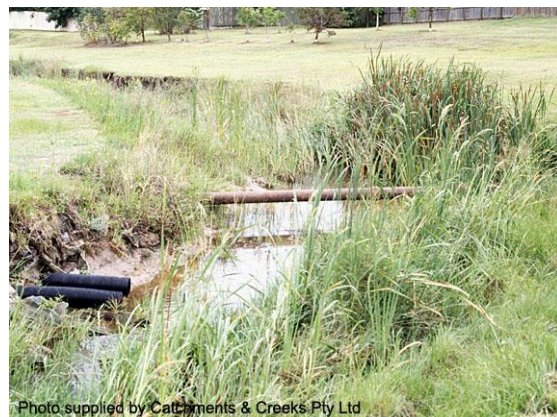
Exposed Ag-pipe & sewer crossing (1997)

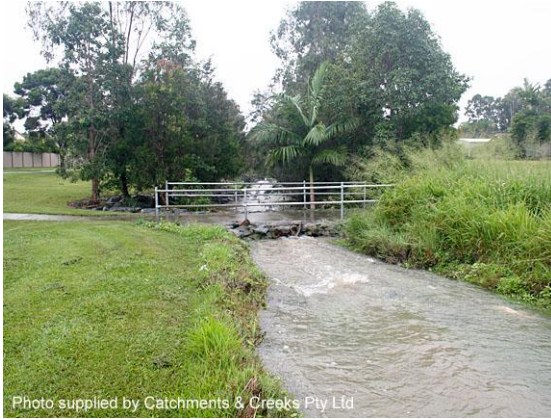
Looking d/s to the footbridge (2010)

Retention of footbridge

- Due to the steep gradient of the creek, and local flood control issues, the decision was made to retain the existing (1998) alignment of the low-flow channel.
- It was also agreed with the council that the footbridge would remain in its current location.

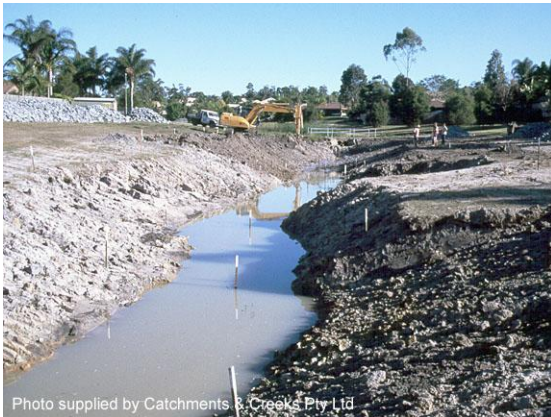
Looking upstream to footbridge (1999)

Removal of slaking soil

- Significant quantities of rubbish (burnt tree stumps) and highly erodible slaking soils were found in the stream banks adjacent the low-flow channel, which resulted in the need for this material to be removed.
- The channel was then lined with stable soil and a rock-lined pool-riffle system was constructed.

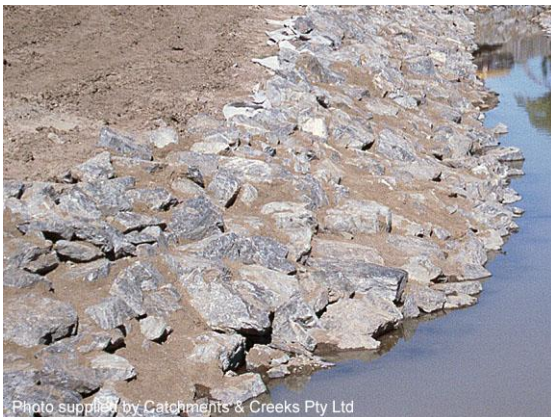
Soil-filled voids ready for planting (1999)

Pocket planting

- This project was one of the first examples in Brisbane where the voids between the rocks were filled with soil allowing plants to be introduced into the channel upon completion of the channel works.
- Prior to this, the practice of filling the voids with soil was considered unacceptable due to the risk of the soil being washed from the rocks by stream flows.
- Even though some soil is lost, the benefits gained through the earlier establishment of vegetation are significant.

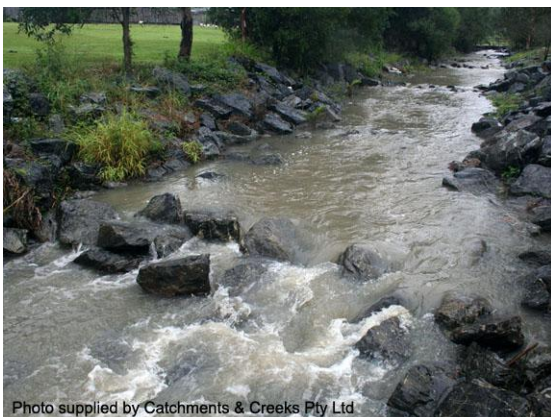
Pool-riffle system (2010)

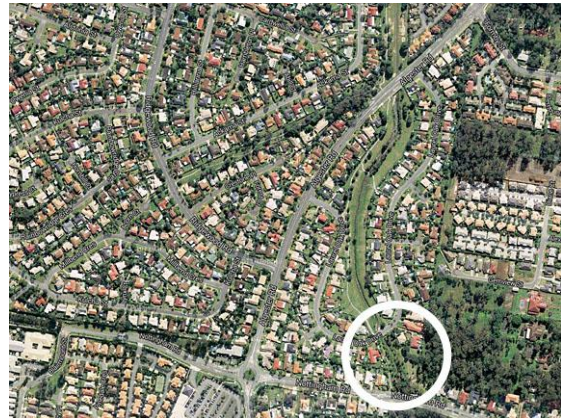
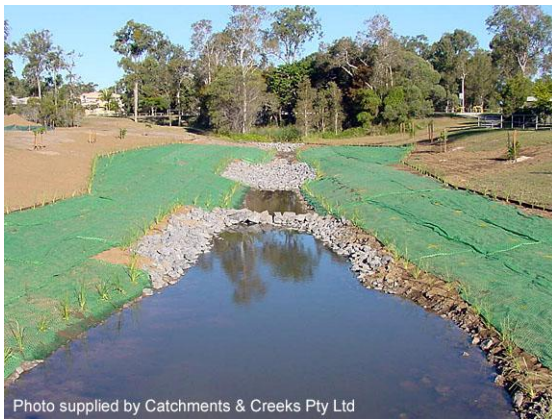
Upstream of Laurel Oak Dr (2001)

- Stage 2 of the Steep Station Gully project consisted of similar channel works being constructed between Nottingham Road and Laurel Oak Drive.
- The lower channel gradient allowed the use of erosion control mats on the battered banks as opposed to rock stabilisation.
- The Laurel Oak Driver culvert was also modified to reduce sediment and debris blockage problems.

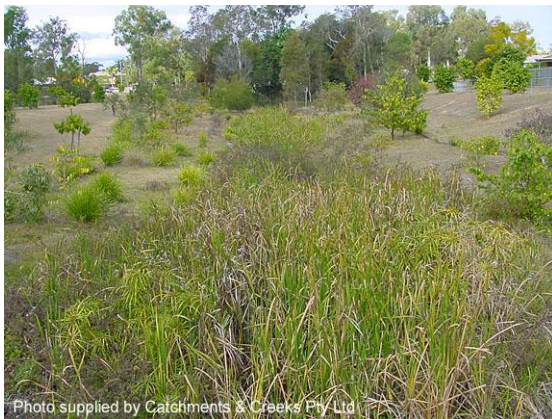
Upstream of Laurel Oak Dr (2004)

- During the early years, plant establishment was dominated by reeds and weeds within the moist low-flow channel.
- At this stage there is the risk of floods causing bank erosion on either side of the reed-infested low-flow channel.

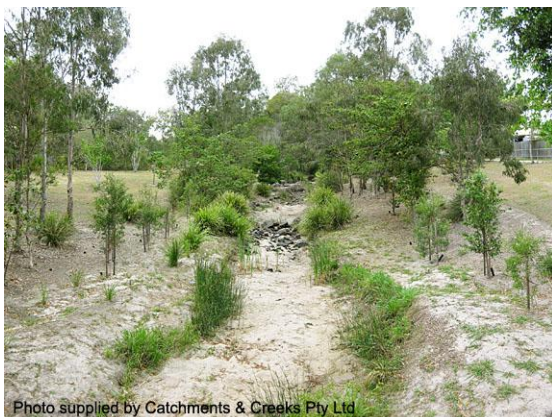
Upstream of Laurel Oak Dr (Nov, 2014)

- Even though a canopy cover has not been successfully achieved, an open low-flow channel is now well defined and the channel banks are partially stabilised with vegetation.
- Ongoing maintenance is required to encourage the establishment of a canopy cover to better control weeds and shade the low-flow channel.
- Loss of rocks is occurring at the riffles.

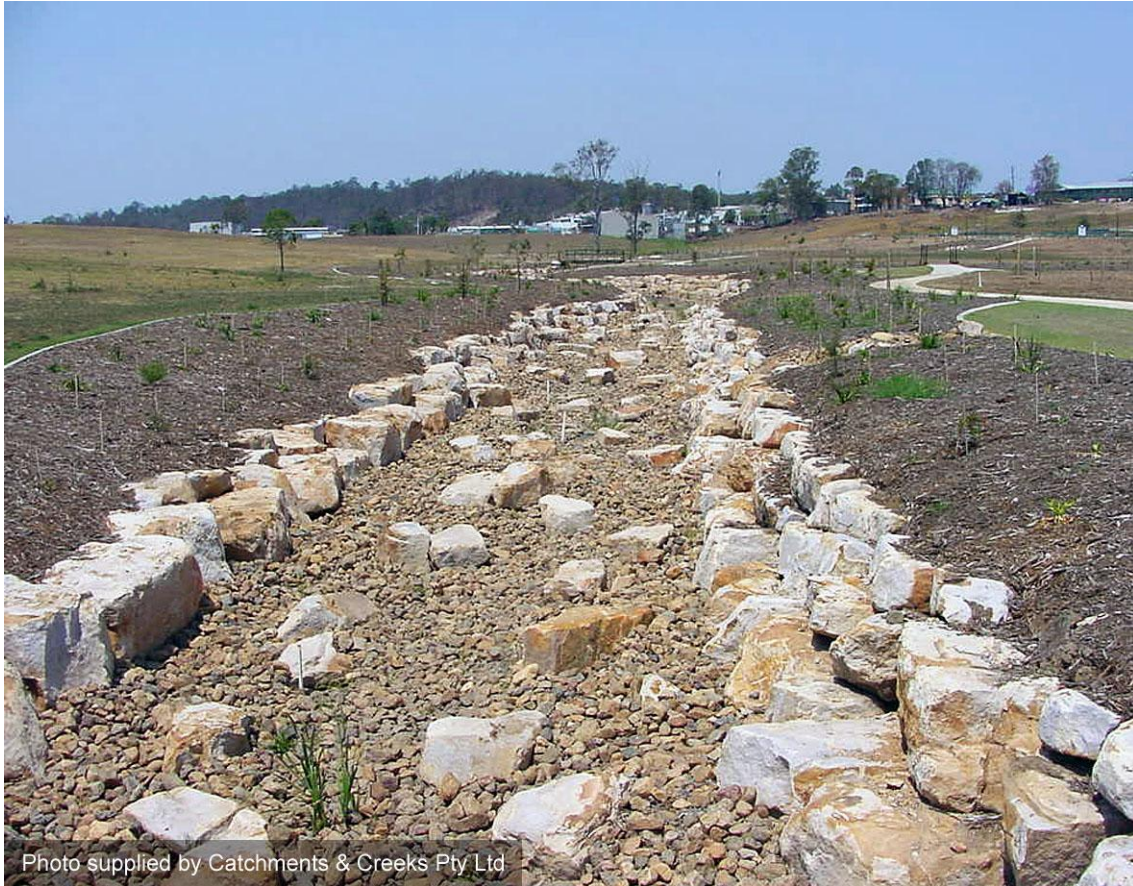
Constructed waterway looking downstream from the Sinnamon Road culvert (2000)

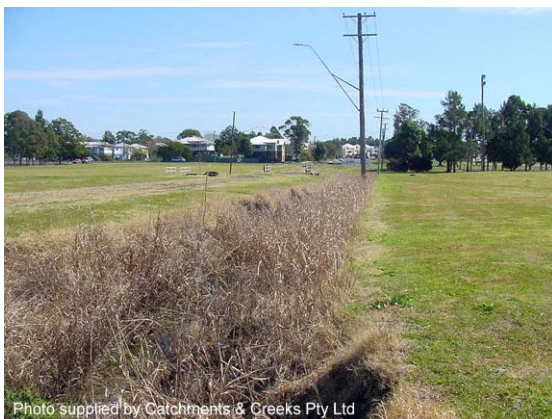
Pre-works site conditions (2003)

- The site was constrained by a planned road south of the drain, and the sports oval north of the drain.
- It was also considered desirable to avoid the relocation of the telephone pole.
- The site contains a cracking clay soil that benefits greatly from suitable vegetation cover that reduces the loss of soil moisture.
- The visually unattractive, low-value stormwater drain was also subjected to urban litter, including shopping trolleys.

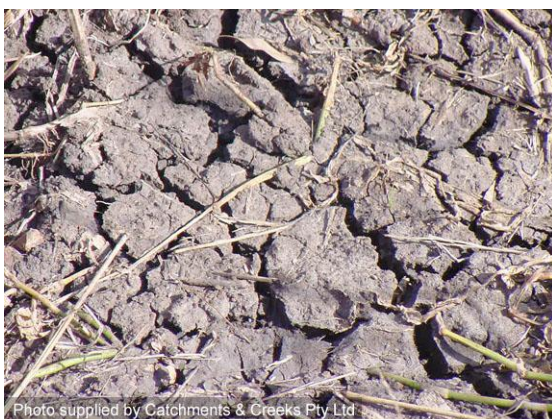
Erodible, cracking black soils

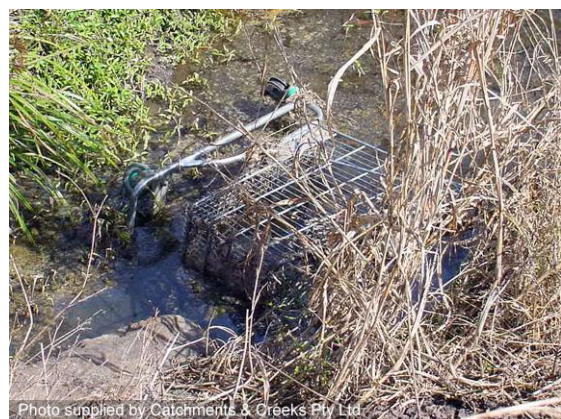
Deposition of rubbish in storm drain

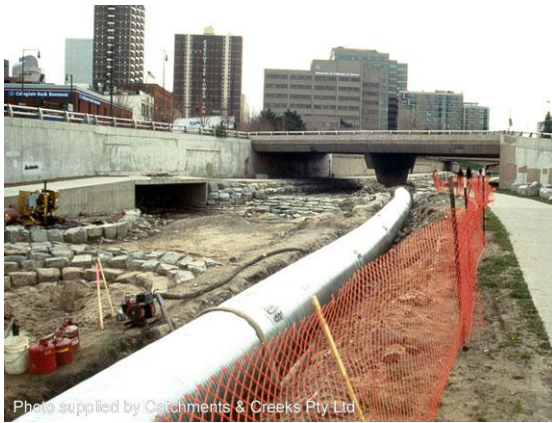
Cherry Ck, Market St, Denver (1995)

- As previously mentioned, Cherry Creek passes through central Denver.
- It is difficult to view these channel works from a 'Queensland perspective' because we do not experience the annual conditions of heavy snow cover, and the effect of this snow cover on riparian vegetation.
- Note the curved weir crests, which focuses flows towards the centre of the channel.
