Natural Channel Design

Part 4: Case Studies

Part 4 – Case Studies

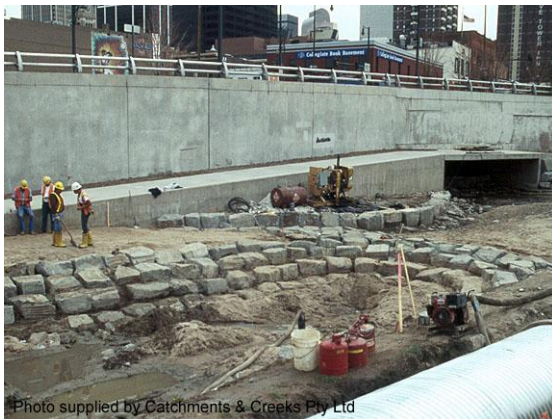
Construction of a weir (1995)

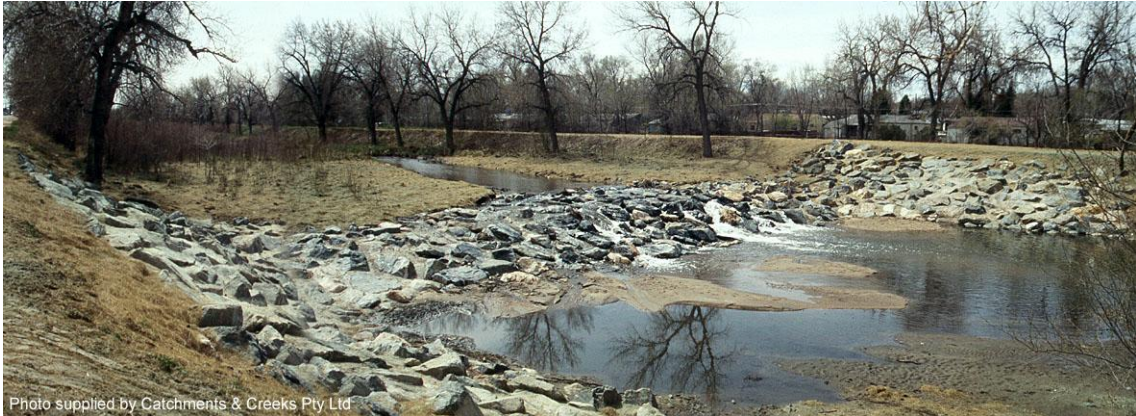
Grouted rock drop structure, Denver (1995)

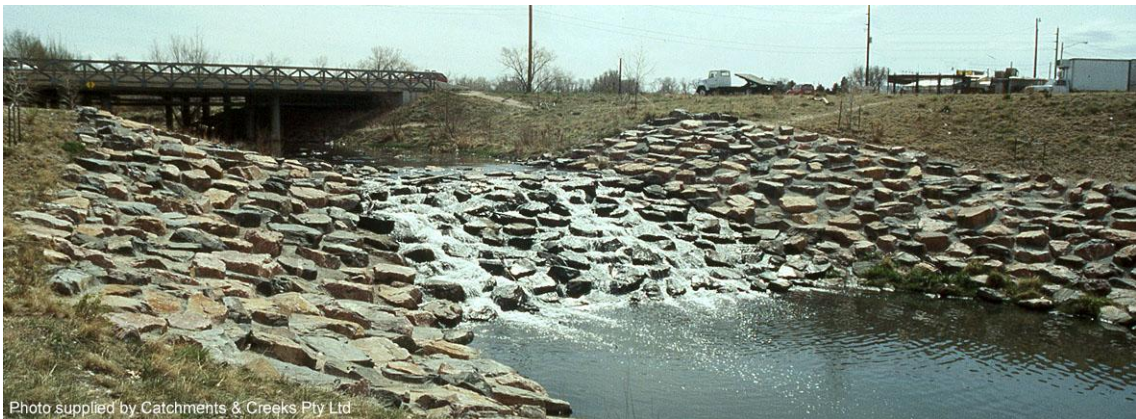
Grouted boulder drop structure, Denver (1995)

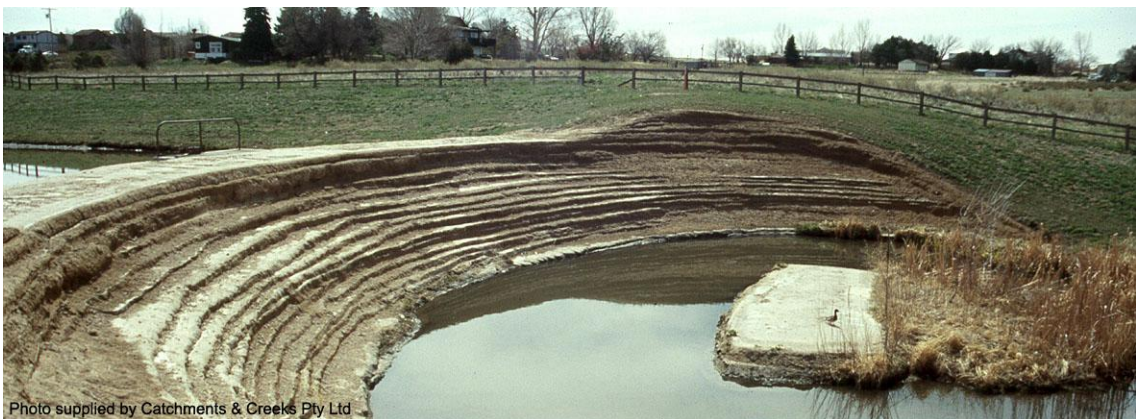
Rolled soil-cement drop structure, Denver (1995)

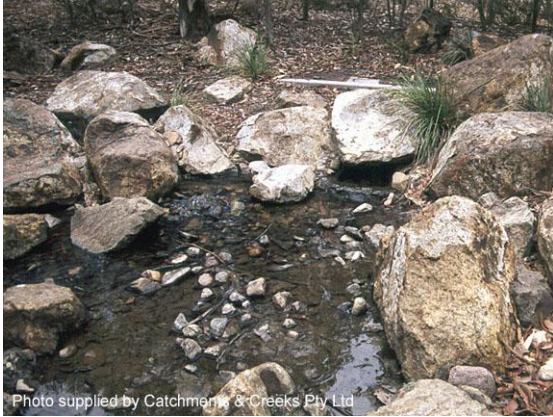
The source of the stream (1998)

- Water is pumped from the adjacent lake and released as a 'spring' at the top of the hill.
- The water passes down a fully constructed rock-lined spring until it reaches the lower wetlands.
- The water is aerated as it descends the channel.

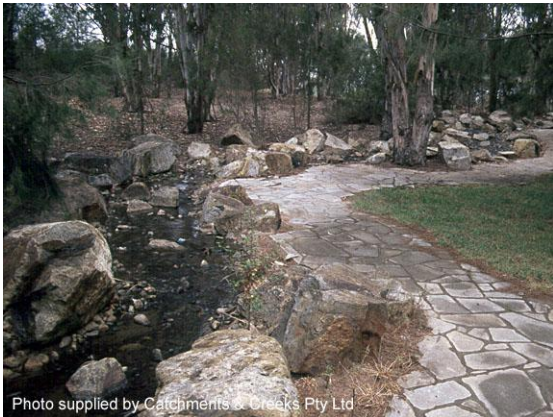
Constructed rock-lined watercourse

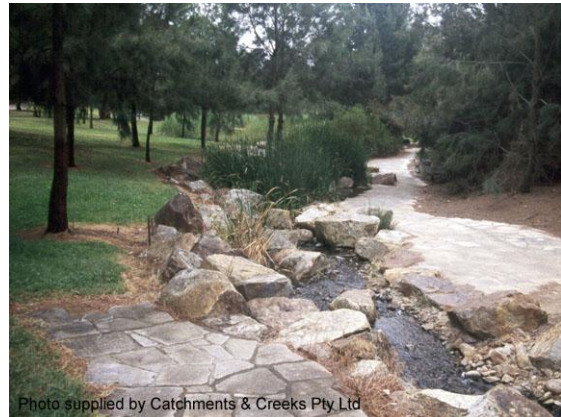
Constructed rock-lined watercourse

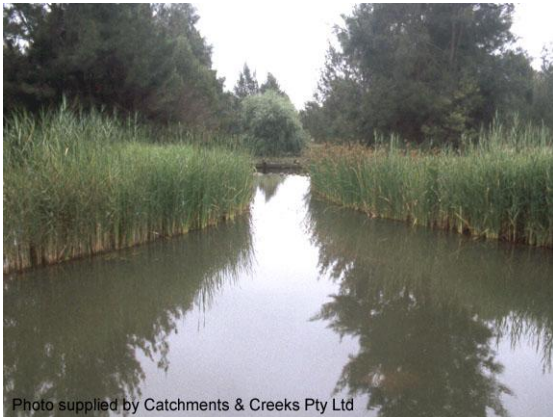
Constructed wetland

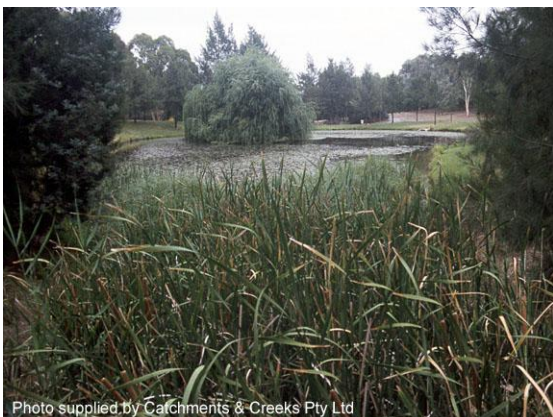
- The water then passes through a series of wetlands within which the water benefits from nitrogen removal, and the settlement of fine particles.

Constructed wetland

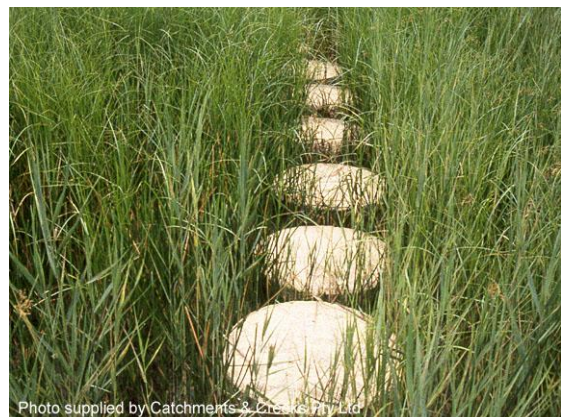
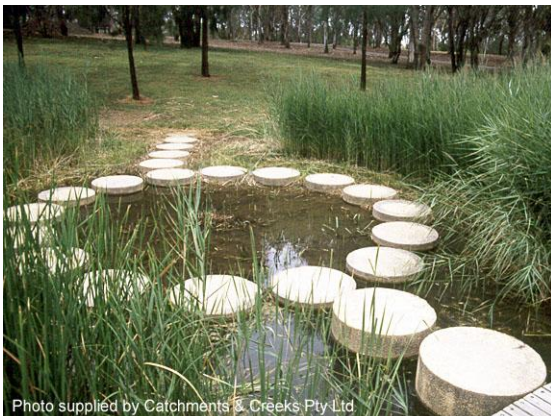
Stepping stones through the wetland

- If appropriately designed, the various pedestrian crossings and stepping stones can be used to reduce the risk of 'deadwater' zones within the wetlands.

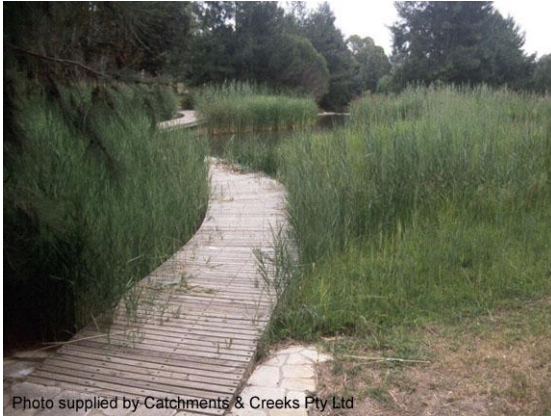
Boardwalk through the wetland

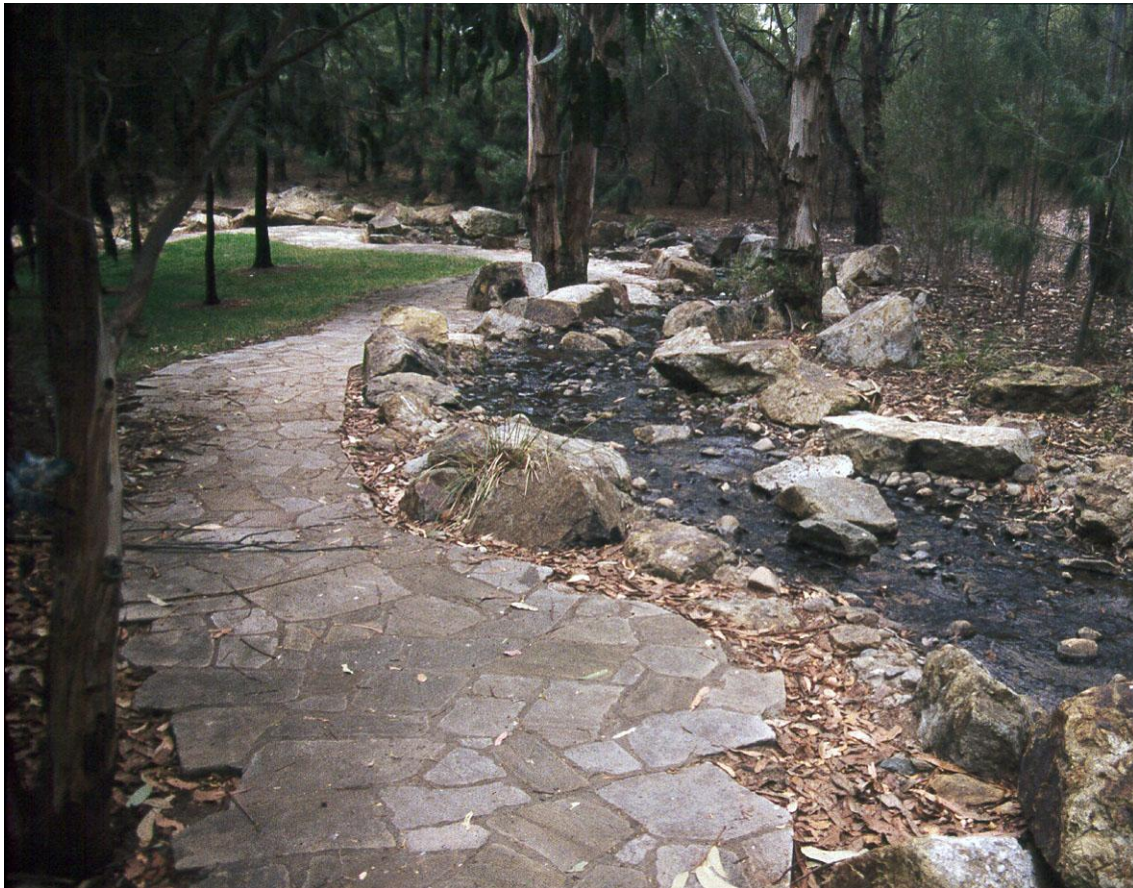
Constructed, constant pump-fed watercourse (ACT)

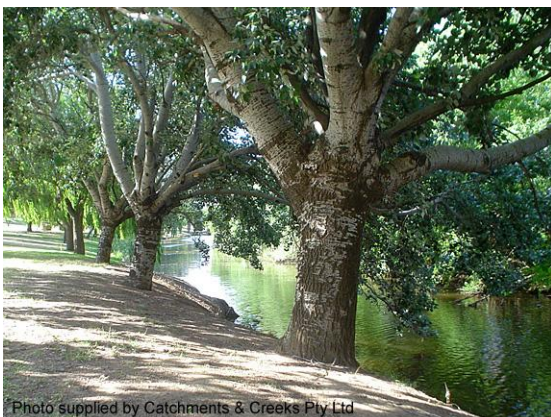
- Adelaide is well known for being a 'planned' city, which usually means a city primarily planned for human usage.
- The city's parks, including the linear park, are largely designed as open space parks with few regions of dedicated bushland.
- The Torrens River downstream of the city has only isolated sections of fauna-friendly riparian vegetation.
- It is the need for flood control that often prevents the retention of healthy, fauna-friendly riparian cover.

Poor riparian cover (2006)

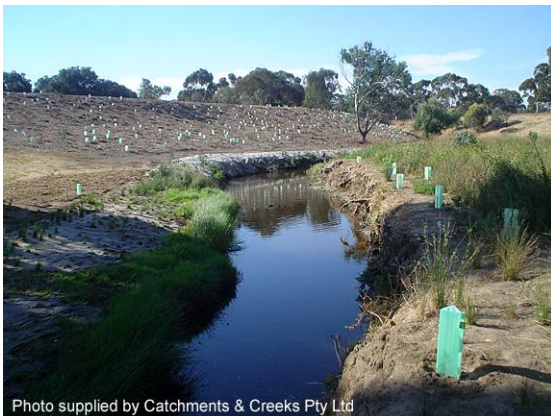
- The Torrens River does contain several regions of healthy riparian cover that provide:
 - wildlife shelter and habitat
 - wildlife movement corridors
 - erosion control
 - pollutant filtration
 - riverine aesthetics.
- 'Continuity' is essential for fish passage, terrestrial movement and flood control, but it is also desirable for human movement.

Replanting of riparian zone (2006)

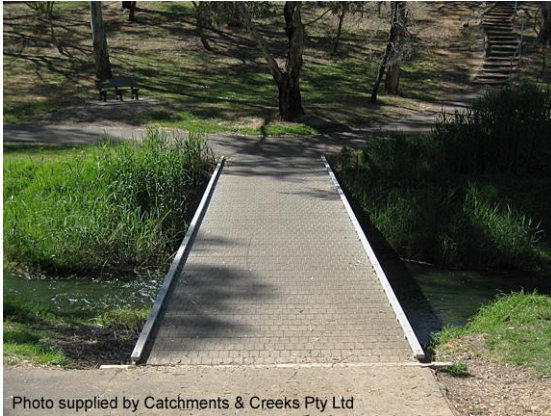
Footbridge (2014)

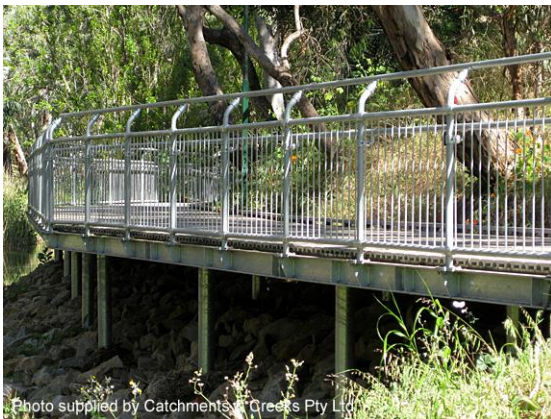
- People that are involved in the design of human movement corridors could learn a lot from a tour of Adelaide's linear park.
- The designers the linear park have used a variety of pathway designs in order to provide continuity along the waterway, while also addressing flood control issues.
- At some locations the pathway leaves the channel, and moves along adjacent roadways.

Elevated pathway (2014)

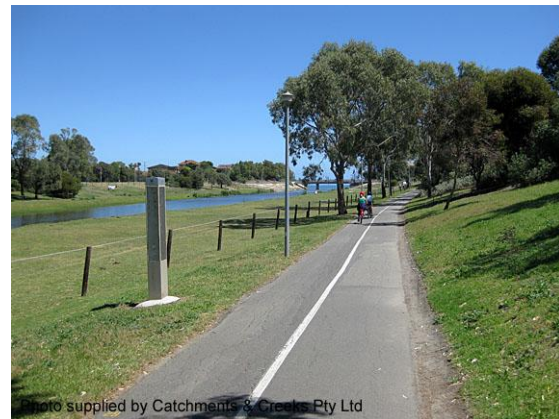
Pedestrian and cycle way (2014)

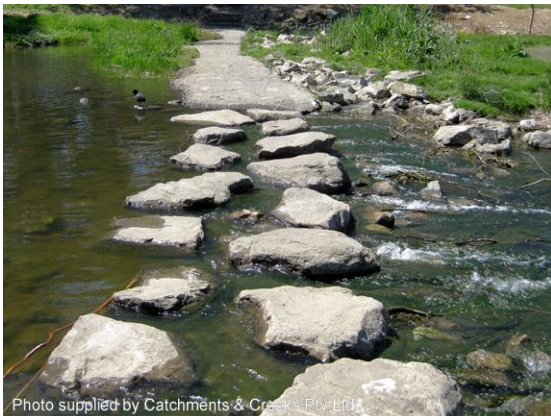
Stepping stones (2014)

- The Torrens River utilises a number of different pedestrian crossings of the river.
- Stepping stones allow human movement and fish passage, but can limit terrestrial movement.
- Weirs, which are common in the lower reaches of the Torrens River, can be used for human movement and terrestrial movement (if appropriately designed), but are undesirable for fish passage, and consequently have fishways incorporated into their design.

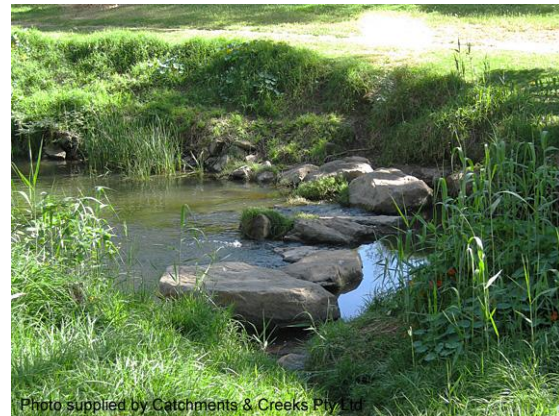
Stepping stones (2014)

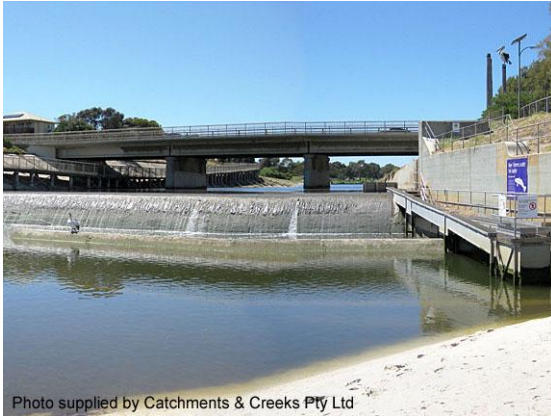
Outlet weir (2014)

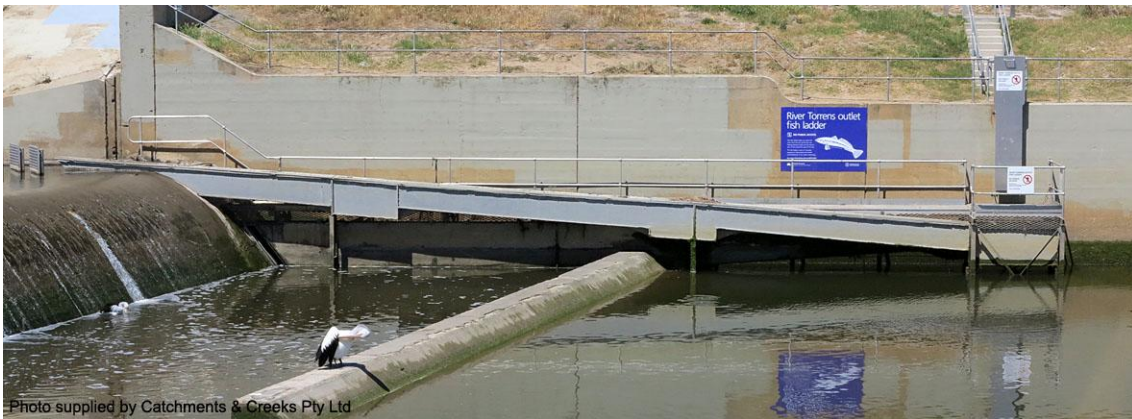
Fish ladder (fishway)

- Fish passage along waterways is critical to the survival of native fish.
- All freshwater fish and some salt water species, regardless of their size, move within waterways at different times to access food and shelter, to avoid predators, and to seek out mates to breed and reproduce.
- Of the 83 species of freshwater fish in south-eastern Australia, approximately half migrate at least once as part of their life cycle.

Fishway (2014)

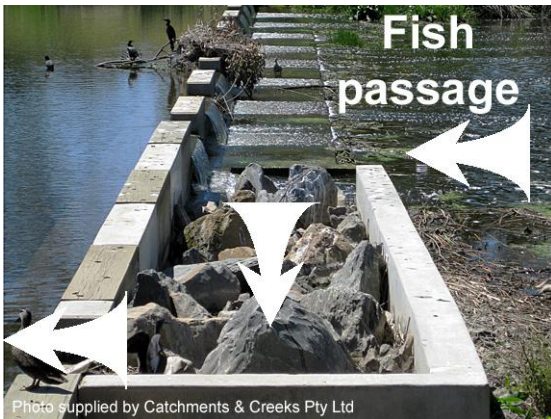
Fishway (2014)

Fishway integrated into the weirs

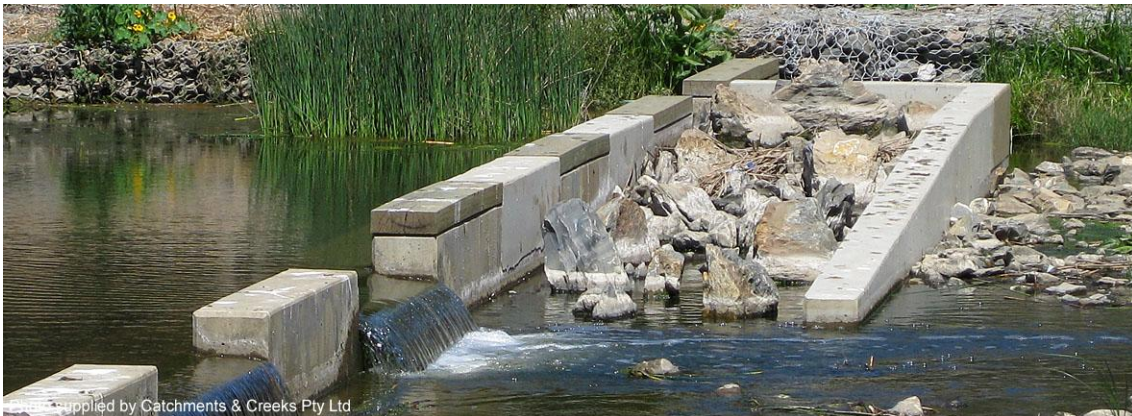
- Fish passage is the movement of fish and other aquatic organisms up and down a watercourse.
- Movement can be for a variety of reasons including:
 - migration
 - reproduction
 - access new habitats
 - feeding
 - avoid predators
 - shelter from floodwaters.

Fishway (2014)
