Natural Channel Design

Part 4: Case Studies

Part 4 – Case Studies

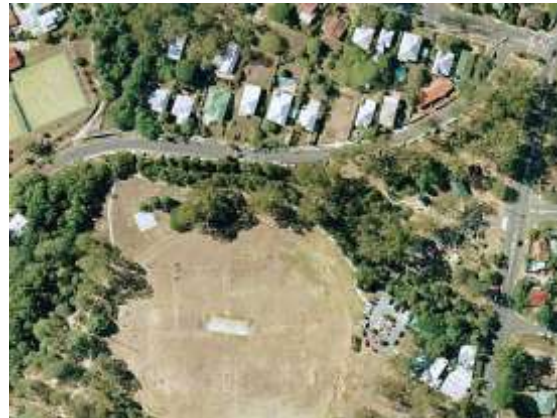
Aerial image showing vegetated channel

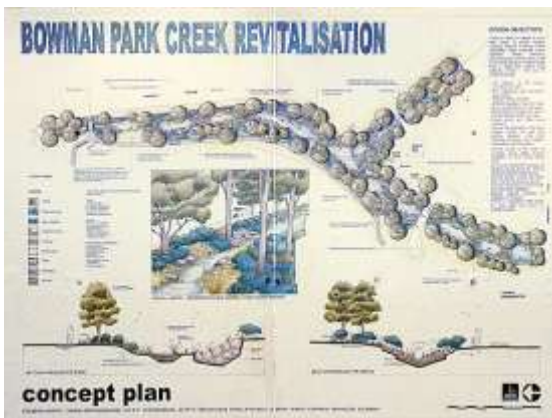
Bowman Park concept plan

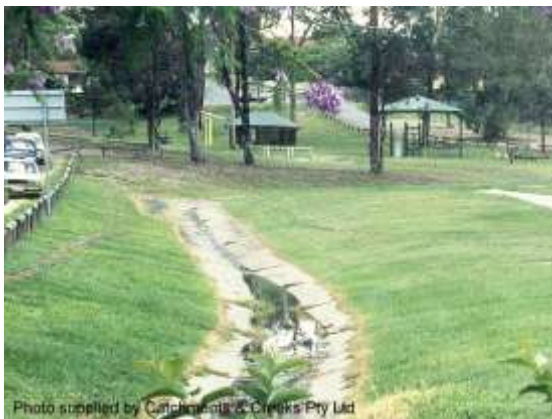
Original concrete drain (1998)

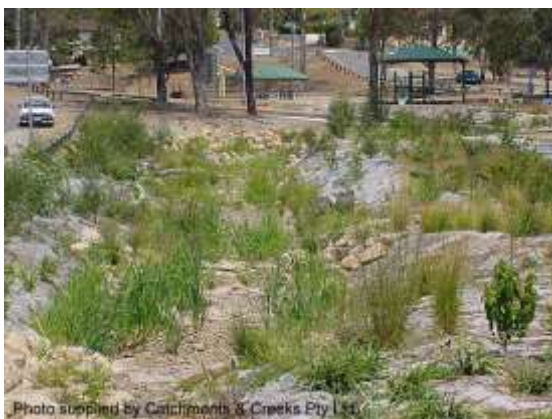
Rehabilitated drain (2000)

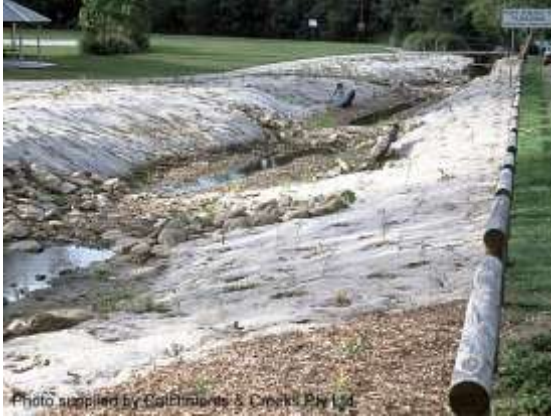
Pool-riffle system (2000)

- In theory, pool-riffle systems should only be constructed within waterways that would normally contain such a system.
- The adjacent Ithaca Creek is a waterway that does contain similar pools and riffles.
- To maintain sufficient trickle flow through the pools, a clay lining was placed under the channel to minimise the infiltration of water into the subsoil.
- The pool-riffle dimensions were based on information gained from local waterways.

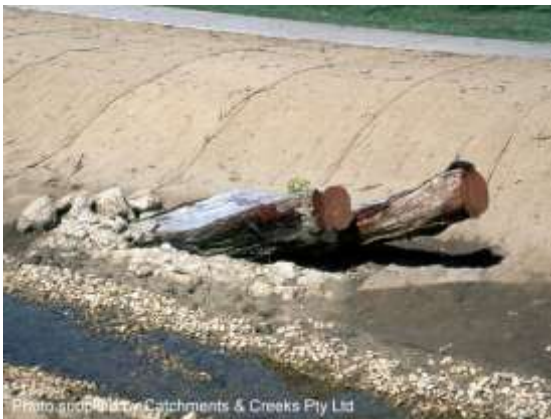
Anchored habitat logs (2000)

- Several logs were anchored into the channel as [habitat logs](#) to provide roosting for local wildlife, such as lizards.
- Such channel features can also provide shelter for aquatic life during high-velocity flood flows.
- The logs are aligned with the direction of flow in order to minimise the risk of the logs catching flood debris.

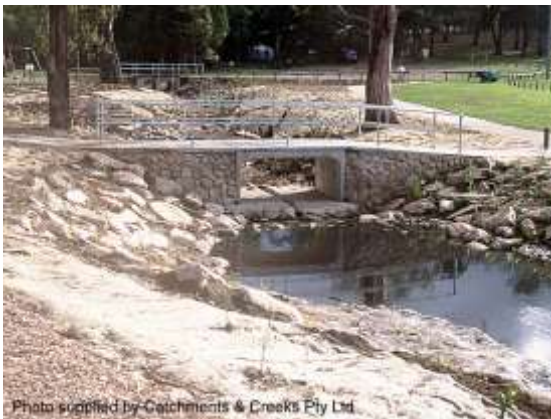
New footbridge (d/s of junction, 2000)

- Replacing the concrete-lined storm drain with a vegetated waterway meant that pedestrian access to the sports oval had to be enhanced with the inclusion of footbridges and stepping stones.
- The rehabilitated park has become very popular with the local residents and children, as such, the pathways also provide valuable bikeways.

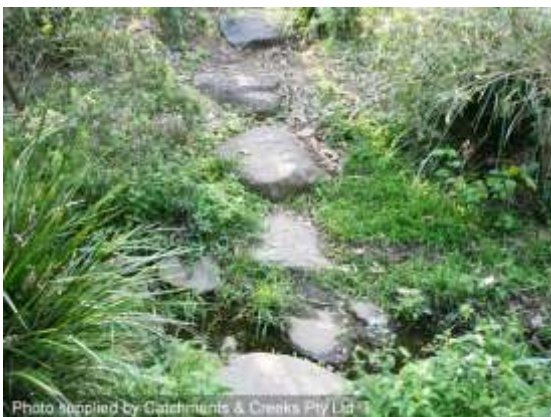
Stepping stone pathways (2008)

- In a world of increasing public safety and risk management, the days of constructing stepping stone crossings of waterways maybe becoming a thing of the past.
- Fortunately, this channel rehabilitation project has incorporated numerous recreational features that enhance a child's ability to access and explore the waterway.

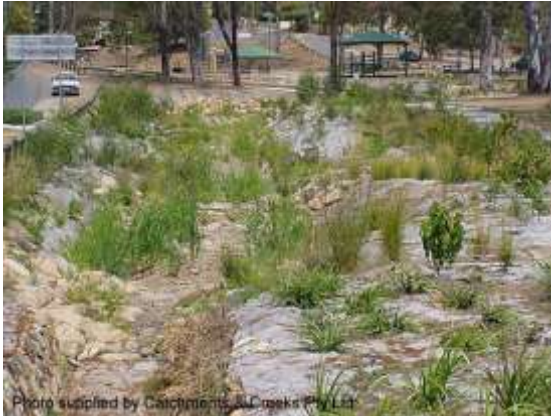
Main channel (looking south, 2000)

- Initial plant establishment within jute erosion and weed-control blankets.

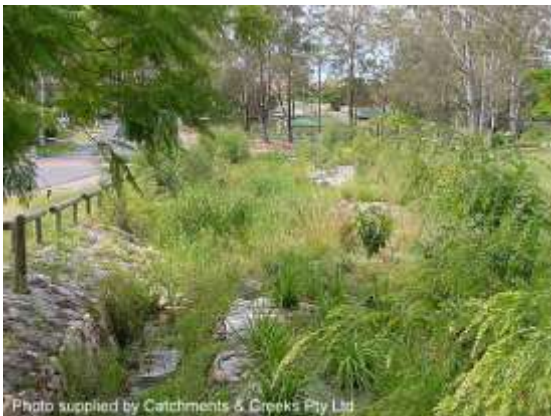
Main channel (looking south, 2001)

- Fully open canopy.
- Channel enters its initial 'weedy' phase.
- Pools are almost completely filled with invading reeds.

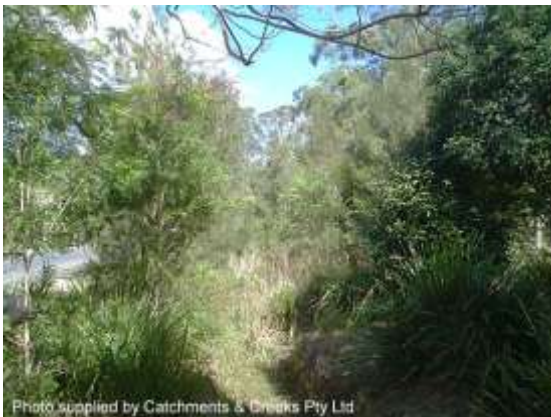
Main channel (looking south, 2005)

- Insufficient canopy cover still exists over the low-flow channel.
- Significant weed growth still exists within the channel.
- A dense cover of understorey native plants exists.

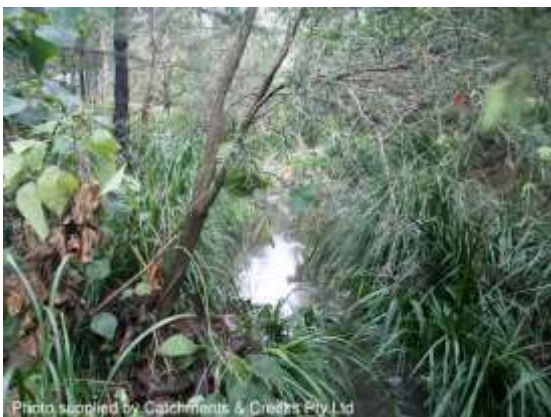
Main channel (looking south, 2010)

- Canopy has formed producing sufficient shade to thin plant density and allow the shading-out of some weeds.
- The pools are becoming clear of reeds.
- A pool is visible in the centre of this image.
- A riffle is just visible in the foreground of the image.

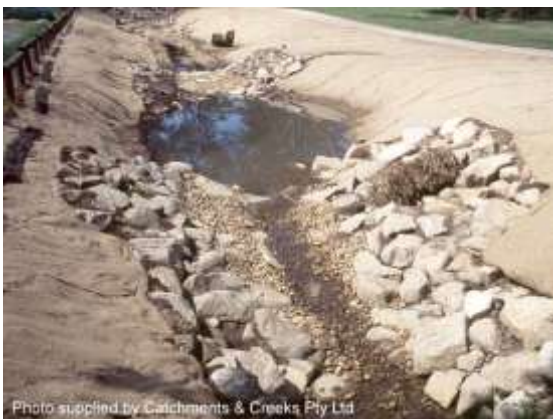
Pool-riffle system (2000)

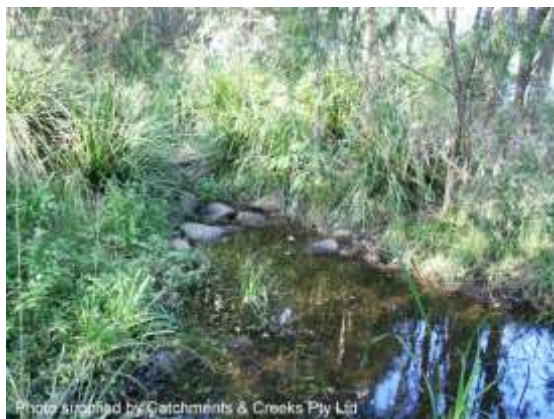
Pool-riffle system (2008)

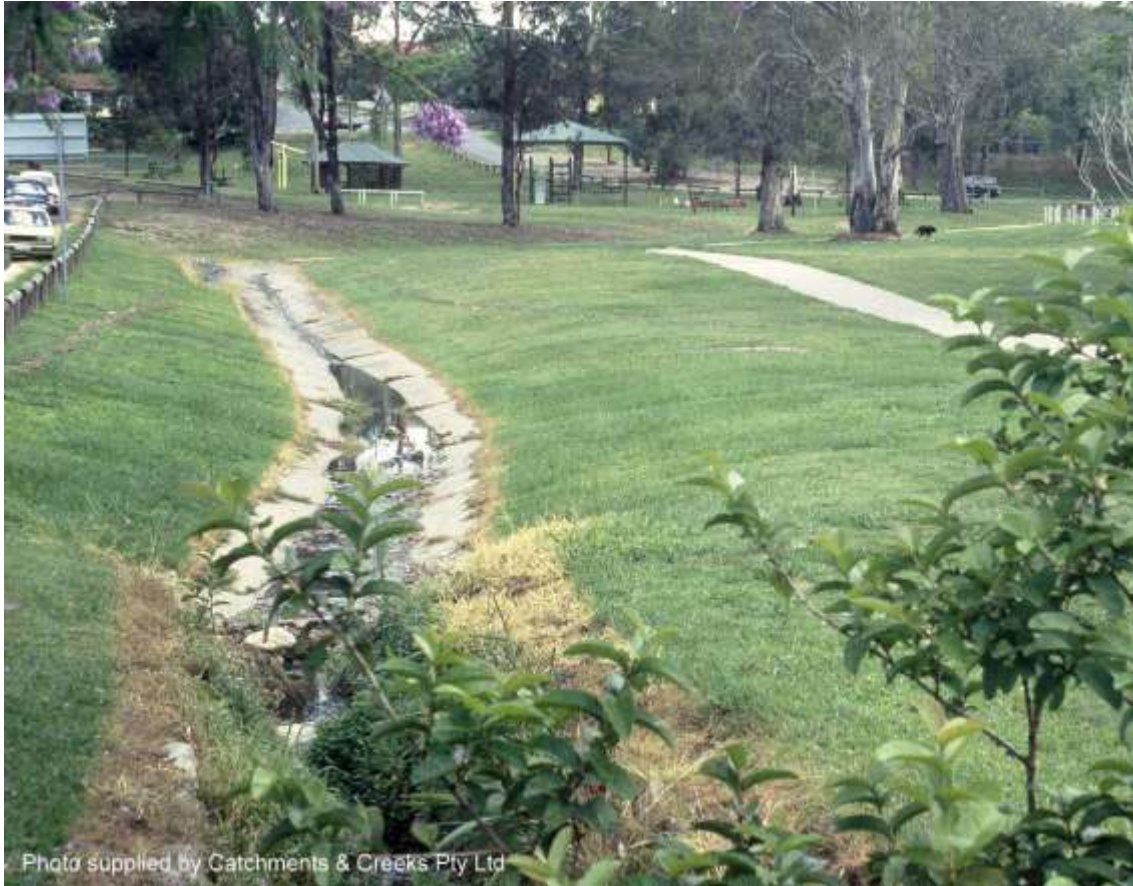
Original concrete drain looking upstream with sports oval to the right (1998)

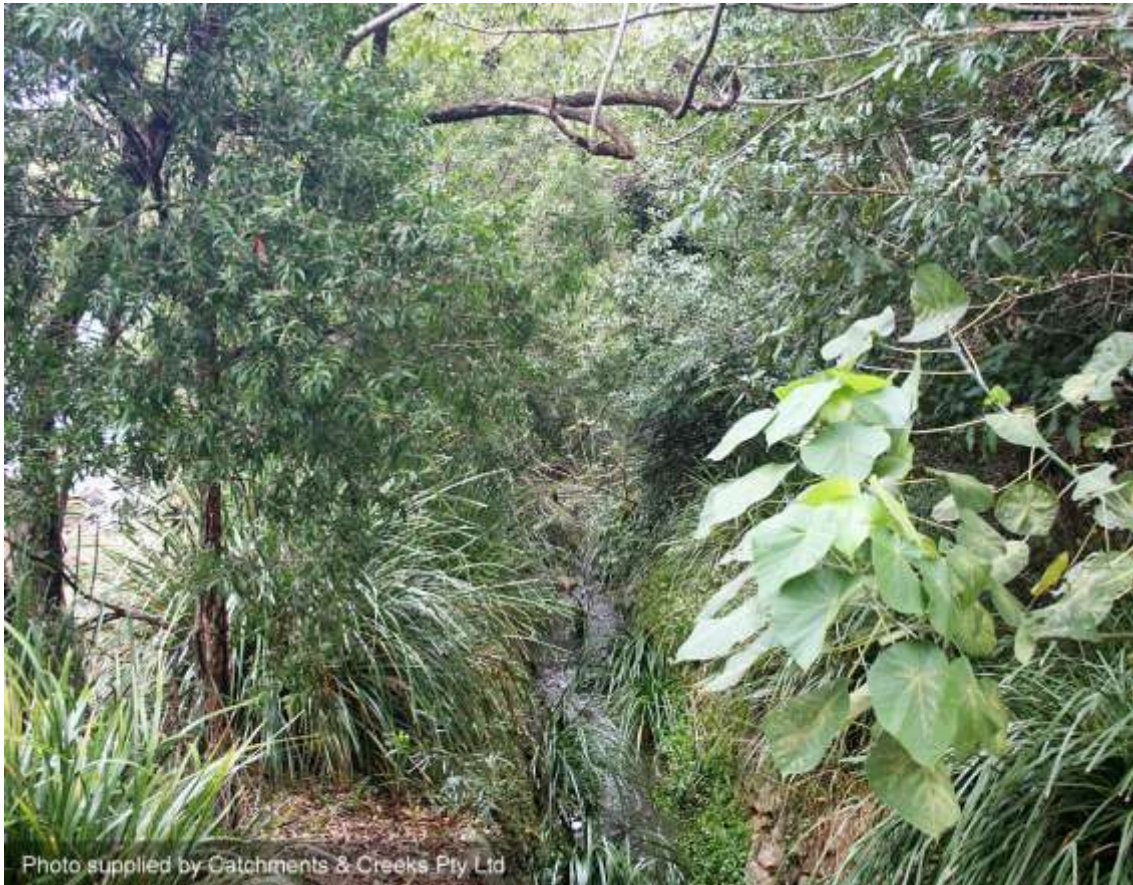
Rehabilitated waterway looking upstream with sports oval to the right (2010)

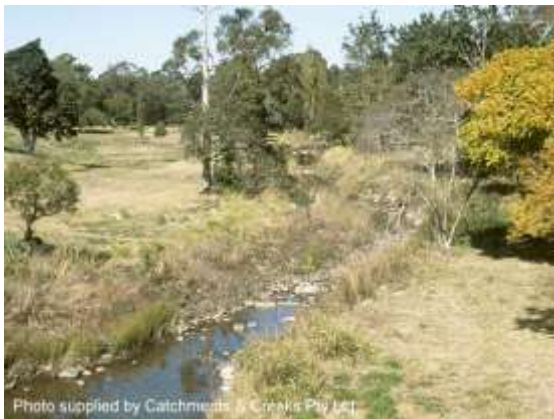
Looking d/s from Moggill Rd (1991)

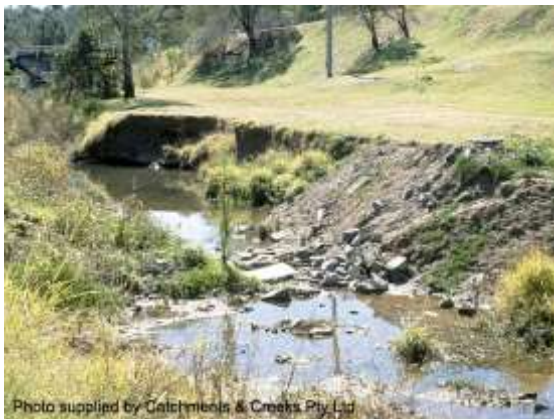
Protection of sewer with rubble (1991)

- In the early 1990s the creek had poor aesthetic appeal due to the exposed, weedy banks.
- Construction waste, in the form of rock, broken concrete and earth, had been used to stabilise and protect the channel banks adjacent the various sewer pipe crossings and sewer inspection chambers (just visible on the right of this image).

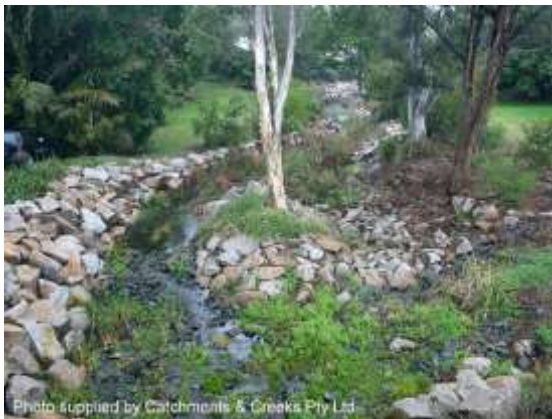
Looking upstream from Samford Rd (2007)

Year 2007

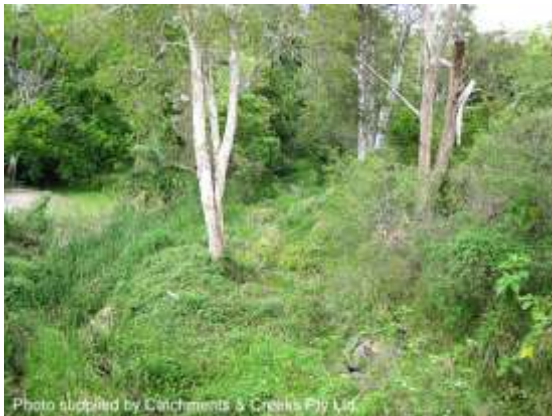
Looking upstream from Samford Rd (2014)

Year 2014

- Significant weed infestation along the channel bed.
- The north-south alignment of the creek, and the open canopy to the north of the creek produced by the existence of Samford Road, meant that this section of the creek will always experience a weed problem.
- The shading produced by the growing canopy cover should reduce weeds within the upstream section of the creek.

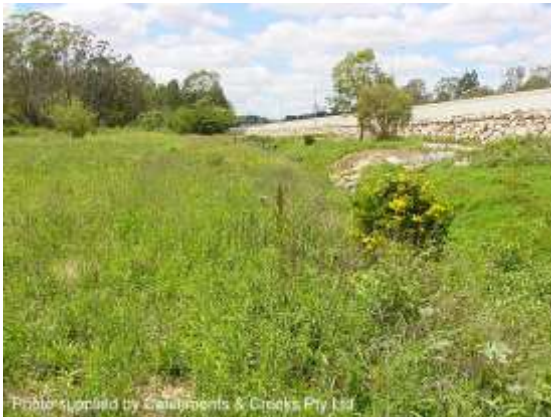
Looking downstream from culvert (2000)

Site history

- Riparian vegetation was largely cleared along the creek to provide flood mitigation.
- In the 1990s Norman Creek in this area resembled little more than an open storm drain passing through a grassy field.

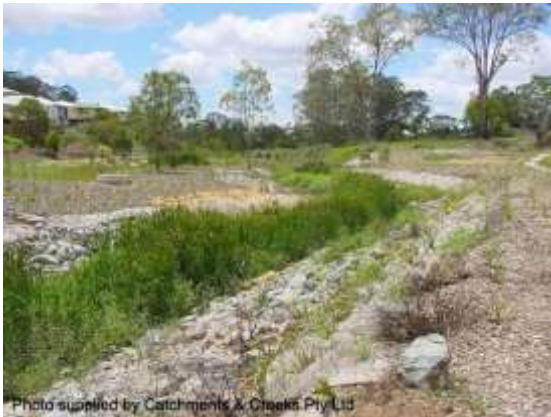
Upstream reach (2001)

The project – stage 1

- Construction of the busway adjacent to the South East Freeway resulted in a second phase of creek rehabilitation.

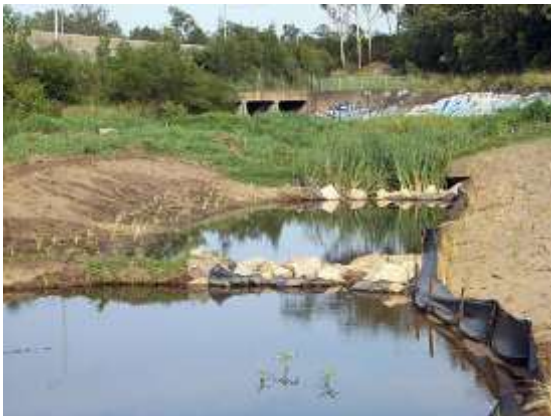
Looking downstream to culvert (2001)

The project – stage 2

- Lobbying by the Norman Creek Catchment Coordinating Committee (N4C) resulted in the proposal for more substantial creek rehabilitation.
- A series of pools and riffles were formed along the creek based on the past success of a similar creek rehabilitation project adjacent to Willis St, Tarragindi (Ekibin).

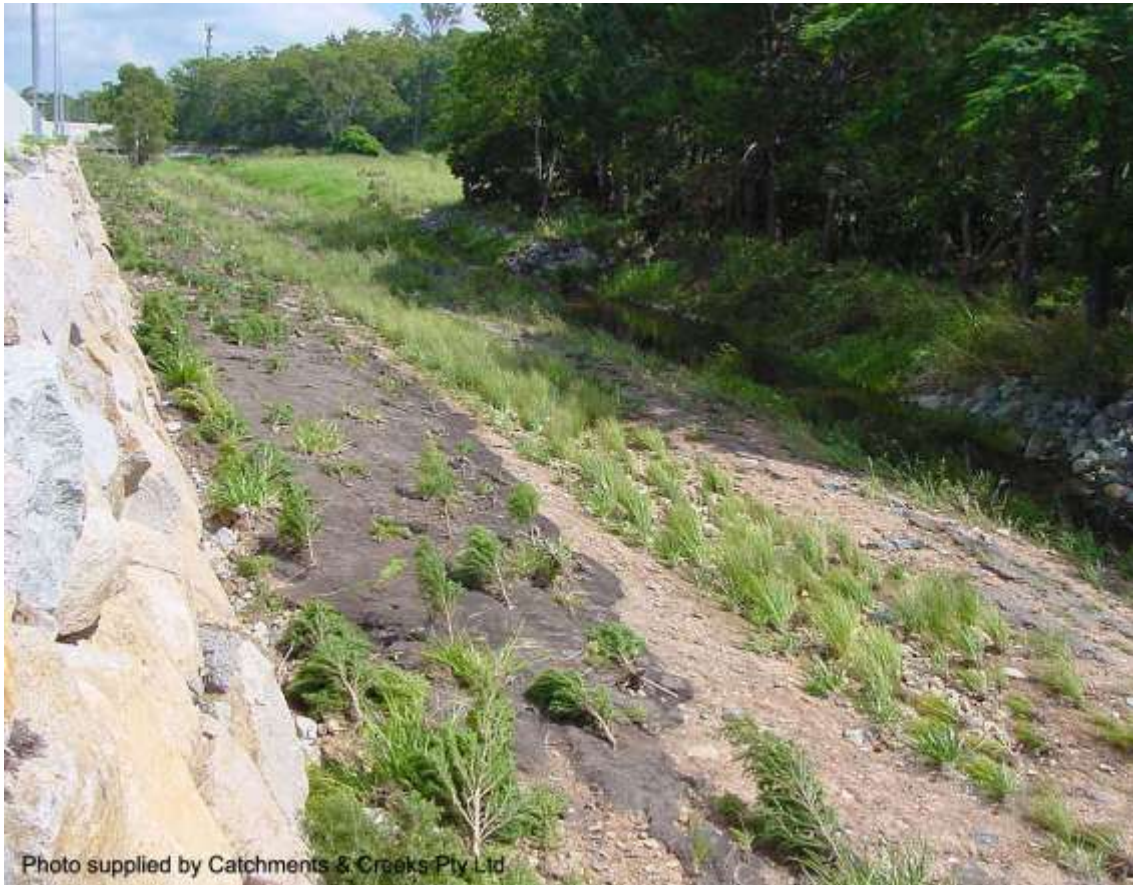
Looking downstream towards the culvert (after flood damage, 2001)

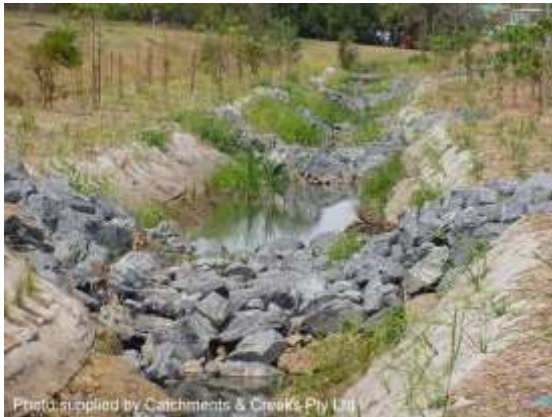
Pool-riffle system (looking upstream)

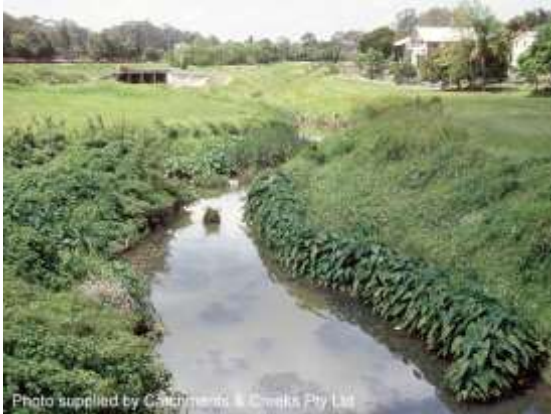
Looking upstream from bridge (1999)

Year 1999

- Site conditions prior to the works.
- Creek channel has significant weed infestation

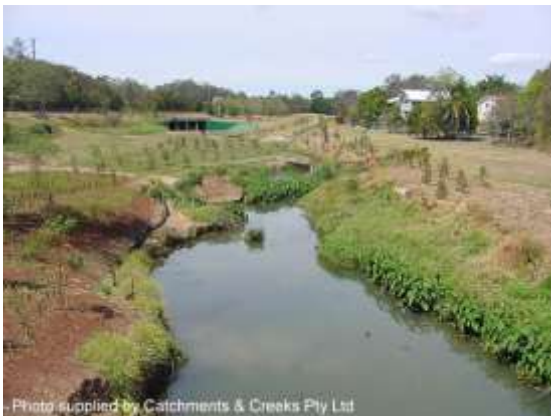
Following first stage of works (2001)

Year 2001

- Site conditions after channel modifications.
- Pools and riffles established within the tributary, with some planting within over-bank areas.
- Creek is nutrient-rich with heavy algae growth.

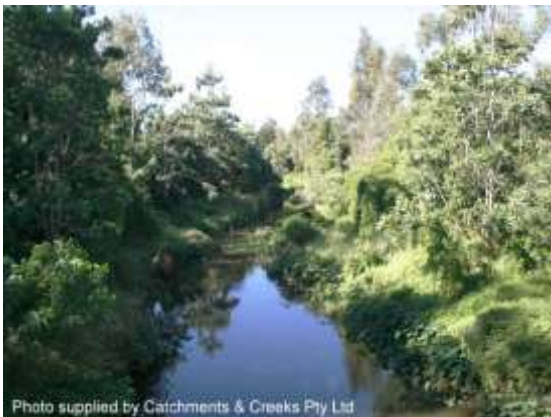
Looking upstream from bridge (2010)

Year 2010

- Canopy trees have achieved significant height, but not full maturity.
- Significant weed cover exists within the understorey.
- Tree establishment along the northern bank (visible to the left) is now beginning to shade the waterway.

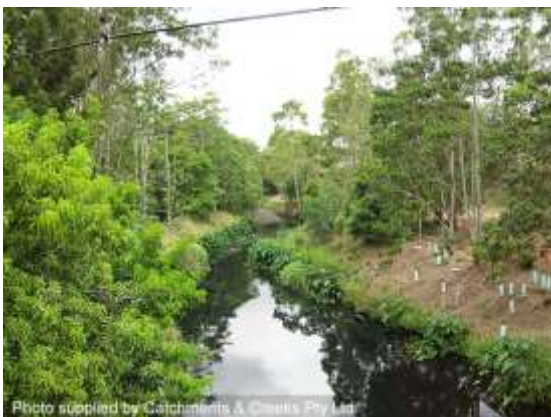
Looking upstream from bridge (2014)

Year 2014

- Weeding and partial removal of grass cover within the riparian zone by the local community group.
- Shading from the established canopy cover also helps to thin the understorey and groundcover plants.
- The creek experienced significant flood flows during 2009, 2010 and 2011.

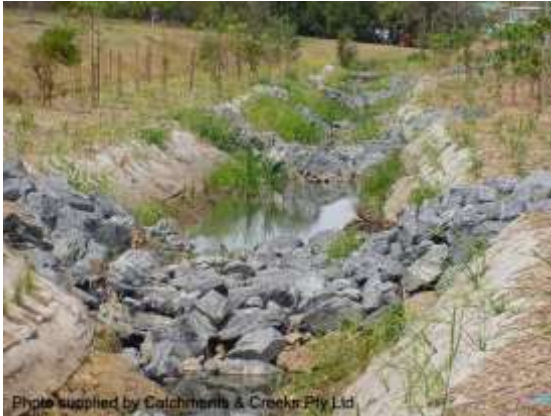
Constructed pool-riffle system (2001)

Pool-riffle system

- Pool-riffle systems are not natural in all waterways, and thus should not be considered an essential element of all creek rehabilitation projects.
- In this case the riffles help to control channel erosion that would otherwise have occurred once the canopy cover began to shade-out the grass cover.
- The use of 'blue' quarry rock may not be ideal, but the rocks usually develop a more natural brown/green colour over time.

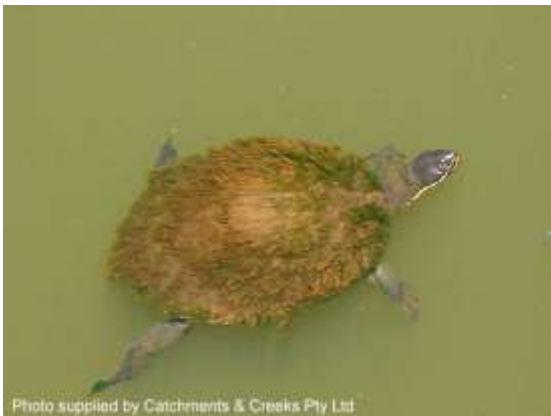
Nutrient-rich waters (2001)

Algae problem

- This image of an algae encrusted turtle was taken within the deep pool that exists upstream of the Arnwood Place bridge in 2001 just after the completion of the channel works.
- This algae problem contributes to a reduction in dissolved oxygen within the water.
- Improved shading of the water body and improved stormwater practices within the catchment should see a reduction in this algae problem.

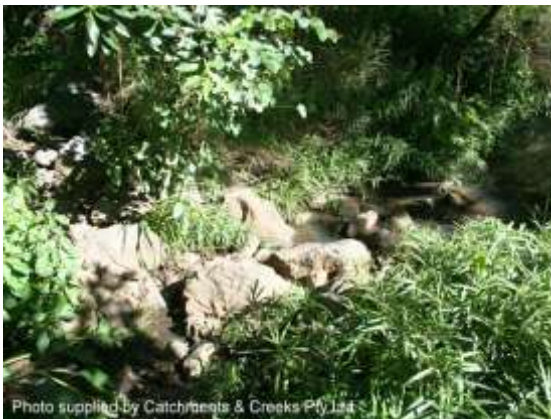
Downstream riffle (2010)

Stepping stones

- The most downstream riffle has been adopted by locals as a stream crossing point.
- The riffle rocks substitute as stepping stones.

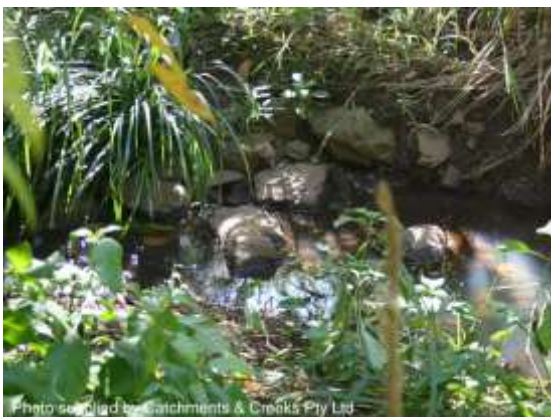
Upstream riffle (2010)

Fish passage

- The riffles have established desirable flow conditions that would encourage fish passage up the waterway.

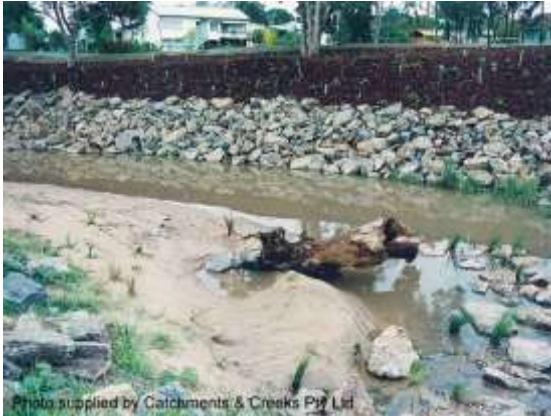
Log and sand bench (1997)

Habitat log and sand bench

- Two habitat (roosting) logs were anchored into the channel.
- These logs provide habitat and shelter (from flood flows) for aquatic wildlife, and sunning perches for reptiles.
- Washed sand was introduced to the inside of channel bends to mimic the channel feature commonly found in alluvial river systems (now viewed as inappropriate within urban creeks).

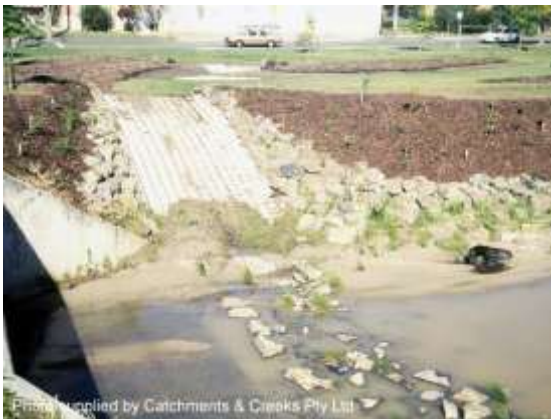
Maintenance access ramp (1997)

Maintenance access ramps

- Maintenance access ramps were installed into the channel both upstream and downstream of the Wardell Street culvert.
- These access ramps were formed from flexible geotextile/concrete mats (Humes *Flexmat*).
- Use of these mats allows vegetation (grasses) to grow between the concrete blocks to partially hide the hard surfacing.

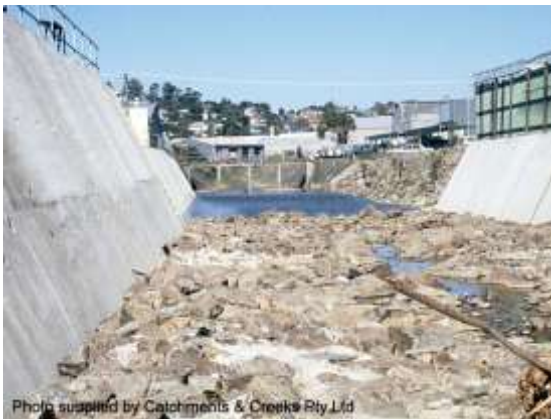
Grouted rock bed on concrete channel

Habitat pool and grouted rock roughness

- A deep sediment trap and habitat pool was established between the downstream end of the new concrete channel and the upstream end of the existing concrete channel, upstream of the Magura Street footbridge.
- To enhance the environmental features of the concrete channel, rocks were grouted to the bed of the downstream end of the new concrete channel.
- The intent was to allow vegetation to establish over these rocks.

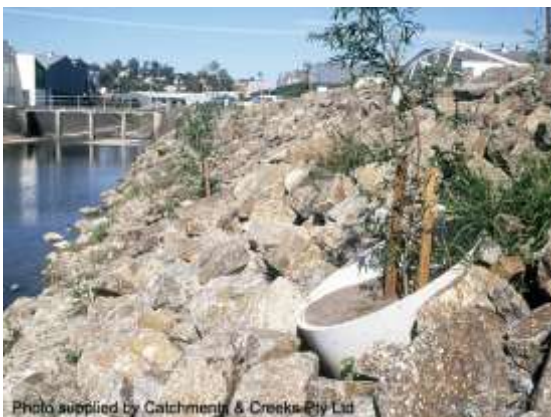
Tree planter boxes set into boulders

Planter cell in rock bank

- To help shade the habitat pool, tree planter boxes (concrete pipe segments) were installed in the boulder-lined southern bank of the creek adjacent the Magura Street footbridge.

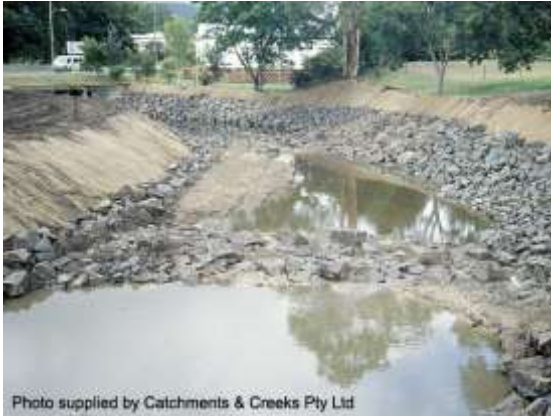
Looking upstream from Wardell St (1997)

Year 1997, February

- Pre-planting site conditions.
- Jute erosion control blankets placed over exposed soil banks prior to planting.

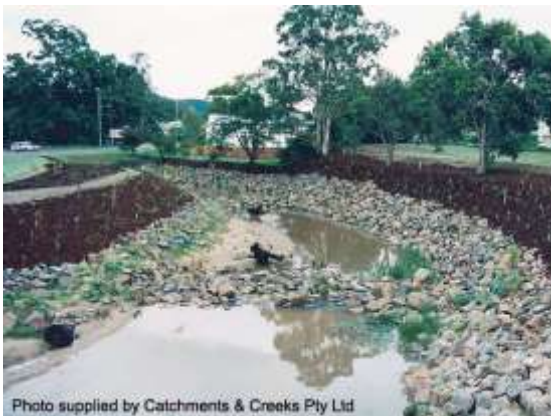
Looking upstream from Wardell St (1997)

Year 1997, June

- Site conditions just after initial plant establishment.
- Heavy loose mulching of the upper banks and over-bank areas.
- Limited pocket planting within the rock voids.

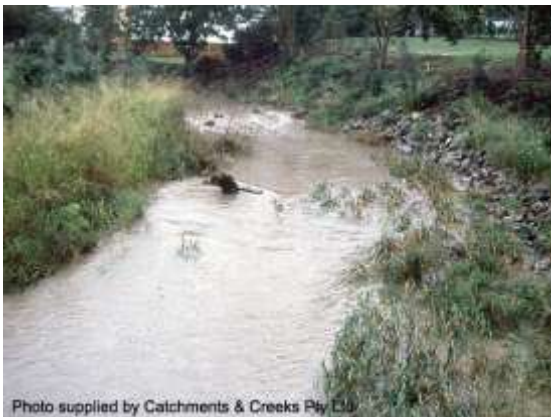
Looking upstream from Wardell St (1998)

Year 1998, April

- Significant weed (grass) growth within the bank vegetation.
- Channel bed effectively remains free of significant weed (reed) growth.

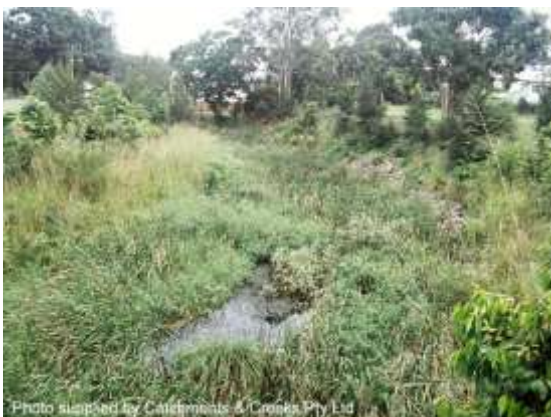
Looking upstream from Wardell St (1999)

Year 1999, April

- Significant weed growth along the banks and on the channel bed.
- A low-flow channel is beginning to establish in the centre of the channel bed.

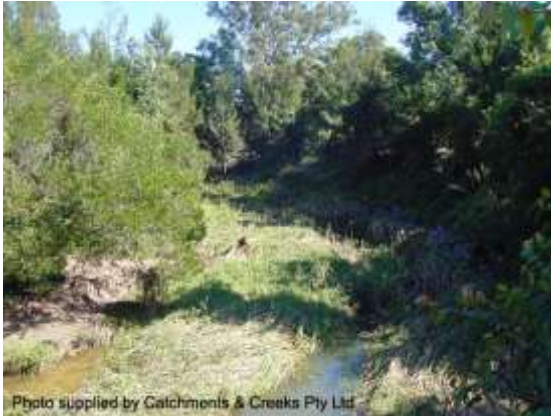
Looking upstream from Wardell St (2003)

Year 2003

- Upper-storey canopy trees are slowly beginning to shade the channel, but currently they are only controlling weeds on the banks.
- Dry-land grasses are beginning to invade the channel bed during the extended drought of 2000–2008.
- A well-defined low-flow channel still exists.

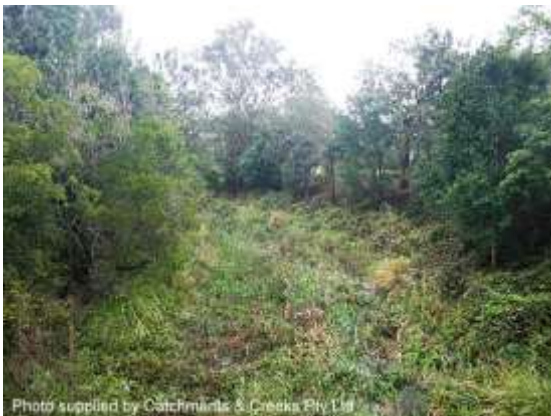
Looking upstream from Wardell St (2007)

Year 2007

- Riparian vegetation has thinned due to a past drought.
- Channel bed thick with weeds, mainly grasses.
- This image shows the channel just after a storm that caused the bed vegetation to fold in the direction of flow.

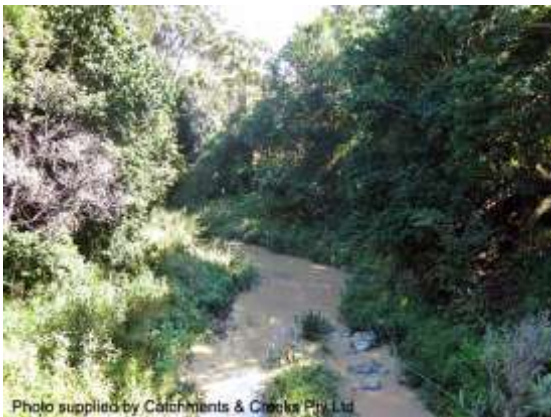
Looking upstream from Wardell St (2011)

Year 2011

- Canopy trees are beginning to shade the channel bed and limit weed growth.
- The low-flow channel is now more pronounced within the wide channel bed.
- The original riffle rocks are now becoming exposed and forming a riffle.

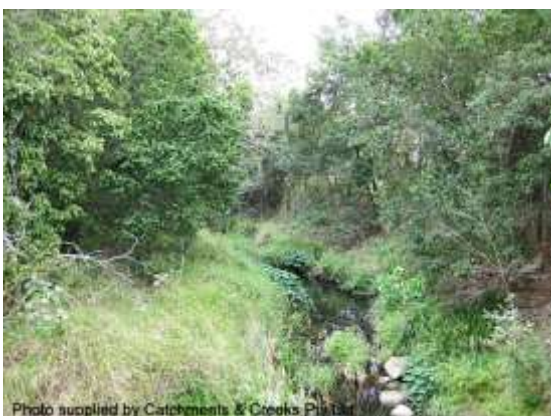
Looking upstream from Wardell St (2014)

Year 2014

- The low-flow channel is well-defined.
- Excessive sediment deposition is occurring on the inside of the channel bend, and this sediment is being stabilised by weeds.

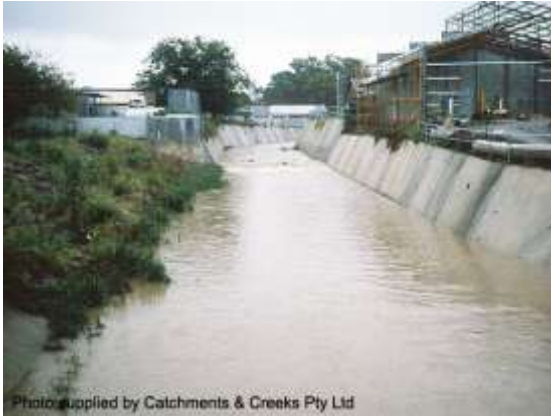
Looking upstream Magura St (1998)

Year 1998

- A habitat pool was established between the downstream end of the new concrete channel and the upstream end of the existing concrete channel.
- This habitat pond also acted as a sediment trap.

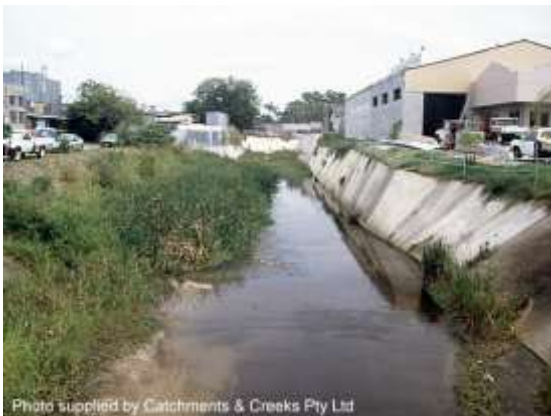
Looking upstream Magura St (1999)

Year 1999

- The rising bed level of the pond (due to sediment deposition) is allowing reeds to establish adjacent to the boulder wall.

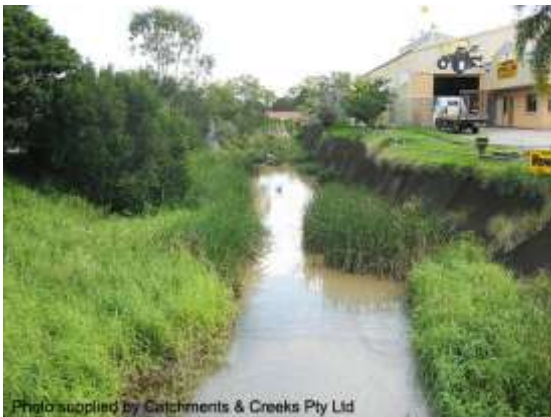
Looking upstream Magura St (2011)

Year 2011

- Significant sediment deposition has occurred within the habitat pond.

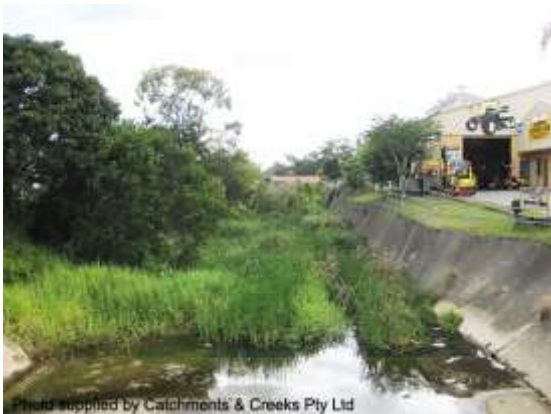
Looking upstream Magura St (2014)

Year 2014

- The habitat pond is now near-full of sediment resulting in the establishment of reeds and grasses across the full width of the pond.

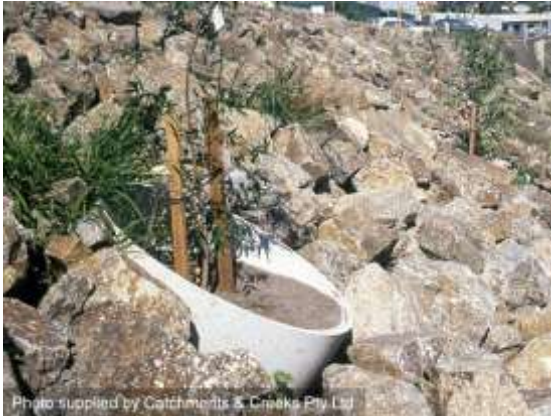
Tree planter boxes (1997)

Year 1997

- Tree planter boxes consisting of concrete pipe segments were installed in the boulder-lined southern bank of the creek to help shade the habitat pool.

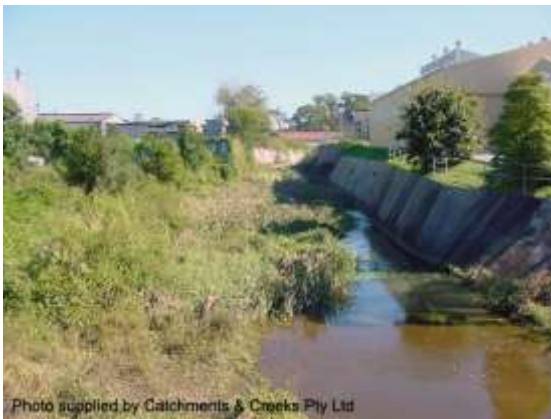
Looking upstream Magura St (2003)

Year 2003

- Canopy trees just beginning to appear above the weed-infested rock bank.

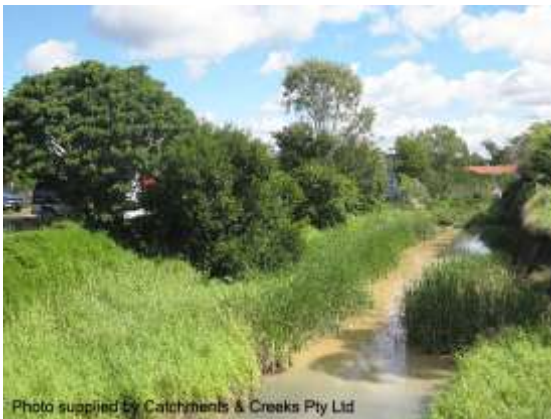
Looking upstream Magura St (2011)

Year 2011

- Substantial tree growth.

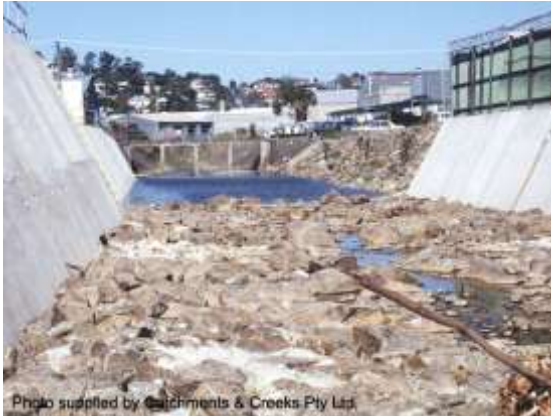
Year 1997

Looking d/s to Magura St footbridge

- At the request of a business located adjacent to the channel, 'ecological features' were designed into the concrete channel.
- These 'experimental' features included rocks being grouted to the channel floor.
- The intent was for vegetation to establish over these rocks to help establish a more-natural channel bed ecosystem.

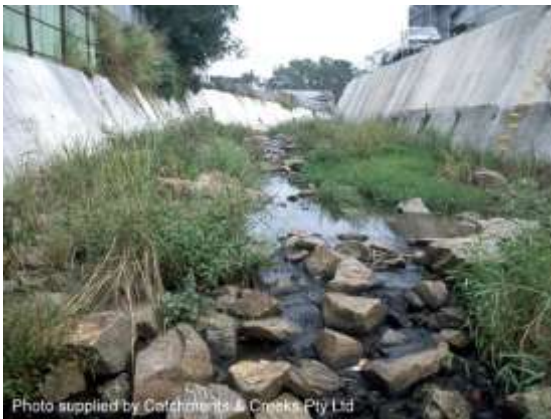
Year 1999

Looking upstream (1999)

- Sediment has settled between the rocks and plants are now beginning to establish on the channel bed.
- A low-flow channel has formed through the planted rocks.

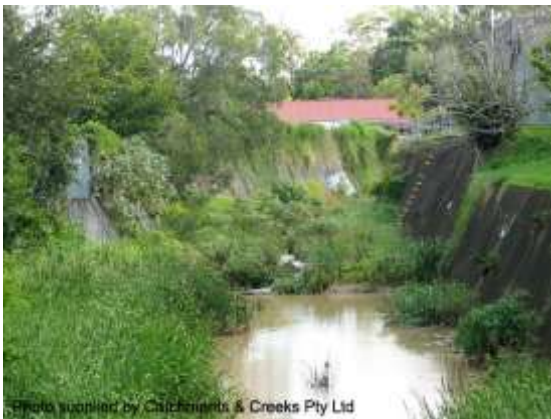
Year 2011

Looking upstream from footbridge (2011)

- Plants and an associated ecosystem have established on the bed of the grouted, rock-lined, concrete channel bed.
- The habitat pond is still visible in the foreground.

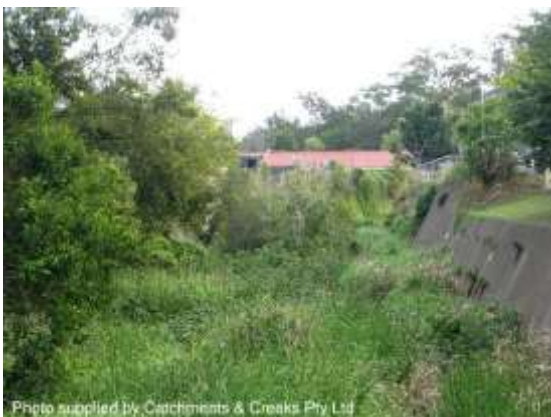
Year 1999

Looking upstream from footbridge (2014)

- Woody species (*Melaleuca*) are now becoming established within the rock-lined concrete channel.
- The growth of such woody species in the concrete channel would not be desirable from a flood control perspective, as well as there is the risk that the roots could dislodge the grouted rocks, which could result in all the plants being dislodged during a flood event.

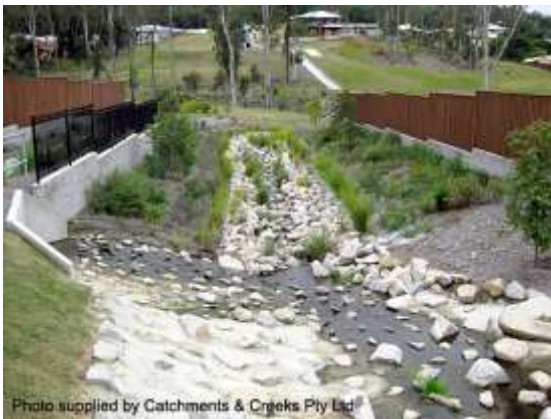
Constructed drainage channel

- The project involved:
 - constructing a vegetated drainage channel in a location where no creek or concentrated flow path had previously existed, and
 - modifying an existing creek channel upstream of Tilquin Street.
- Aspects of this project were closely aligned with the principles of *Natural Channel Design*.

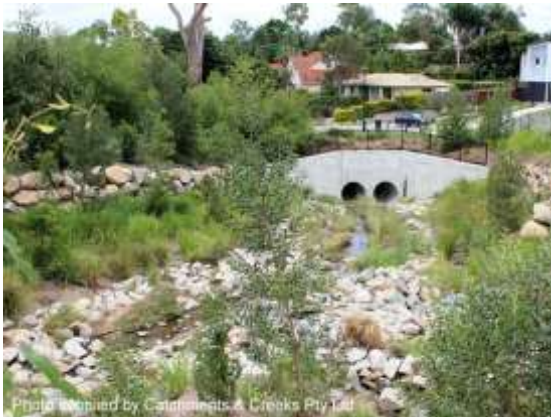
Modified creek channel u/s of Tilquin St

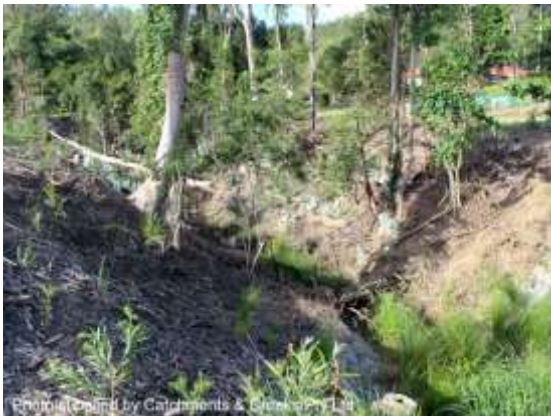
Existing creek upstream of the site (2012)

- The creek that passes through the subdivision is relatively steep.
- Prior to the modifications made during construction of the residential subdivision, the creek contained significant weed infestation and was subject to some ongoing bed and bank erosion.
- The developer was required to stabilise the creek and remove the weeds.

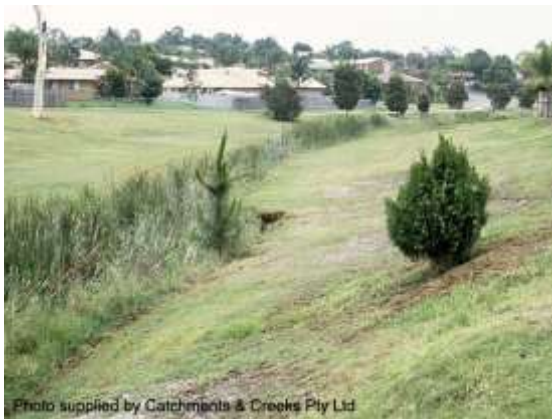
Original grassed trapezoidal channel

- The grass-lined trapezoidal waterway was originally constructed during the 1980s urbanisation of the area.
- The channel was originally developed without a formed low-flow channel, but instead had a sub-surface Ag-pipe drainage system.
- Over time the Ag-pipe blocked with sediment causing a low-flow channel to form (erode) along the channel invert.

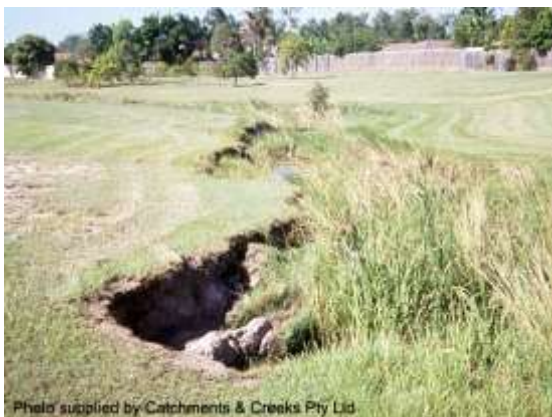
Channel erosion (1998)

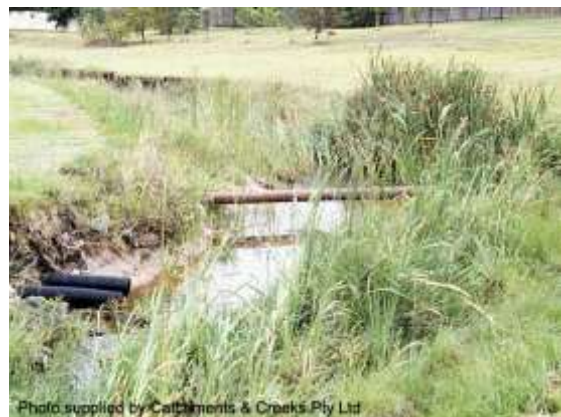
Exposed Ag-pipe & sewer crossing (1997)

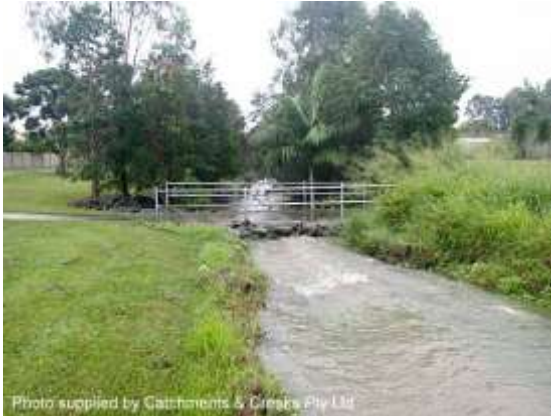
Looking d/s to the footbridge (2010)

- Due to the steep gradient of the creek, and local flood control issues, the decision was made to retain the existing (1998) alignment of the low-flow channel.
- It was also agreed with the council that the footbridge would remain in its current location.

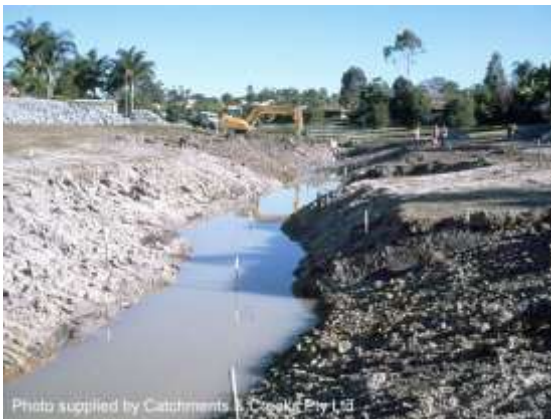
Looking upstream to footbridge (1999)

- Significant quantities of rubbish (burnt tree stumps) and highly erodible slaking soils were found in the stream banks adjacent the low-flow channel, which resulted in the need for this material to be removed.
- The channel was then lined with stable soil and a rock-lined pool-riffle system was constructed.

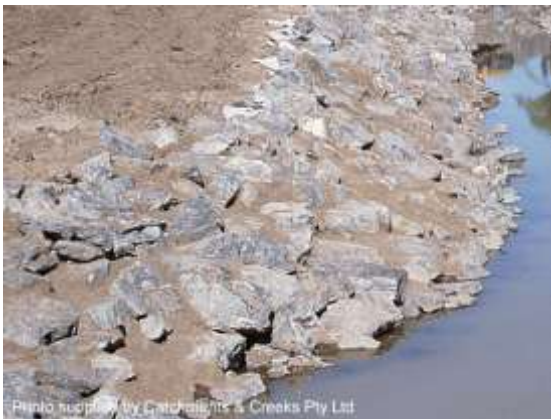
Soil-filled voids ready for planting (1999)

- This project was one of the first examples in Brisbane where the voids between the rocks were filled with soil allowing plants to be introduced into the channel upon completion of the channel works.
- Prior to this, the practice of filling the voids with soil was considered unacceptable due to the risk of the soil being washed from the rocks by stream flows.
- Even though some soil is lost, the benefits gained through the earlier establishment of vegetation are significant.

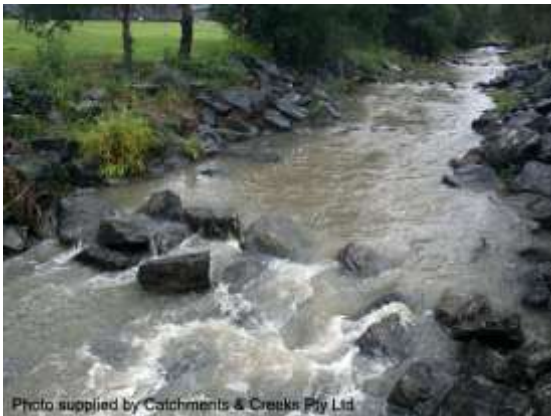
Pool-riffle system (2010)

- The channel falls in elevation only 400 mm at each riffle system, which is approximately the size of the rocks.
- When initially constructed (see photos over page) the individual pools and riffles were not clearly distinguishable amongst all the other bank stabilisation rock.
- Establishment of a canopy cover, which helps to control weeds, allows the pool-riffle system to be more clearly identifiable.

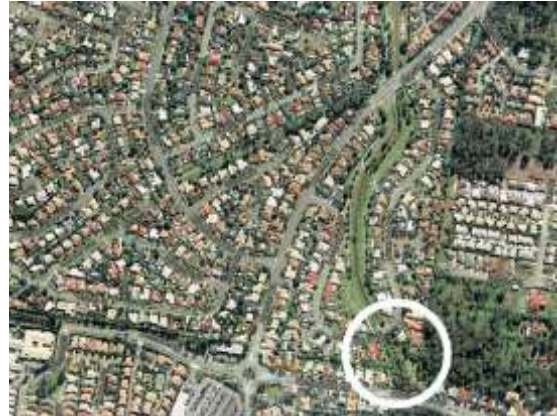
Upstream of Laurel Oak Dr (2001)

- Stage 2 of the Steep Station Gully project consisted of similar channel works being constructed between Nottingham Road and Laurel Oak Drive.
- The lower channel gradient allowed the use of erosion control mats on the battered banks as opposed to rock stabilisation.
- The Laurel Oak Driver culvert was also modified to reduce sediment and debris blockage problems.

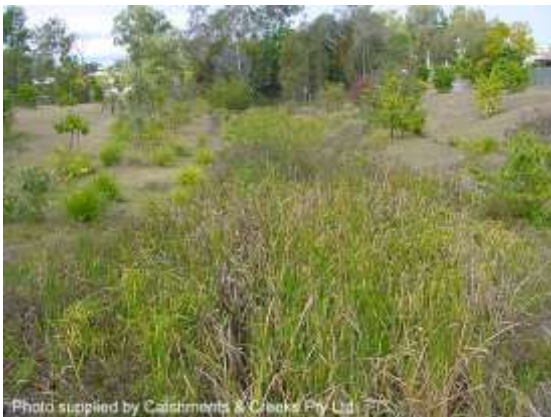
Upstream of Laurel Oak Dr (2004)

- During the early years, plant establishment was dominated by reeds and weeds within the moist low-flow channel.
- At this stage there is the risk of floods causing bank erosion on either side of the reed-infested low-flow channel.

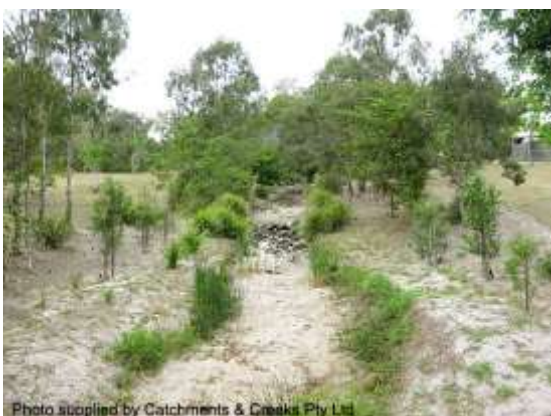
Upstream of Laurel Oak Dr (Nov, 2014)

- Even though a canopy cover has not been successfully achieved, an open low-flow channel is now well defined and the channel banks are partially stabilised with vegetation.
- Ongoing maintenance is required to encourage the establishment of a canopy cover to better control weeds and shade the low-flow channel.
- Loss of rocks is occurring at the riffles.
