Natural Channel Design

Part 4: Case Studies

Part 4 – Case Studies

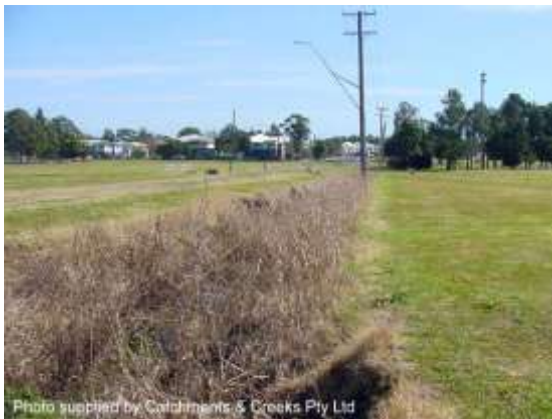
Pre-works site conditions (2003)

- The site was constrained by a planned road south of the drain, and the sports oval north of the drain.
- It was also considered desirable to avoid the relocation of the telephone pole.
- The site contains a cracking clay soil that benefits greatly from suitable vegetation cover that reduces the loss of soil moisture.
- The visually unattractive, low-value stormwater drain was also subjected to urban litter, including shopping trolleys.

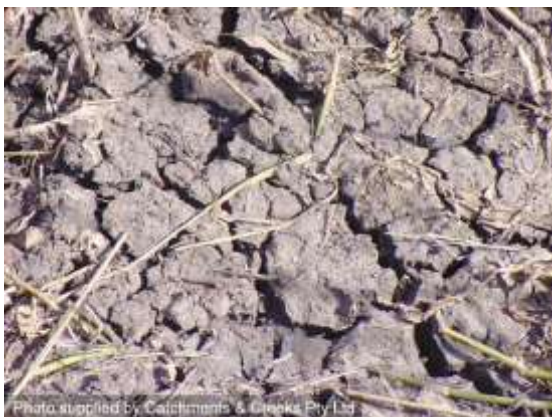
Erodible, cracking black soils

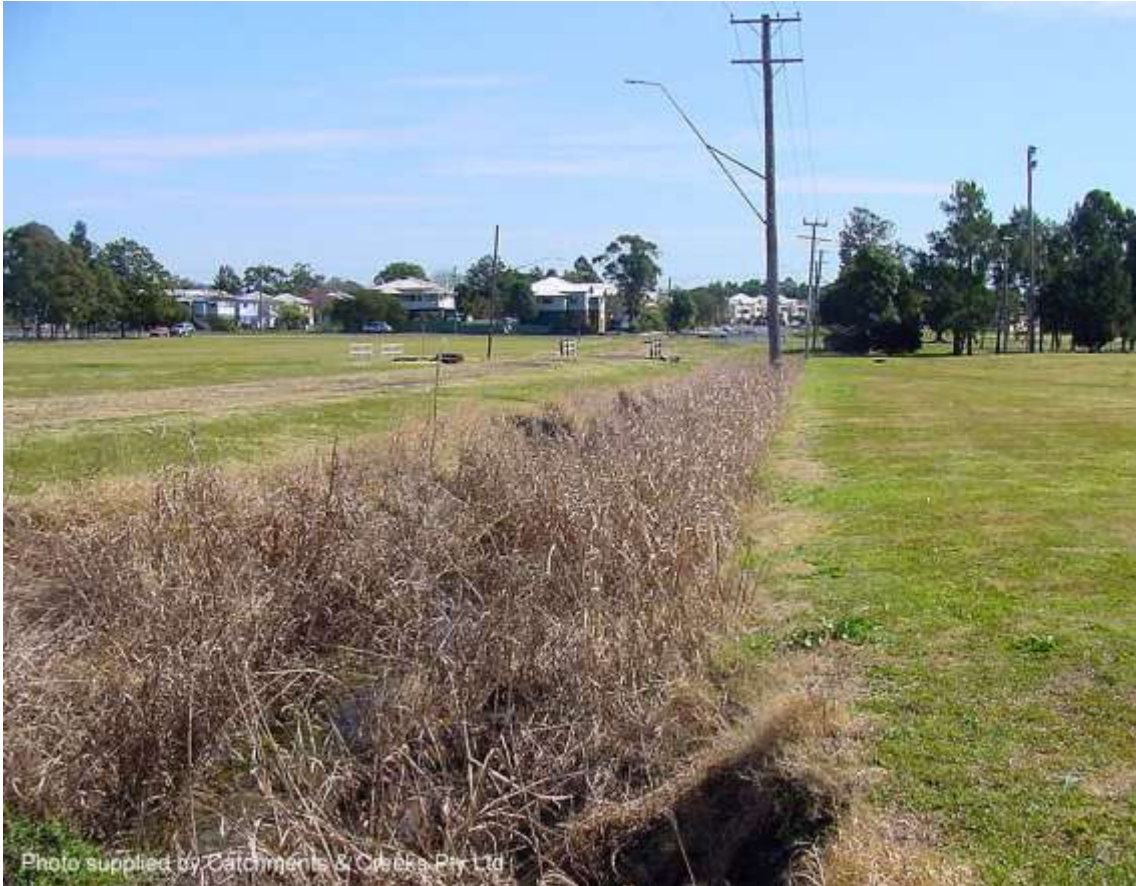
Browns Creek looking downstream in 2003

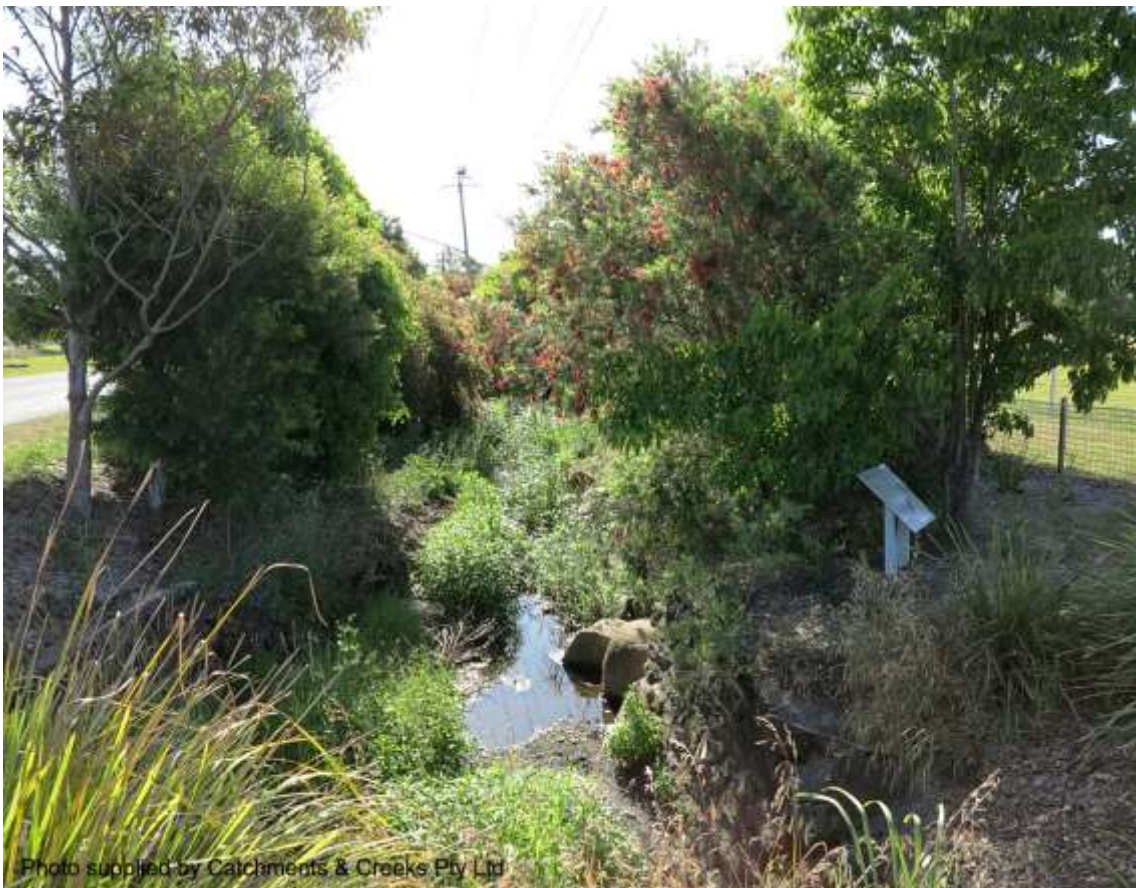
Browns Creek looking downstream in 2014

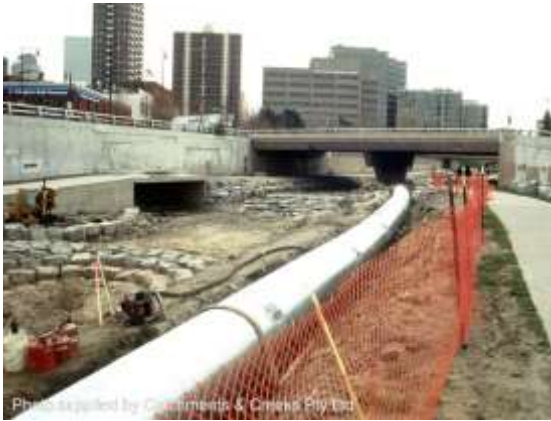
Cherry Ck, Market St, Denver (1995)

- As previously mentioned, Cherry Creek passes through central Denver.
- It is difficult to view these channel works from a 'Queensland perspective' because we do not experience the annual conditions of heavy snow cover, and the effect of this snow cover on riparian vegetation.
- Note the curved weir crests, which focuses flows towards the centre of the channel.

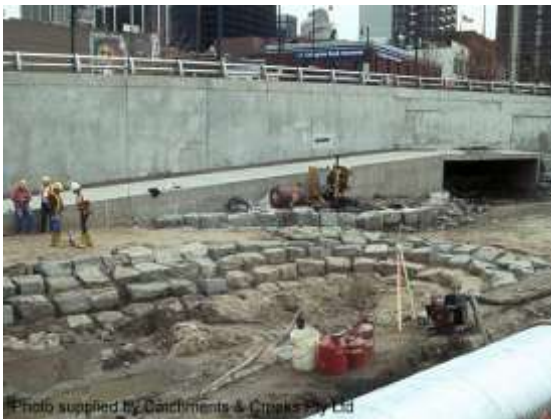
Construction of a weir (1995)

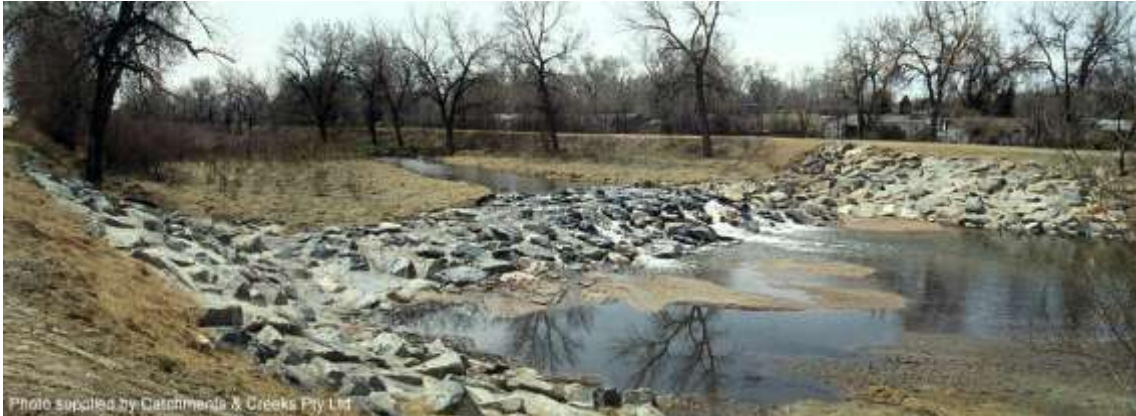
Grouted rock drop structure, Denver (1995)

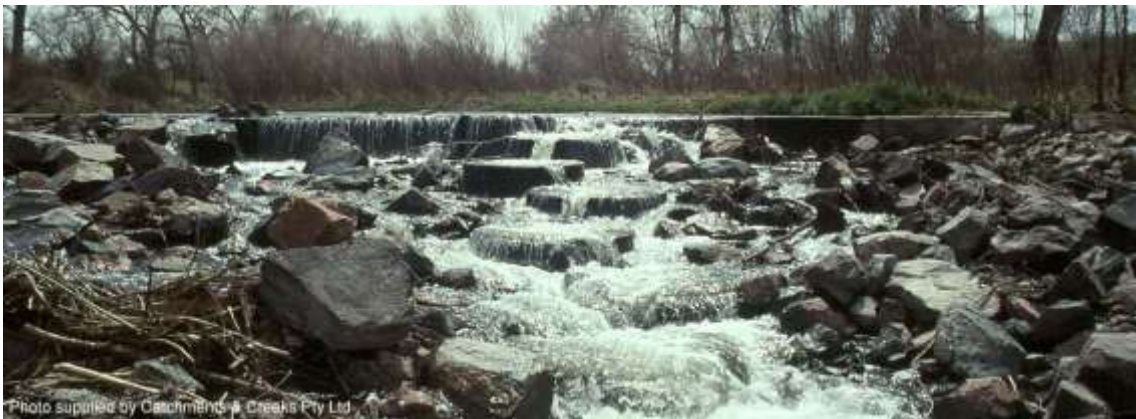
Fishway built into a concrete weir, Denver (1995)

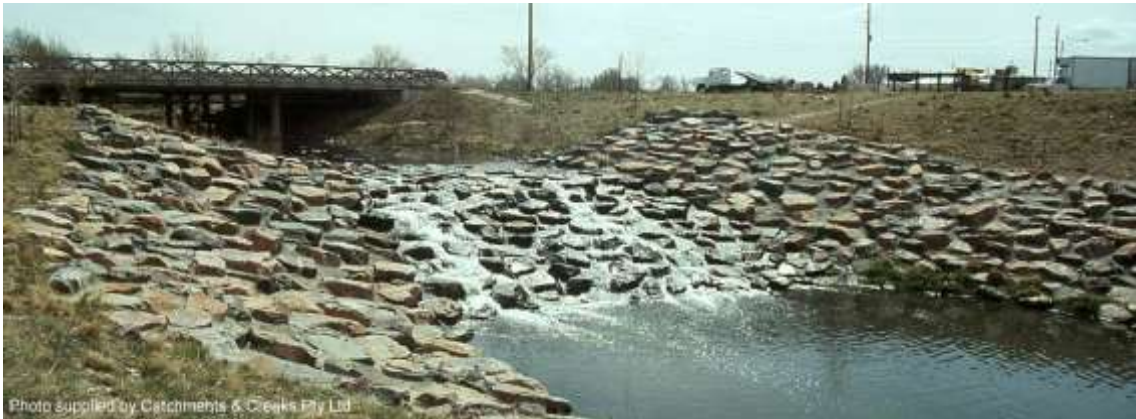
Grouted boulder drop structure, Denver (1995)

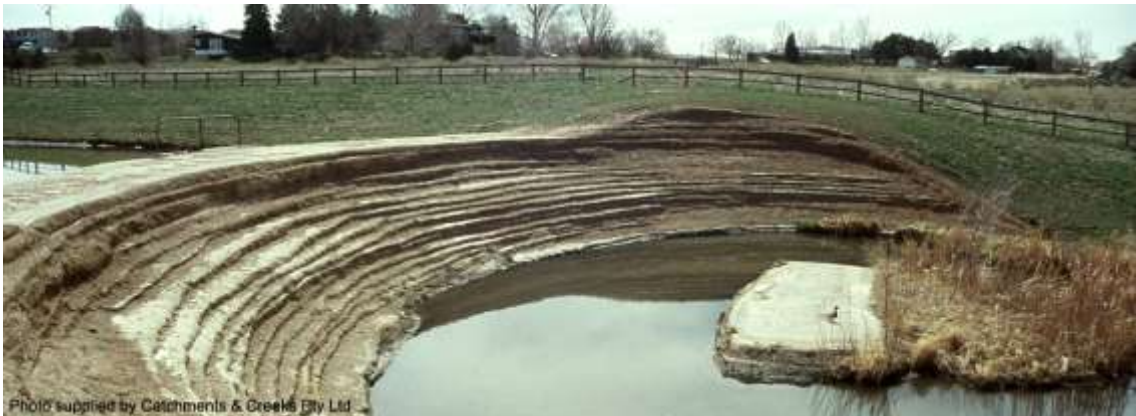
Rolled soil-cement drop structure, Denver (1995)

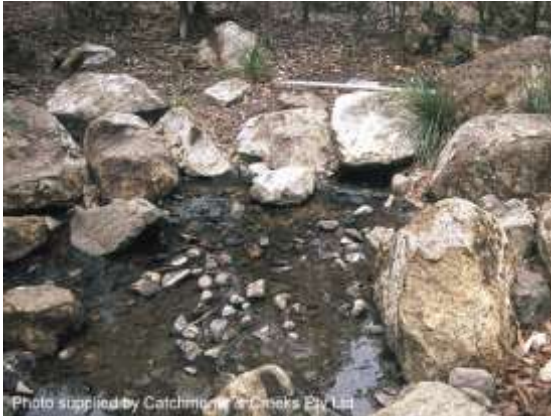
The source of the stream (1998)

- Water is pumped from the adjacent lake and released as a 'spring' at the top of the hill.
- The water passes down a fully constructed rock-lined spring until it reaches the lower wetlands.
- The water is aerated as it descends the channel.

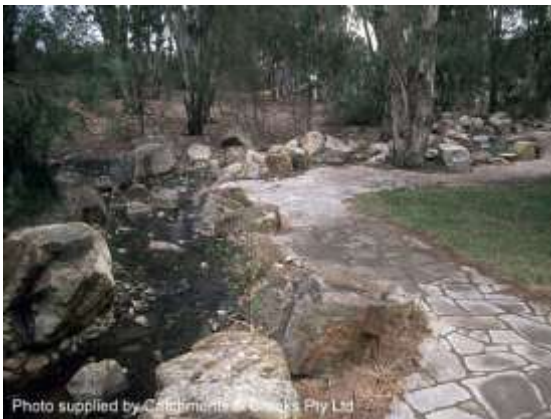
Constructed rock-lined watercourse

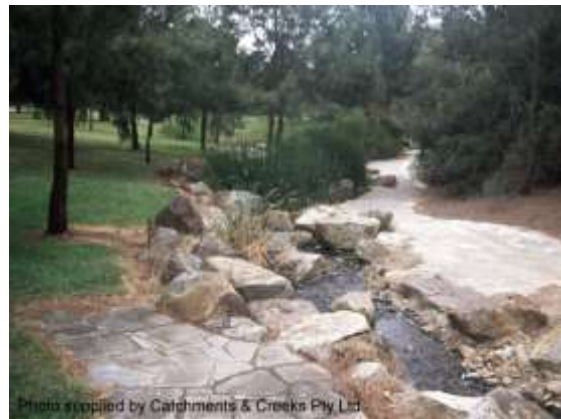
Constructed rock-lined watercourse

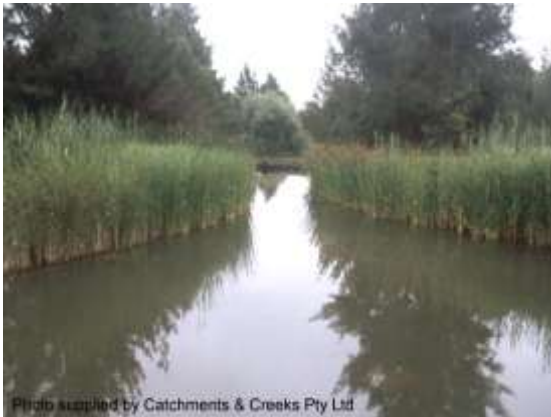
Constructed wetland

- The water then passes through a series of wetlands within which the water benefits from nitrogen removal, and the settlement of fine particles.

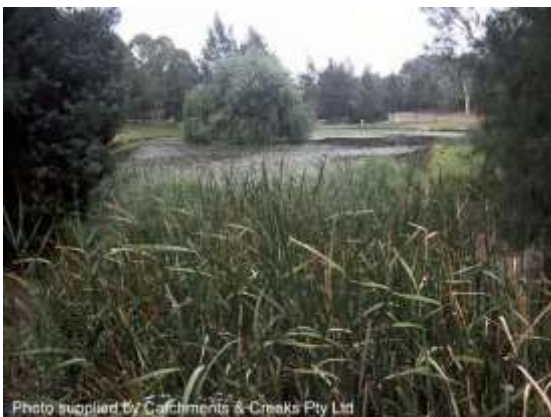
Constructed wetland

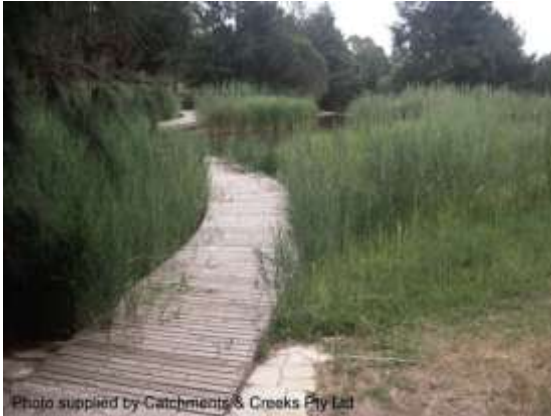
Boardwalk through the wetland

Public access across the wetlands

- If appropriately designed, the various pedestrian crossings and stepping stones can be used to reduce the risk of 'deadwater' zones within the wetlands.

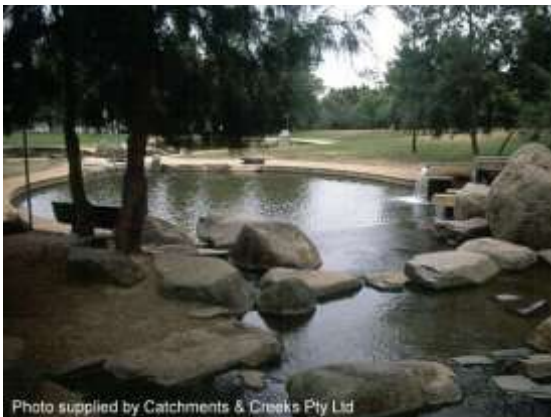
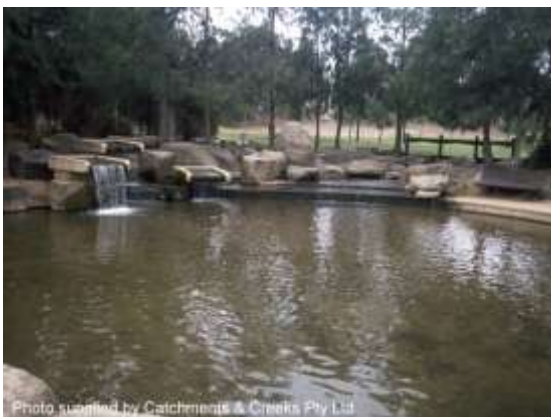
Lower recreation area

Stormwater treatment ponds

- After passing through the wetlands, the water enters a series of shallow ponds, which allows UV treatment of the water.
- The water finally exits the treatment systems by passing down a stepped drop structure (weir), that re-aerates the water before it returns to the lake.

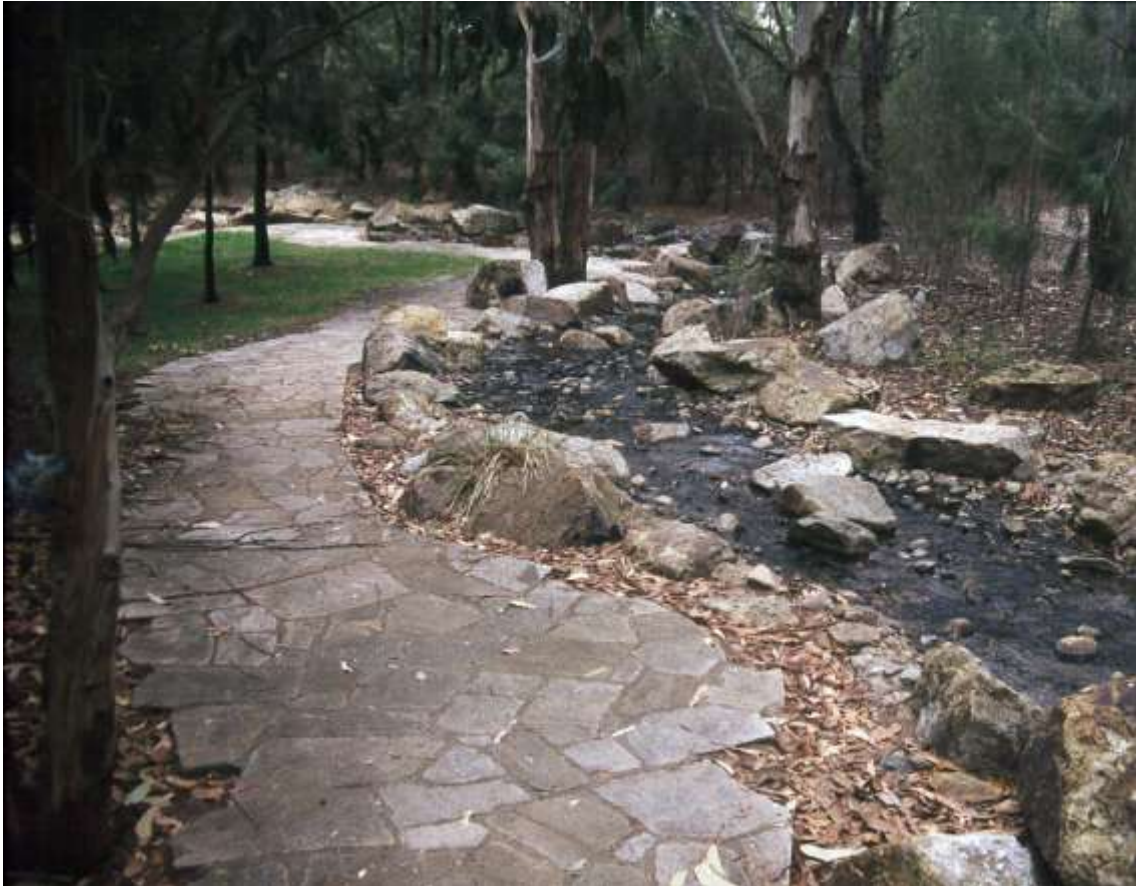
Constructed, constant pump-fed watercourse (ACT)

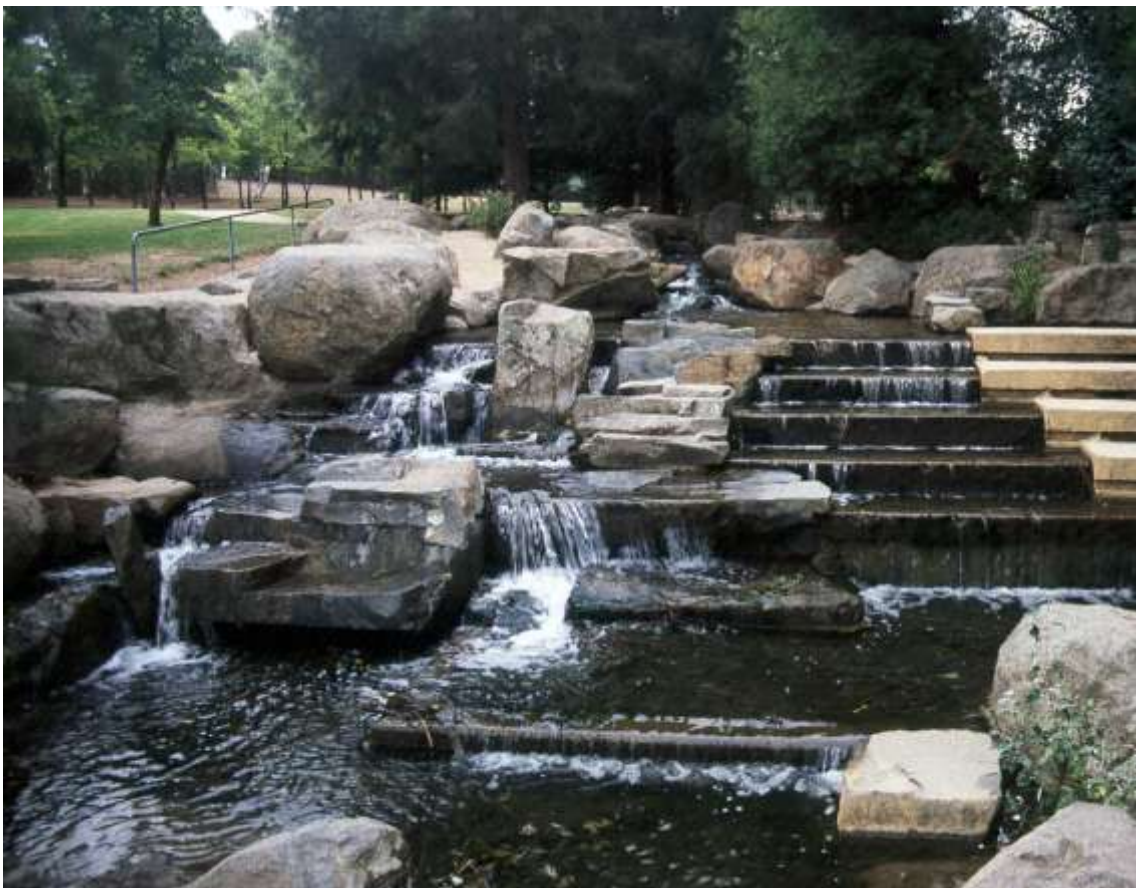
Final discharge spillway into Lake Ginninderra (ACT)

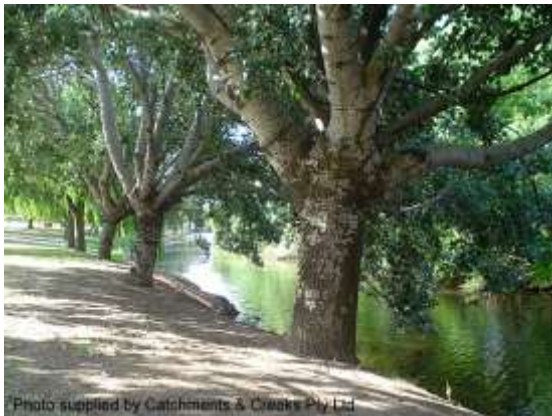
- Adelaide is well known for being a 'planned' city, which usually means a city primarily planned for human usage.
- The city's parks, including the linear park, are largely designed as open space parks with few regions of dedicated bushland.
- The Torrens River downstream of the city has only isolated sections of fauna-friendly riparian vegetation.
- It is the need for flood control that often prevents the retention of healthy, fauna-friendly riparian cover.

Poor riparian cover (2006)

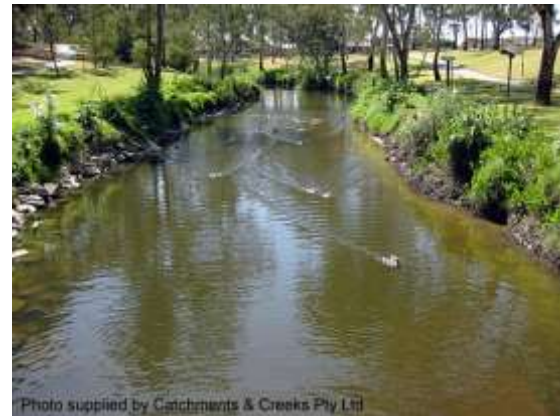
Poor riparian cover (2014)

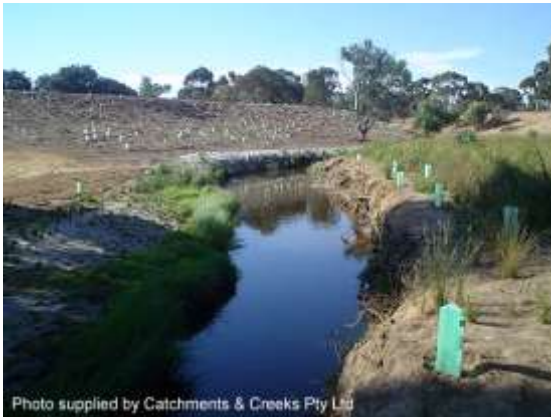
Replanting of riparian zone (2006)

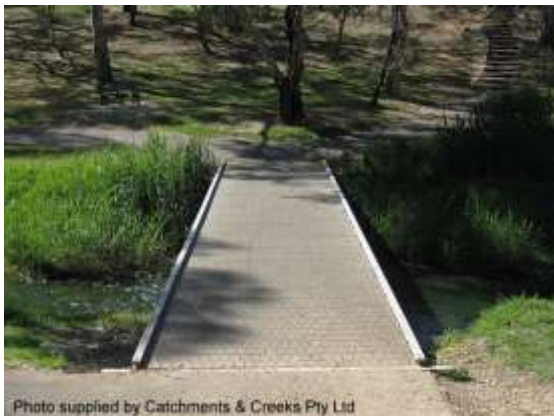
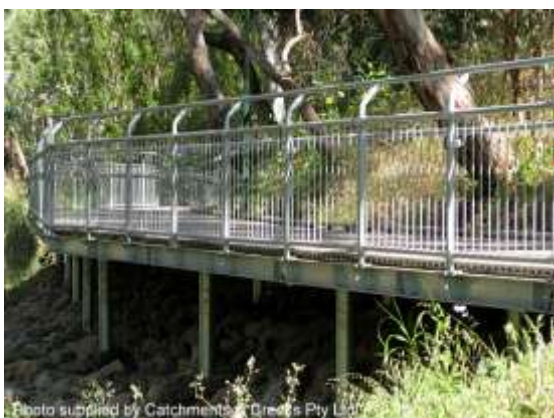
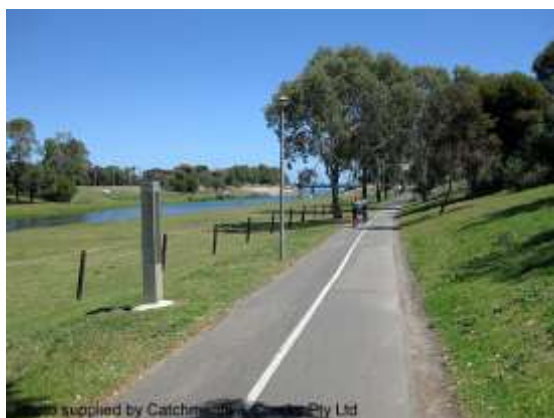
Public access to the river

Footbridge (2014)

- People that are involved in the design of human movement corridors could learn a lot from a tour of Adelaide's linear park.
- The designers the linear park have used a variety of pathway designs in order to provide continuity along the waterway, while also addressing flood control issues.
- At some locations the pathway leaves the channel, and moves along adjacent roadways.

Elevated pathway (2014)

Pedestrian and cycle way (2014)

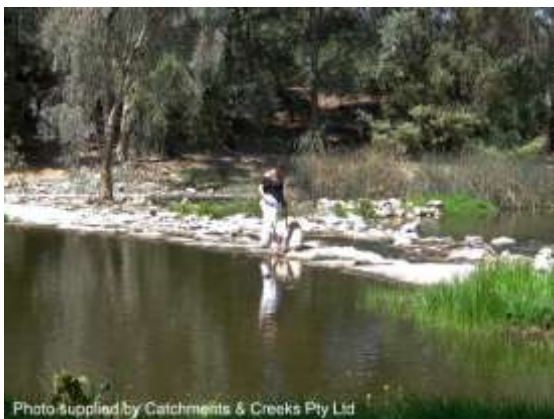
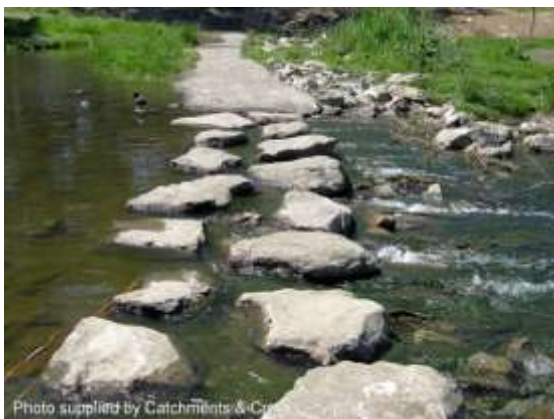
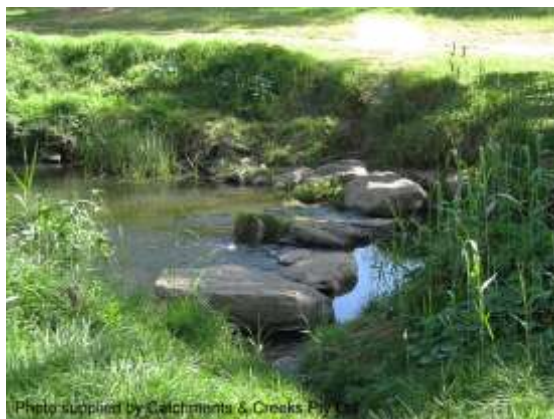
Stepping stones (2014)

- The Torrens River utilises a number of different pedestrian crossings of the river.
- Stepping stones allow human movement and fish passage, but can limit terrestrial movement.
- Weirs, which are common in the lower reaches of the Torrens River, can be used for human movement and terrestrial movement (if appropriately designed), but are undesirable for fish passage, and consequently have fishways incorporated into their design.

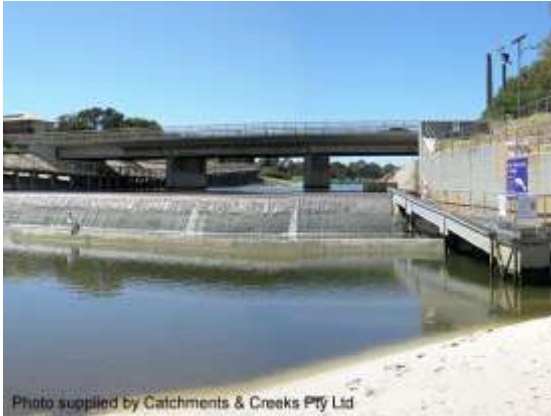
Fish ladder (fishway)

Outlet weir (2014)

- Fish passage along waterways is critical to the survival of native fish.
- All freshwater fish and some salt water species, regardless of their size, move within waterways at different times to access food and shelter, to avoid predators, and to seek out mates to breed and reproduce.
- Of the 83 species of freshwater fish in south-eastern Australia, approximately half migrate at least once as part of their life cycle.

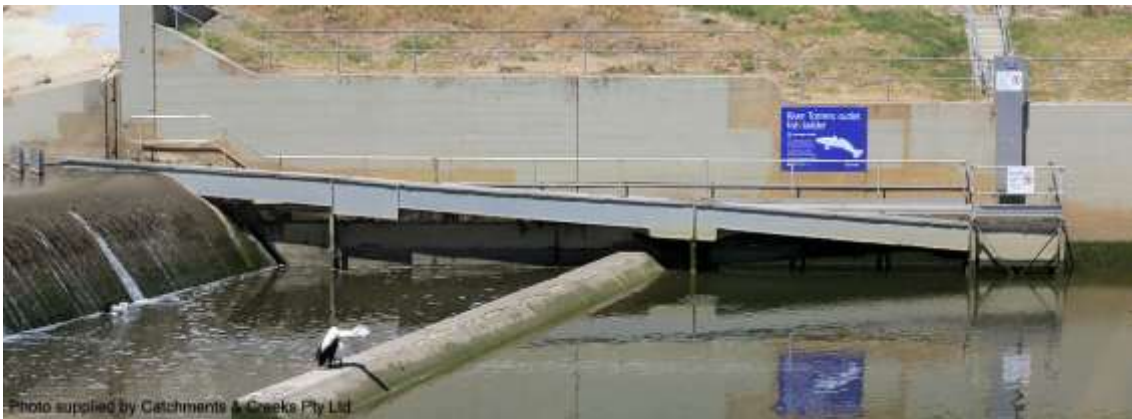
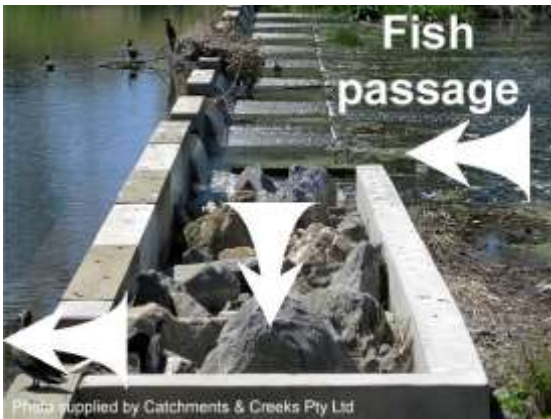
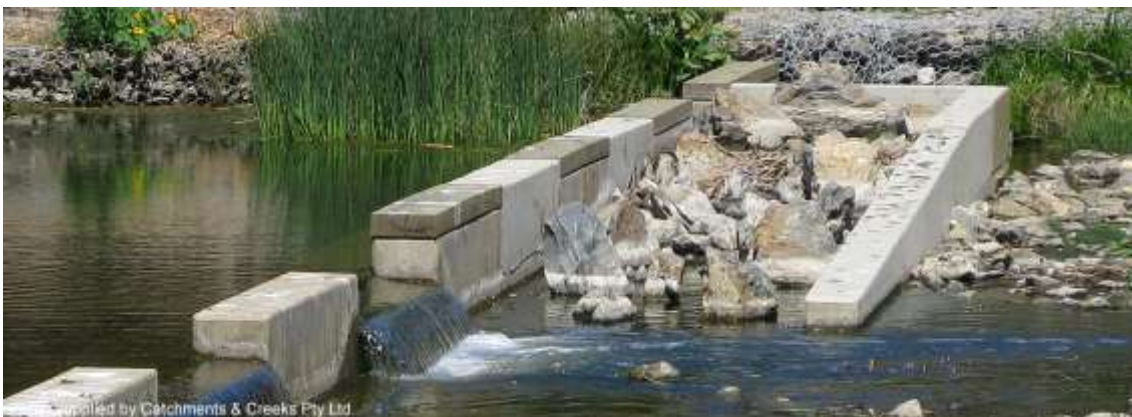
Fishway integrated into the weirs

Fishway (2014)

- Fish passage is the movement of fish and other aquatic organisms up and down a watercourse.
- Movement can be for a variety of reasons including:
 - migration
 - reproduction
 - access new habitats
 - feeding
 - avoid predators
 - shelter from floodwaters.
